ACME Water District

36-inch BWP Aqua Connector

Condition Assessment Report, Standard Analysis

PICA Project: 7654

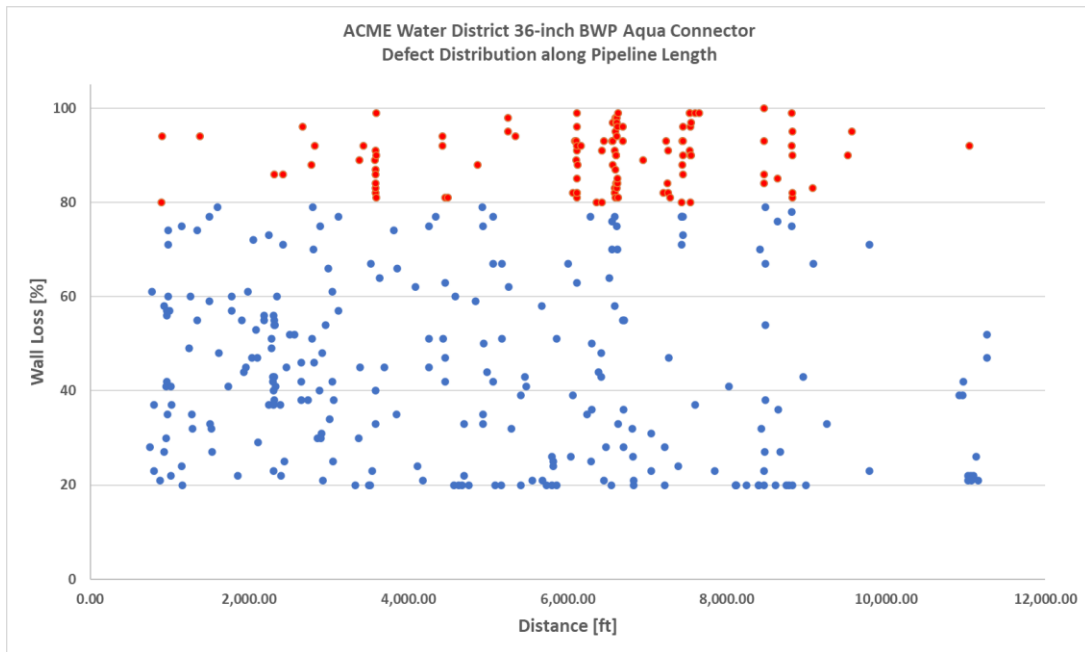
Figure 1 and Figure 2 summarize the distribution of localized wall loss indications along the inspected section. Defects measuring $\geq 80\%$ Wall Loss (LW) are highlighted in red. There may be some (partially) overlapping data points due to defect proximity.

Figure 1 – Distribution of localized wall loss along the 36-inch BWP Aqua Connector.

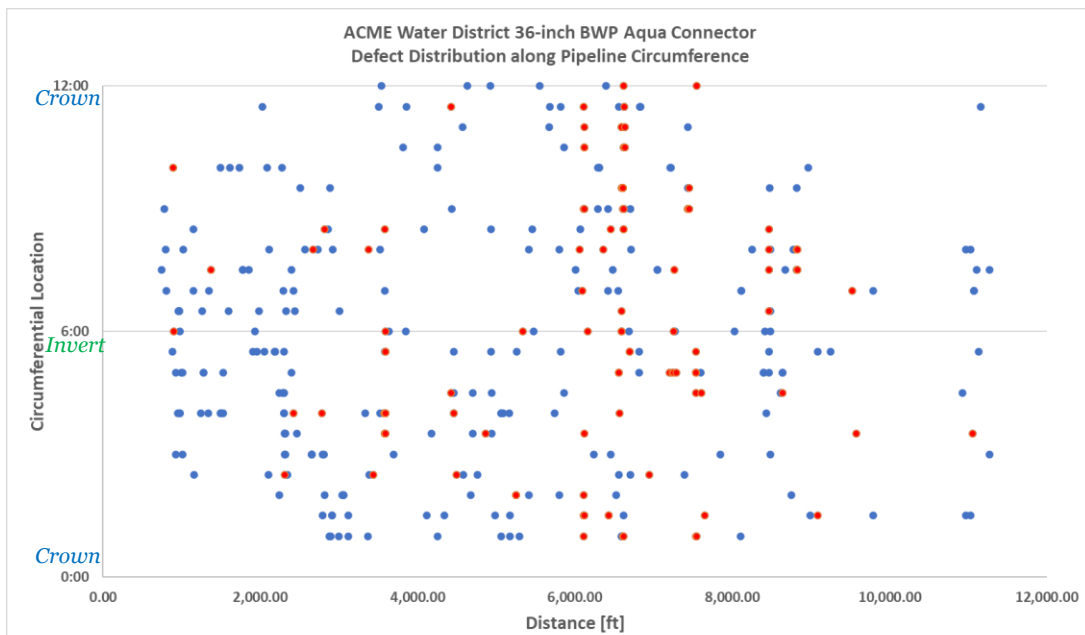
Figure 2 – Distribution of localized wall loss with respect to circumferential location along the 36-inch BWP

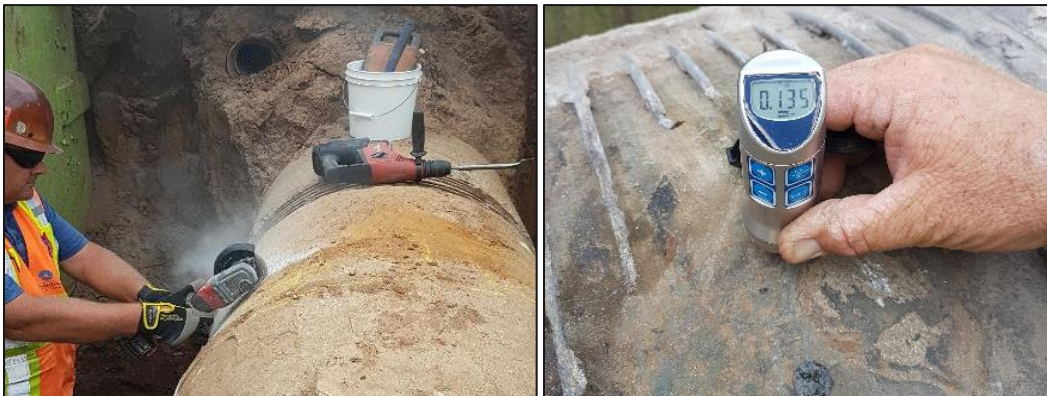
Verification work on Segment 149 occurred in January 2020, immediately following the RFT inspection of the respective section. The RFT data indicated the presence of two (2) significant wall loss indications on this pipe.

Anomaly ID	Location (ft) <i>*From MH1 (7+20)</i>	Clock Position	RFT Reported Wall Loss (%)	UT Measured Wall Loss (%)	Verified Clock Position	Confidence Ranking*
21009	4,427.93	11:30	80%+	~64%	11:30	High
20948	4,428.44	4:30	80%+	~64%	4:30	High

As this segment was fully exposed within the excavated access pit, AWD was able to investigate the reported corrosion indications both internally and externally. Visual inspection of the pipe revealed the external mortar liner to be in good condition, with no evidence of corrosion. Subsequent removal of the mortar liner at the location of the reported anomaly revealed extensive damage and corrosion to approximately 9 bar wraps in the immediate area. AWD also discovered external corrosion on the cylinder using Ultrasonic Testing (UT). The indications, measured as 80%+ wall loss in the RFT data, were estimated to be approximate 64% wall loss based on the UT readings.

Figure A1. The mortar liner was removed by AWD technicians at the reported site of the corrosion (left). A UT probe was then used to measure the depth of the observed external corrosion in Segment 149 (right).

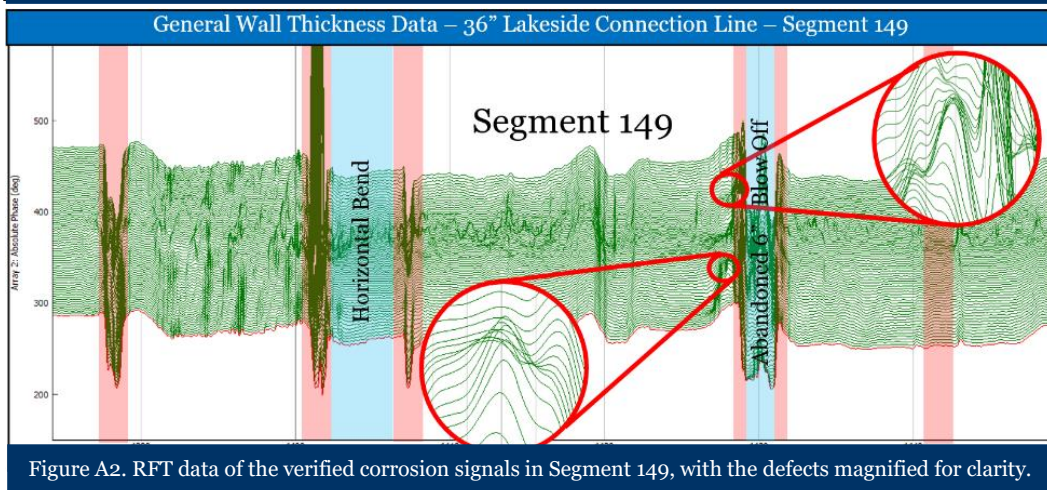
Figure A2. RFT data of the verified corrosion signals in Segment 149, with the defects magnified for clarity.

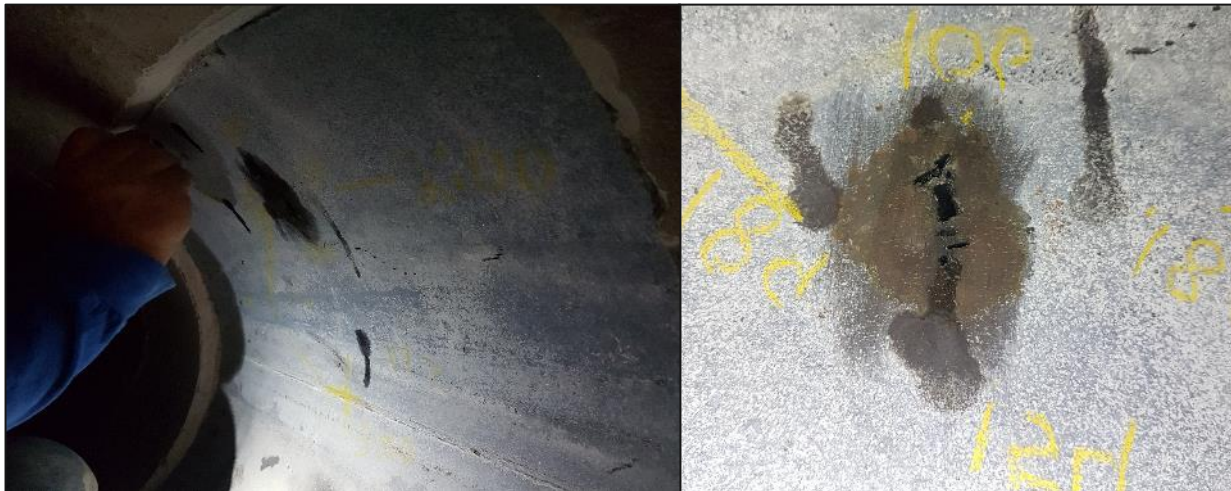
Table A2: Segment 153 – Verified Defect						
Anomaly ID	Location (ft) <i>*From MH1 (7+20)</i>	Clock Position	RFT Reported Wall Loss (%)	UT Measured Wall Loss (%)	Verified Clock Position	Confidence Ranking*
16248	4,493.73	2:30	80%+	100%	2:30	High

The verification on this pipe began with an internal visual inspection. The pipe’s internal mortar liner was found to be in good condition at the reported defect location. Subsequent removal of the mortar liner confirmed the presence of a significant corrosion patch. The defect indication, reported as 80%+ wall loss, was confirmed by AWD to be a through-hole (100% wall loss) using UT.

Figure A3. AWD internally exposed the reported defect location in Segment 153 (left). The reported defect location was then verified to be 100% wall loss using UT (right).

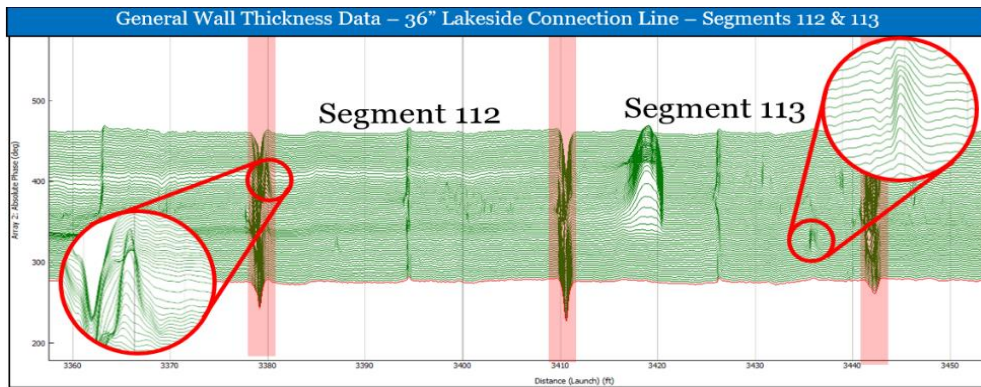
Table A3: Segments 112 & 113 – Verified & Investigated Defects							
Anomaly ID	Location (ft) <i>*From MHI (7+20)</i>	Segment #	Clock Position	RFT Reported Wall Loss (%)	UT Measured Wall Loss (%)	Verified Clock Position	Confidence Ranking*
150074	3,379.79	112	8:00	80%+	100%	8:30	High
149262	3,386.98	112	2:30	45%	N/A	N/A	Low
143832	3,435.80	113	2:30	80%+	100%	3:30	High

The internal and external mortar liner was found to be in good condition at the reported defect locations. Subsequent removal of the internal and external mortar liner confirmed the presence of two (2) of the three reported defect indications.

- **Anomaly # 150074:** Reported as 80%+ wall loss in the RFT results, visual inspection confirmed this indication to be a through-hole (100% wall loss), measuring approximately 2.5” H x 2” W.
- **Anomaly #149262:** Reported as 45% wall loss in the RFT results, AWD technicians were unable to find corrosion at this location. PICA has reclassified this indication as a manufacturing-related anomaly.
- **Anomaly #143832:** Reported as 80%+ wall loss in the RFT results, visual inspection confirmed the presence of two (2) pinholes (100% wall loss) at 3:00 and 3:30.

Figure A4. RFT data of the verified corrosion signals in Segments 112 and 113, with the defects magnified for clarity.

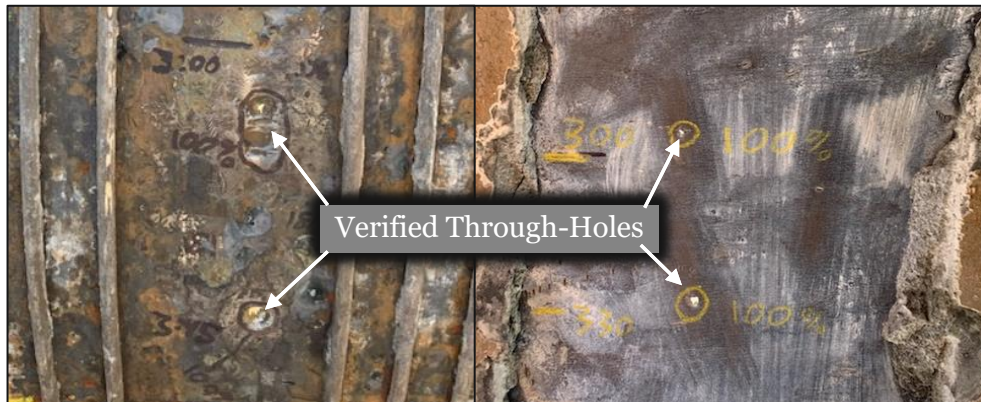
Figure A5. Segment 113 - AWD investigated the reported defect signal externally (left) and internally (right) and discovered two pinholes (100% through-holes) at this location.

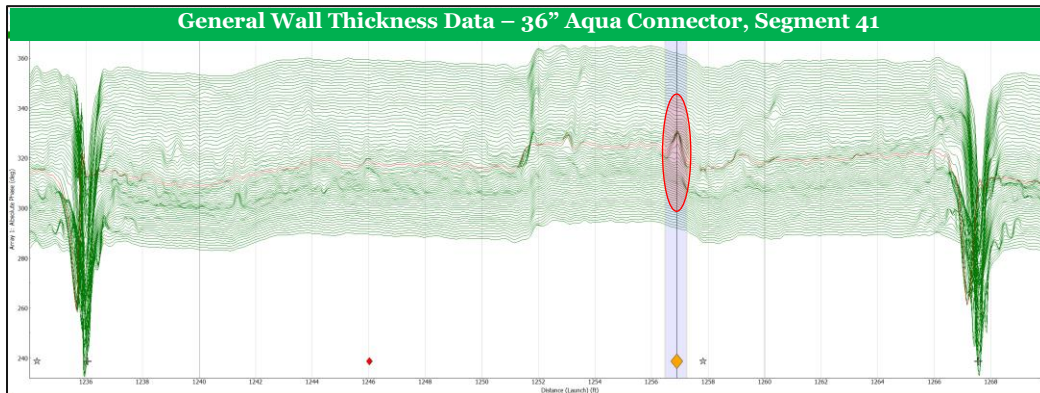
Anomaly ID	Location (ft) <i>*From MH1 (7+20)</i>	Segment #	Clock Position	RFT Reported Wall Loss (%)	UT Measured Wall Loss (%)	Verified Clock Position	Confidence Ranking*
194111	1,256.90	41	6:30	60%	No corrosion found	N/A	Low
184933	1,340.59	44	4:00	55%	No corrosion found	N/A	Low
184087	1,347.72	44	7:00	74%	No corrosion found	N/A	Low

**Prior to the verification, these defects were suspected to be wall loss related but weaker signal responses. PICA now suspects that the observed signals are manufacturing related magnetic permeability anomalies. As a result, these defects, and others with similar characteristics are reported with low confidence.*

Investigation of all three (3) indications did not reveal any corrosion at the reported locations on either the interior or exterior of the pipe. As a result, PICA reclassified these defects, as well as additional defects that shared similar signal characteristics, as low confidence indications. PICA suspects that the observed signals are manufacturing related magnetic permeability anomalies. Contact your PICA representative if additional investigation of other low confidence defects is performed in the future so the results can be further refined.

Figure A6. RFT data of the reported anomaly in Segment 41. AWD did not reveal any corrosion at the reported location.

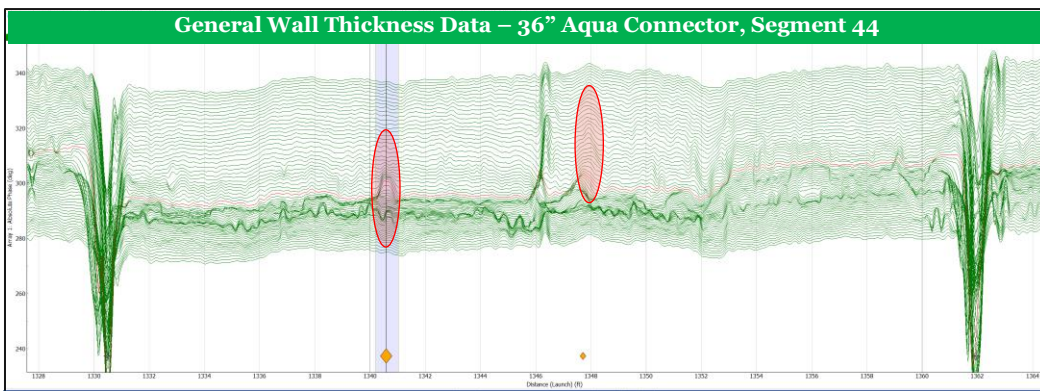
Figure A7. RFT data of the reported anomalies in Segment 44. AWD did not reveal any corrosion at the reported locations.

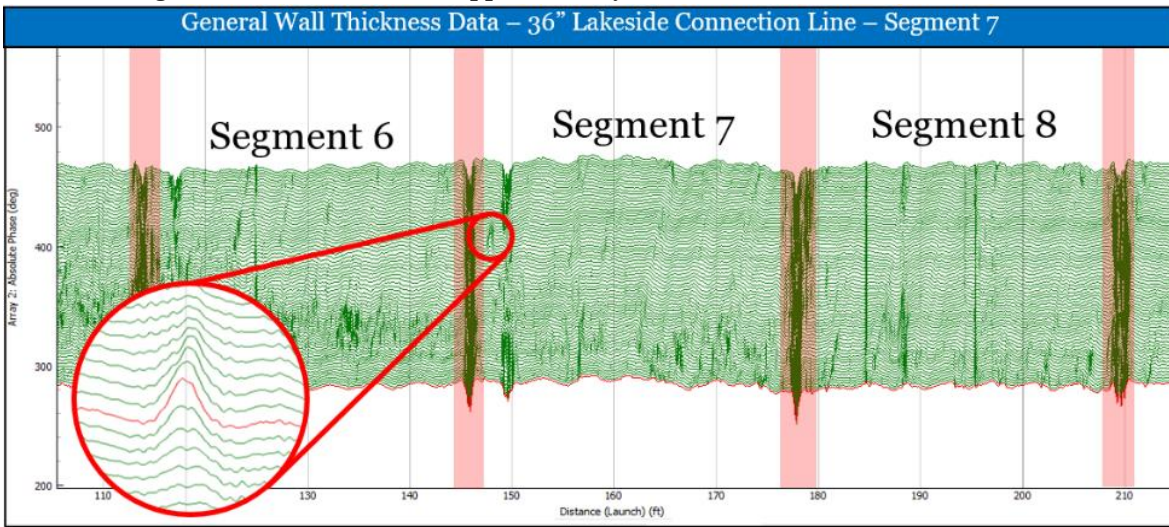
Table A5: Segment 153 – Verified Defect						
Anomaly ID	Location (ft) <i>*From MH1 (7+20)</i>	Clock Position	RFT Reported Wall Loss (%)	UT Measured Wall Loss (%)	Verified Clock Position	Confidence Ranking*
16564	107.72	1:00	80%+	100%	1:30	Medium

Figure A8. RFT data of the verified through-hole (100% WL) in Segment 7, with the defect signal magnified for clarity.

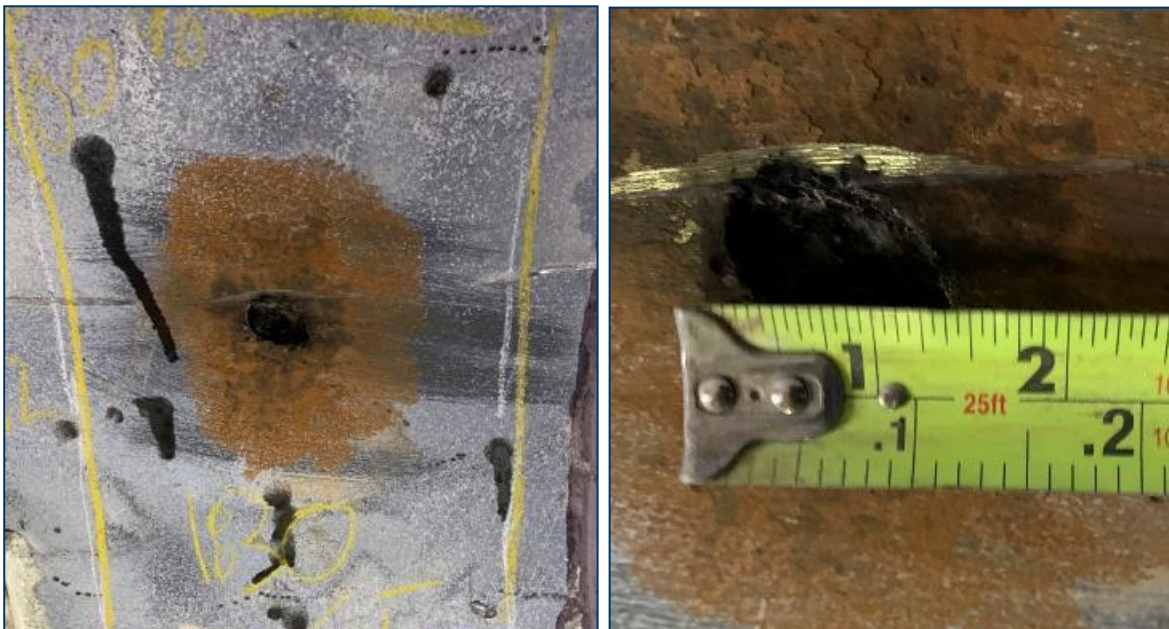
AWD’s initial investigation found the pipe’s interior to be in good condition, with no signs of corrosion through the mortar lining. Subsequent removal of the mortar lining at the reported defect location revealed a through-hole (100% wall loss), approximately 1.0” W x 1.5” H in dimension.

Figure A9. Verified through-hole (100% wall loss) defect in Segment 7, measuring approximately 1.0” W x 1.5” H.

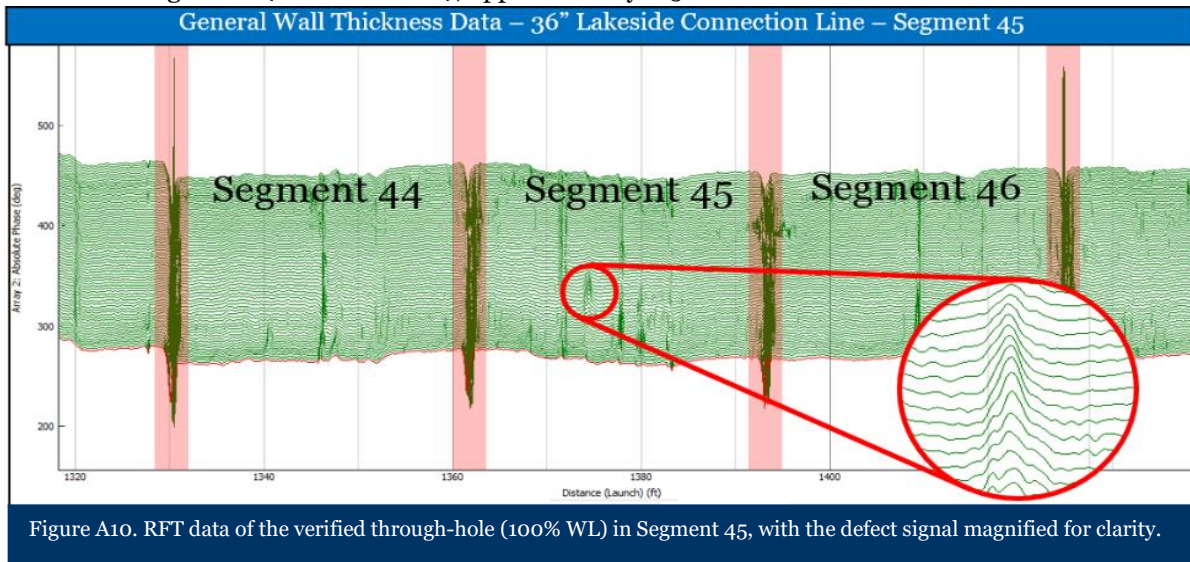
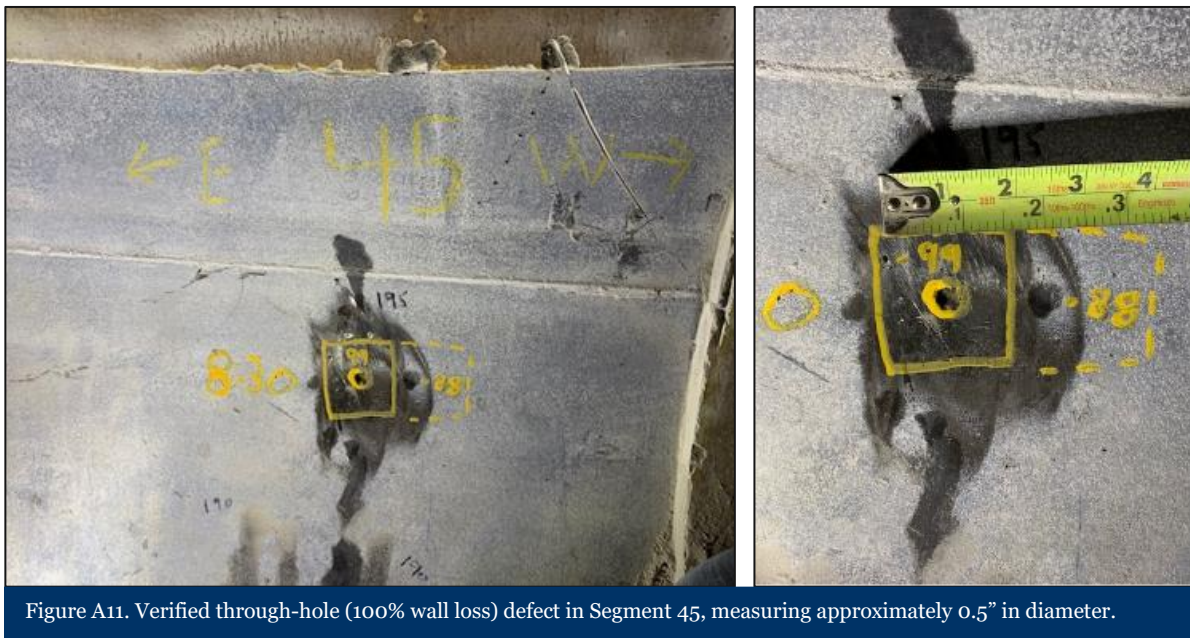
Segment 45 - March 2020

AWD’s initial investigation found the pipe’s interior to be in good condition, with no signs of corrosion through the mortar lining. Subsequent removal of the mortar lining at the reported defect location revealed a through-hole (100% wall loss), approximately 0.5” in diameter.
