Dig Sheet for: Pipe 5010 - 48-inch Steel CML Water Pipeline

Client	Organa Water
Pipeline	48-inch Steel CML Water Pipeline
Location	Tatooine
Pipe Size and Material	48-inch Steel
Inspection Date [Method]	November 2 nd - 4 th , 2021 (Dual Tethered SeeSnake ILI)

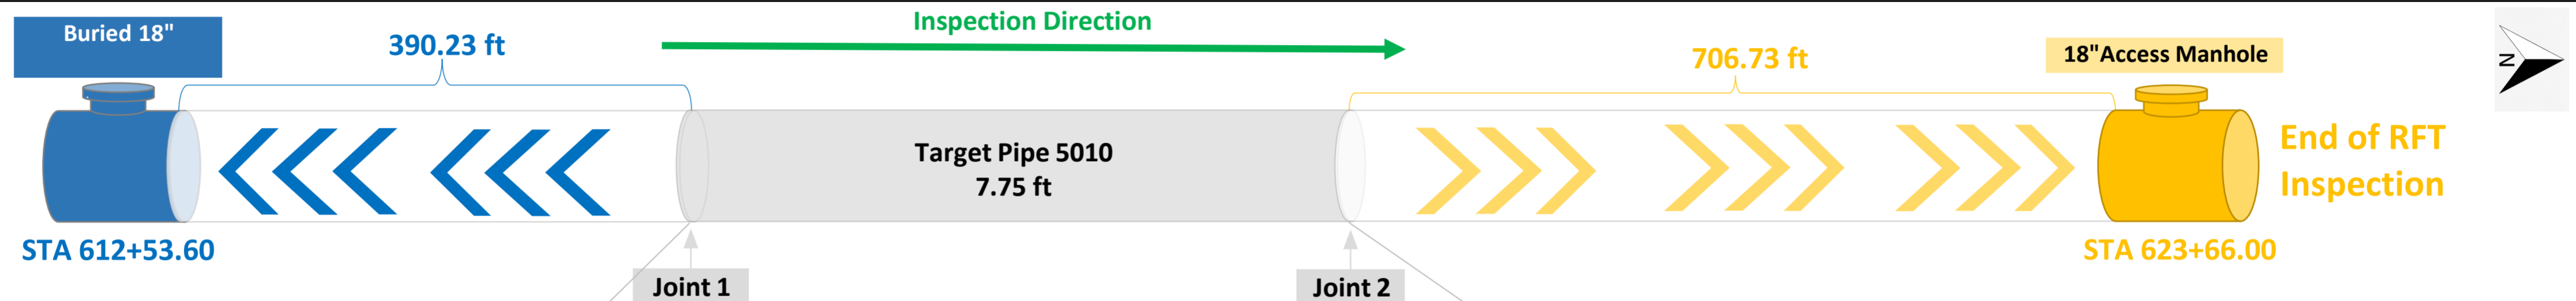
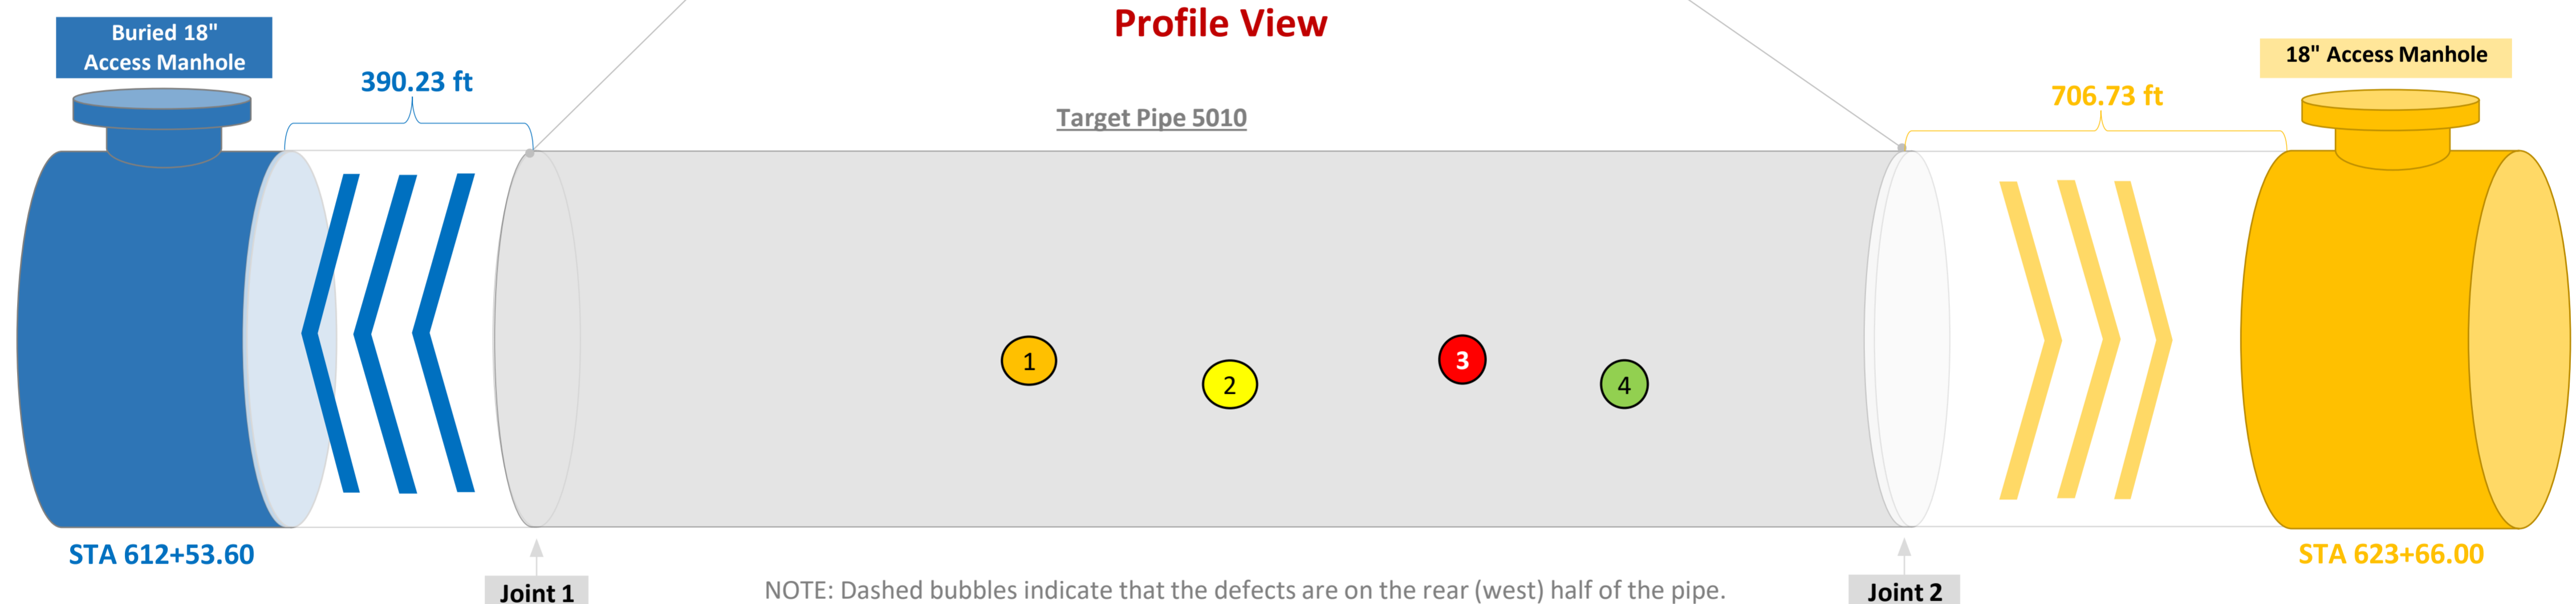
INDICATION LOCATION and MORPHOLOGY									
Pipe Number	Wall Loss ID	Reported Location (ft)	Distance to Joint 1 (ft)	Distance to Joint 2 (ft)	Clock Position *Looking North	Estimated Remaining Wall (%)	Estimated Defect Length (in)	RFT Signal Strength [Span %]*	Additional Notes
5010	LWL-1	3,814.87	2.95	4.80	3:30	31	3.02	63	
5010	LWL-2	3,815.98	4.06	3.69	4:00	42	1.31	27	
5010	LWL-3	3,817.31	5.39	2.36	3:30	<10%	2.71	341	Deepest and largest volume defect in the 48in WTM
5010	LWL-4	3,818.21	6.29	1.46	4:00	64	3.14	139	Large volume defect.
