## 60"-78" EMIT Inspection Tool

## Project Snapshot

- Where: Southern USA
- What: 65 & 66-inch Raw Water Feeder Main Inspection
- When: 2017
- How: Tethered over 16 sections
- Why: Feeder main is over 50yrs old and identified as critical asset
- Distance: Five miles (8 kms) in total; up to nearly 3000 feet/day (between MH access points)

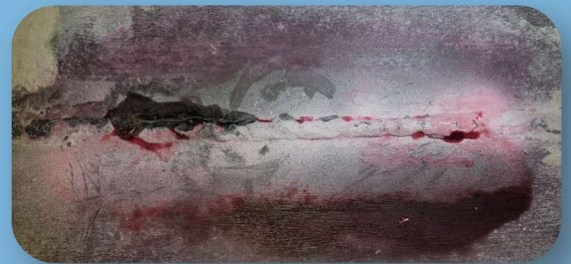
The inspection identified several areas of interest, such as partially threaded grout plugs, and seam weld defects. At one of the seam weld defects, cracking and water intrusion behind the internal cement liner were confirmed by the client; the extent of the weld defect was verified with a liquid penetrant inspection by the pipeline asset management team (image on right).
