Inspection Report
Bracelet™ Probe Inspection
Gwinnett County Force Main Sites

Site # ACDT 16-09B
(254 Springs Road)

Field Crew	Allen Russell and Patrick Lake
Data Analyst	Allen Russell
Inspection dates	July 20, 2017
Reviewer	David Russell
Preliminary report date	July 20, 2017
Revision	0.1

Inspection Test Site # ACDT 16-09B, (254 Springs Road)

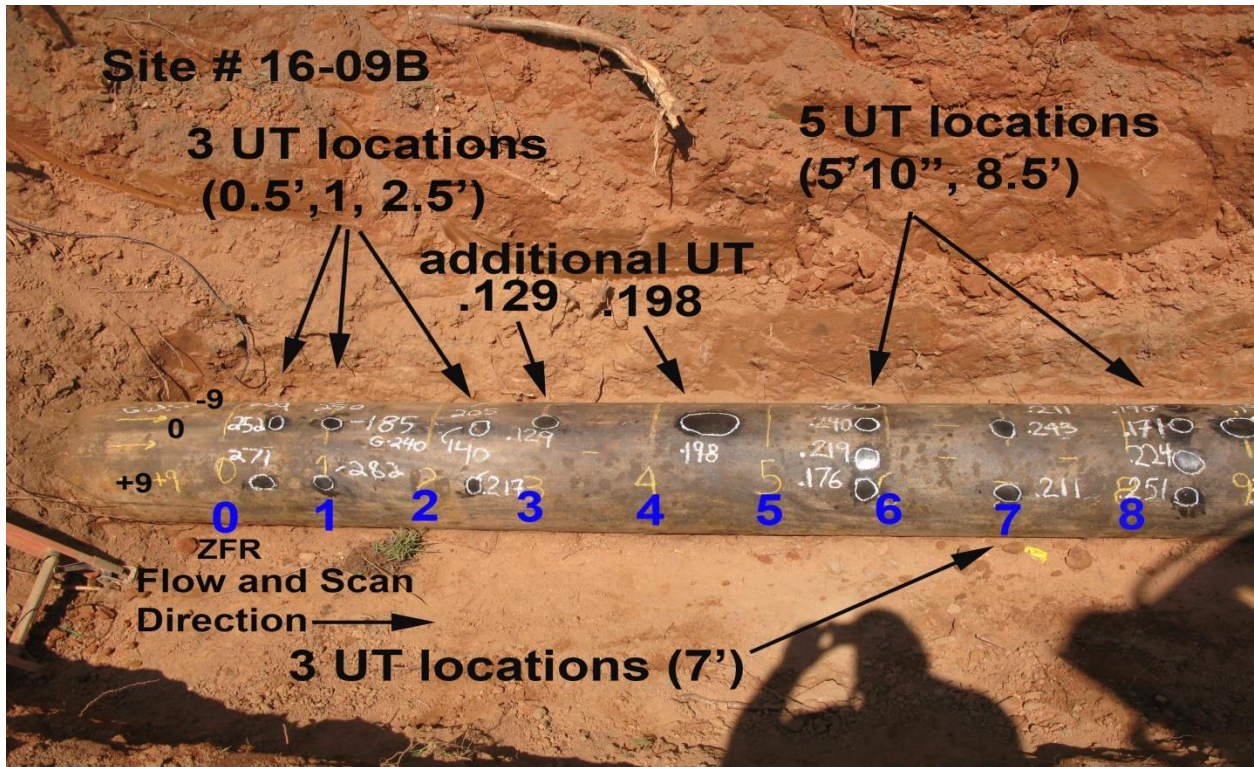
The zero-foot reference (ZFR) was set on the pipe, as shown in Figure 1. Two scans were performed from -9" to 0" and from 0" to +9". Note: further set up details can be found on page 9.

Figure 1. Showing site 16-09B with ZFR, Flow direction and UT locations.

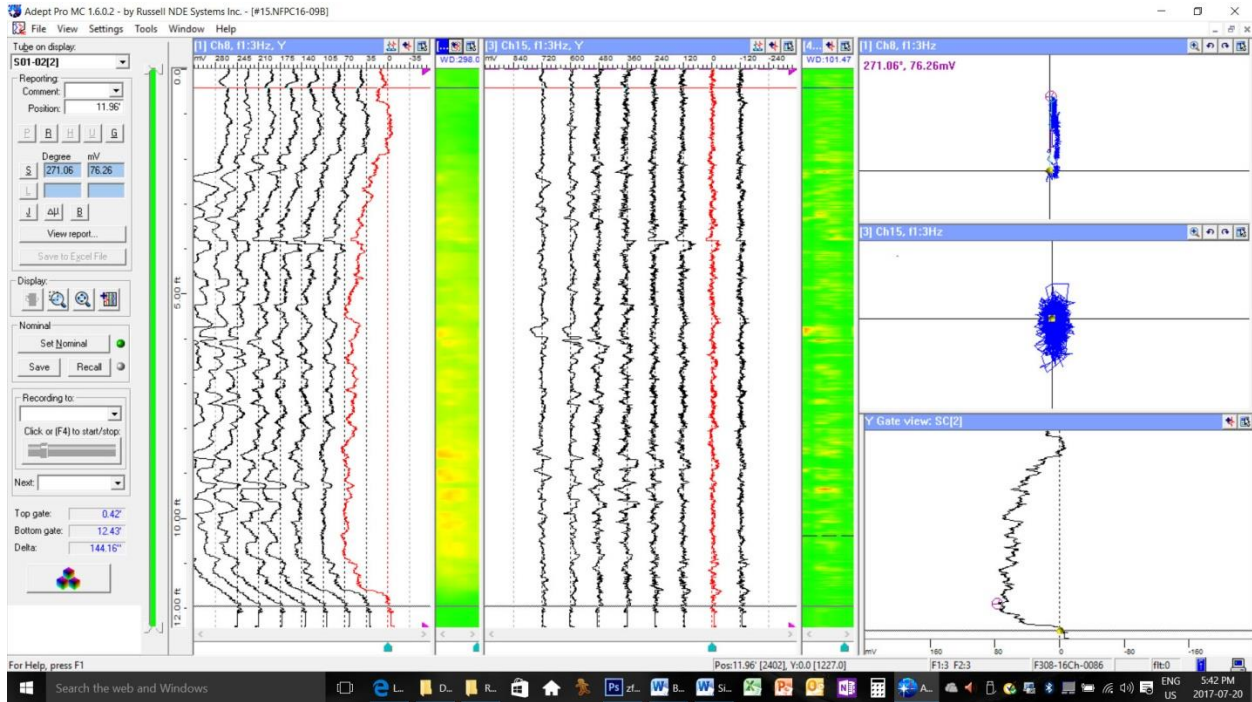
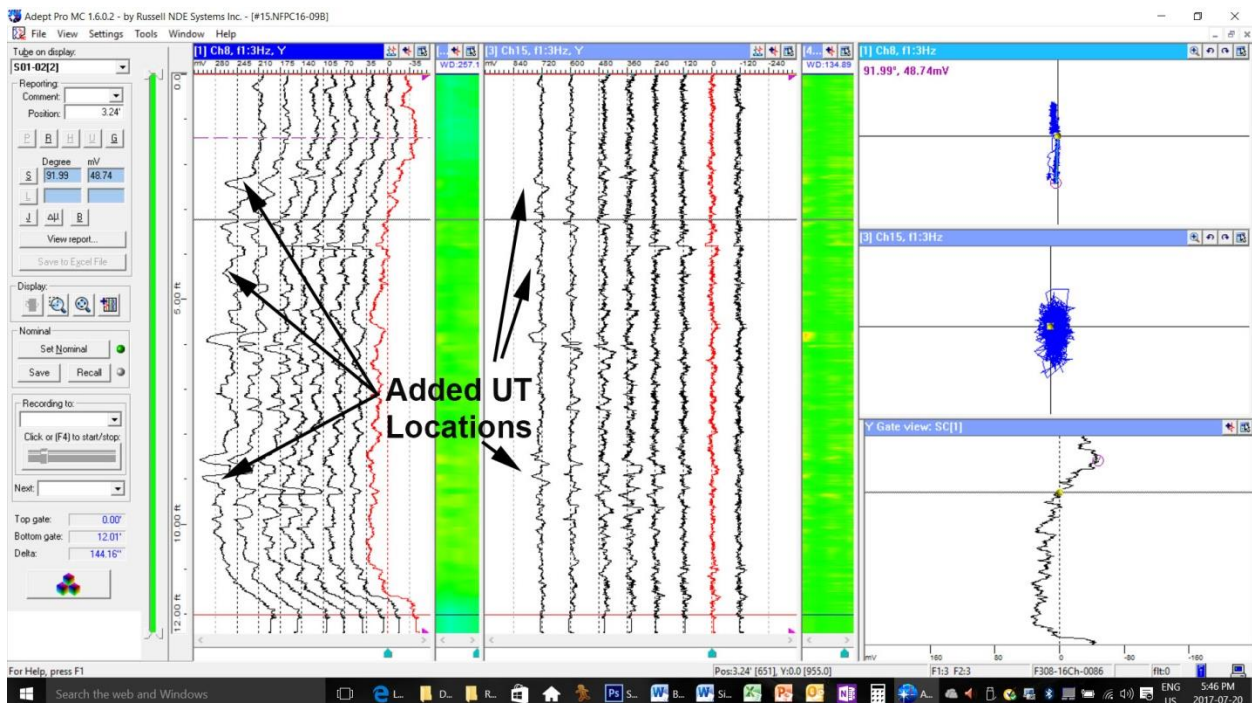
Figure 4 a+b. Note: The bottom screen cap data (4b) had to be nominalized on thinner pipe in order to see the left hand traces ('0' position or 12 o'clock). The extra pitting locations chosen for follow-up UT are shown.
