### **Inspection Report**

### **Bracelet™ Probe Inspection**

## **ACME County Force Main Sites**

## (445 Hansmore Trail,)

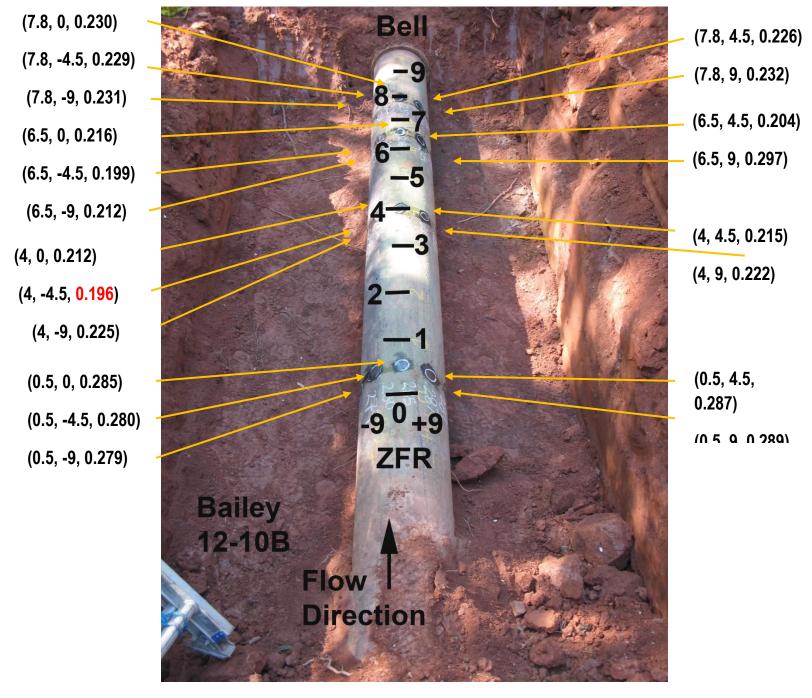
The Zero Foot Reference (ZFR) was set on the pipe, as shown in Figure 1. ZFR was 10 foot 2 inches upstream of the bell edge. Two scans were performed from -9" to 0" and from 0" to +9". Note: further typical setup details can be found in Appendix 2.

Ultrasonic Thickness (UT) thickness readings at selected locations based on BP scan data are listed in Table 1. The lowest thickness is 0.196", representing: 30% wall thickness variation compared to nominal wall thickness of 0.280" as provided by the client.

**Figure 1.** Showing **Site 12-10B** with ZFR, Flow Direction and UT Locations. The 3 numbers in parentheses are coordinates (axial distance from ZFR in foot, circumference distance from 12 o'clock in inches and pipe wall thickness in inches), respectively.

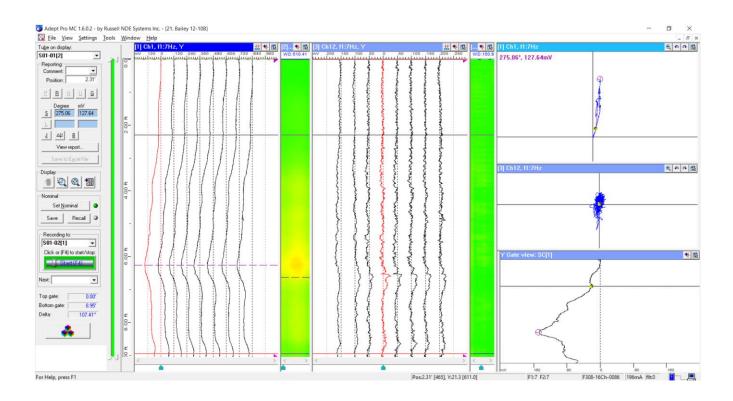
Bracelet Probe (BP) data for all scans are shown in Figure 2 to 3 on page 7-8. No significant external corrosion was found visually. The data showed wall thickness variations along the pipe length with some pitting.

Figure 2 (Scan S01-01) BP data for a scan covering -9" to 0" circumference (Probe centered at -4.5" position)

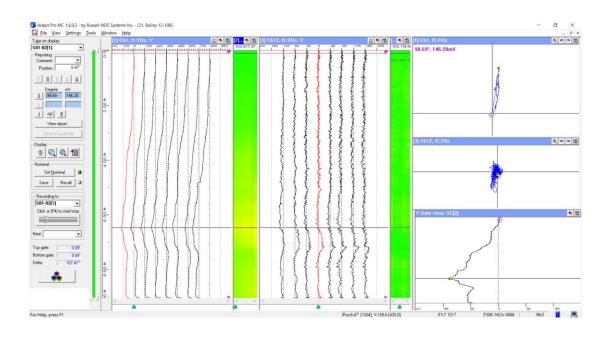
Figure 3 (Scan S01-02) BP data for a scan covering 0" to +9" circumference (Probe centered at 4.5" position)
