**Pipeline Inspection and Condition Analysis Corp.**

## FINAL REPORT

### Navigator Survey

Conducted For:  
Municipality of Sampletown  
Sampletown, AB

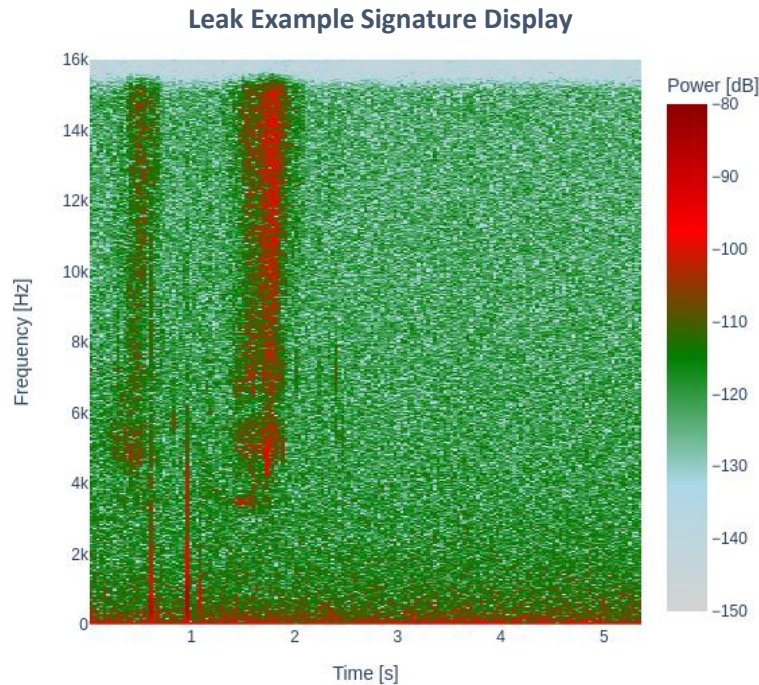
When there is a leak in a pressurized pipe, the water gets forced out due to the pressure difference between the inside of the pipe and the outside environment. The escape of water from the pressurized system into the lower-pressure environment produces vibrations as the fluid interacts with the pipe material at the leak point. The strength and frequency of these vibrations vary based on factors such as the size of the leak and the water pressure. These vibrations generate sound waves. Once created, these sound waves propagate along the pipe, through the water, and even into the surrounding medium (such as the soil around an underground pipe or the air in a room for an indoor pipe). The sound can be amplified or dampened based on factors like the pipe's material, the temperature and properties of the water, and the characteristics of the surrounding medium. If the sound waves reach a point where they can be detected they will be perceived as the characteristic sound - often a hissing, gurgling, or whooshing sound. In the spectral representation, the acoustic manifestation of the leakage can be discerned as a distinct peak, characterized by rapid descent in intensity at the peripheries due to the progressive attenuation of the acoustic signal. The frequency of a leak will usually be broadband, from tens of Hz up to tens of kHz. A leak was detected by the Navigator at approximately XXXXXXXXX"N and XXXXXXXXX"W.

To determine the approximate location of the leak the following methodology was used, the pipe length was determined to be 1860 FT from the images of the inspection path provided by the customer at the time. The inspected pipe was indicated to be an 8" section followed by a 6" section, with the size changing at the second tee located at Hwy XXX & XXXXX, approximately 500 FT from launch point. The average Navigator speed was calculated dividing the total length by the total inspection time in pipe. The speed was then adjusted to represent the slower travel in 8" relative to the 6" section. Using the two speed values and the features that could be discerned in the acoustic and magnetic data sets, an approximate preliminary location was provided to the customer.

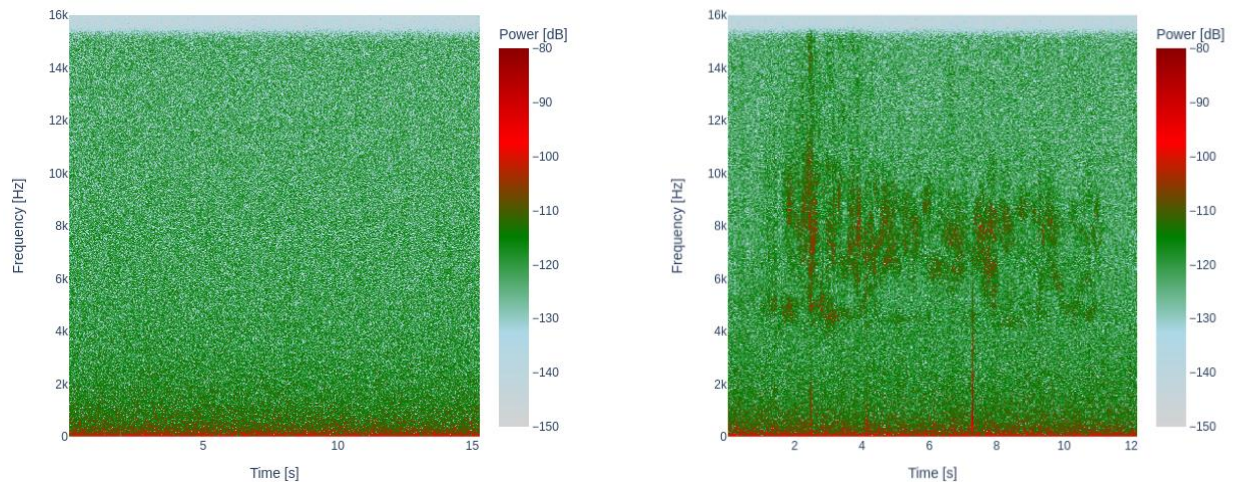
The air or gas pockets in pipes produce a signature that will be clearly distinguishable from a leak. The signature will not have a characteristic peak. The frequency range of the signature will be lower, typically under ten kHz. The distance a pocket can encompass can be much longer than a leak. The location of the pockets will often be correlated with high points along the profile of the pipe. No gas pockets were detected by the Navigator.

Clear/No Indication (Left) Gas/Air Pocket Sample Signature (Right)

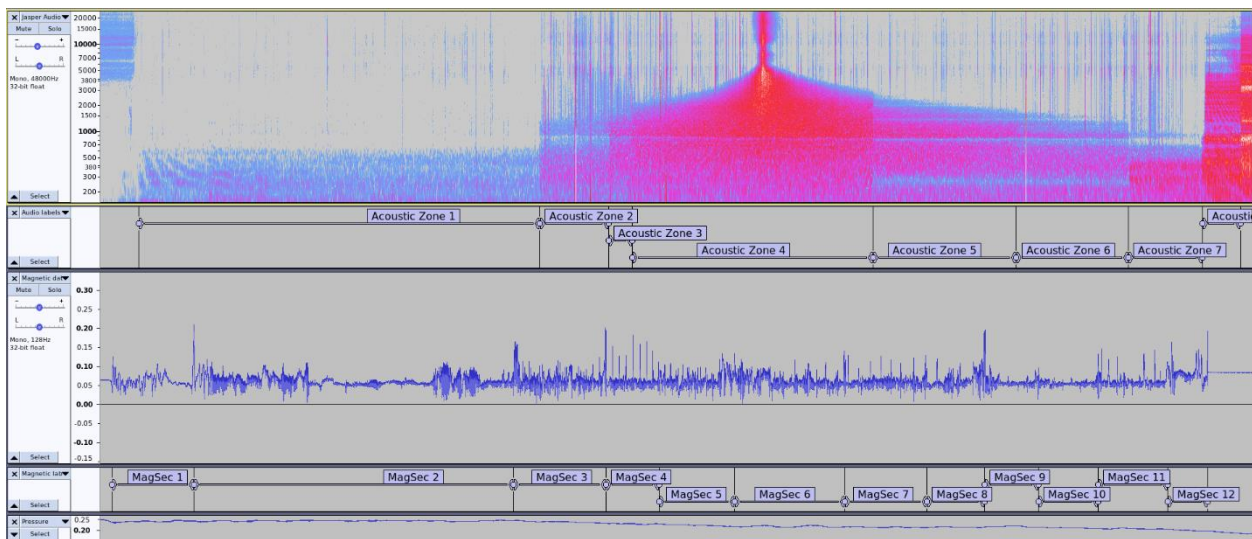
## Leak Signature Image

The Navigator found a leak at approximately xxxxxxxx"N and xxxxxxxx"W and four areas of interest based on the magnetometer findings. The collected acoustic and magnetometer data is of excellent quality and does not have any significant external or internal noise sources that would interfere with or prevent analysis.

The images below provide a visualization of the data collected. The acoustic data is shown on top with the magnetometer data below. The indication of the beginning of the data collection is shown with the complete profile of the data collection shown in the following image.
