**North American Society for Trenchless Technology (NASTT)
NASTT's 2016 No-Dig Show**

TM1-T1-05

Detection of internal pitting on pipes suspended under bridges

D. Russell, PICA USA Corp; Edmonton, Alberta
Y. Yu, PhD, PICA Corp., Edmonton, Alberta
C. Garrett, PICA USA Corp, Miami, Fla

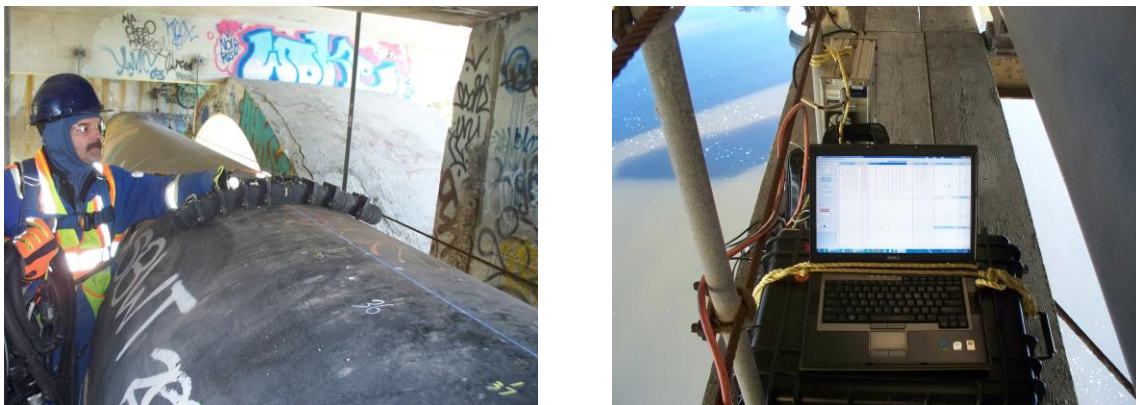
Figure 2. 48” pipe underneath bridge with inspection tool being used to scan it (left) and plank walkway (right).

The 48” steel pipe has a wall thickness of 0.375” and consists of longitudinally welded pipe and girth welds between pipes. MWTD inspectors had noted degradation of the coating and surface rusting and they hired Brown and Caldwell Engineering (“BCE”) as consultants to evaluate the pipe for external and internal degradation, and to recommend remedial steps. BCE searched the market for technologies to inspect the pipe from the outside, with capabilities to detect internal pitting as well. The inspection contract was awarded to PICA Corporation who used an inspection technique known as “Through Transmission”, housed in a flexible, wheeled bracelet probe to perform a partial inspection of the pipe.

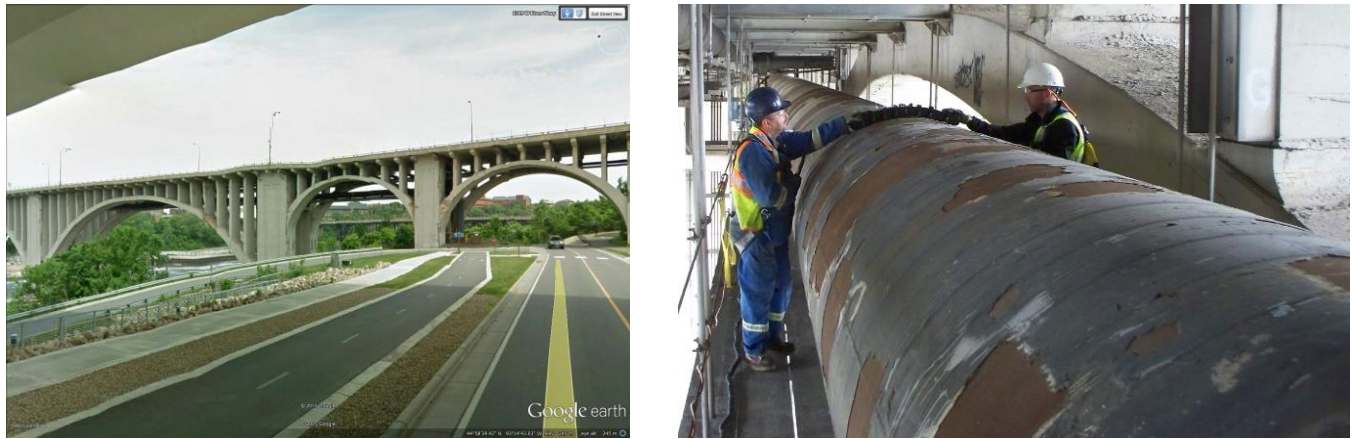
The pipe wall thickness is 0.437” and the pipe is internally lined. The thick external coating is quite degraded and external rusted areas are visible. MWTD was interested in knowing if there is any internal degradation going on as well. If the pipeline had extensive internal pitting as well as the visible external pitting, they may lean towards a replacement of the pipe rather than rehabilitate the coating and repair any badly pitted areas.

Figure 4. Street view of 10th Avenue Bridge (left) and scanning of 54” pipe under bridge (right)

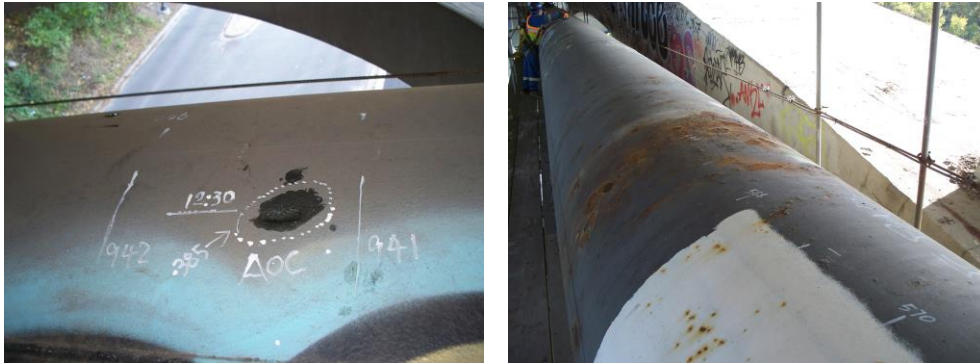
Fig 6 Local external pitting examples. The right hand photo is directly under an expansion joint of the bridge deck
