June 23, 2015
MWEA – 90th Annual Meeting

COMPREHENSIVE INSPECTION AND CONDITION ASSESSMENT OF DUCTILE IRON FORCE MAIN PIPES

MILWAUKEE METROPOLITAN SEWERAGE DISTRICT

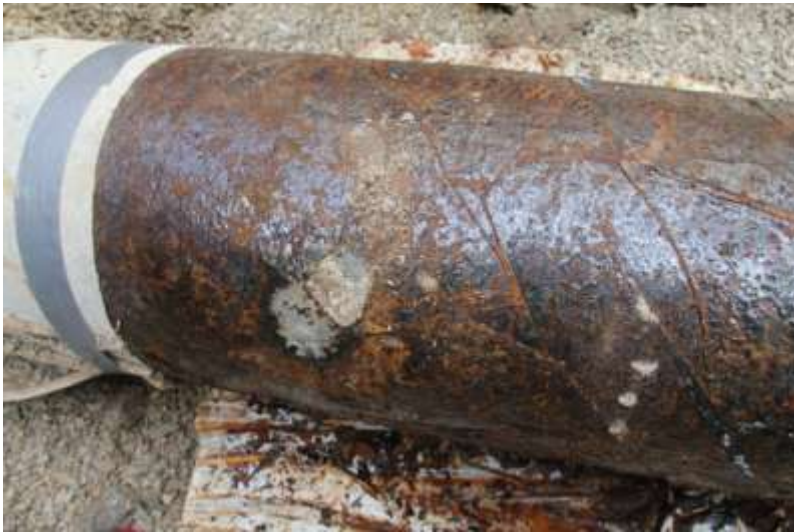
- Visual Inspection Poly Wrap Pipe, No Cathodic Protection

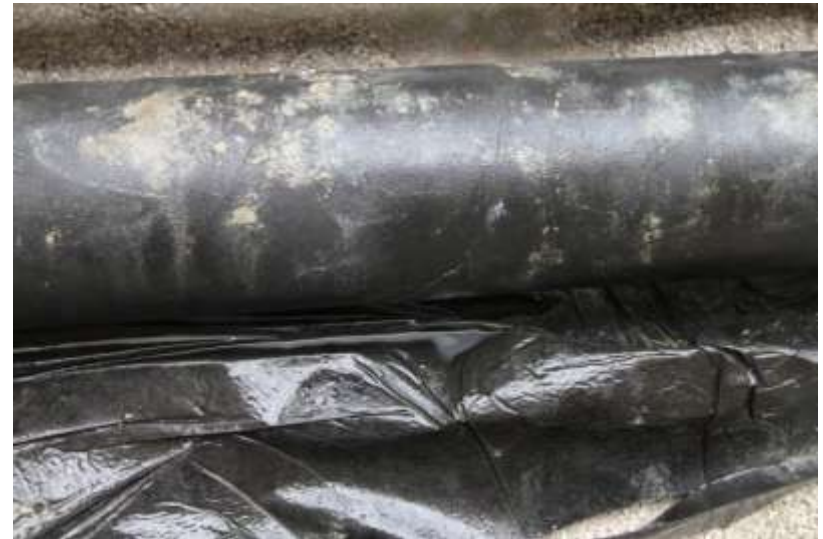
- Visual Inspection Poly Wrap Pipe with Cathodic Protection

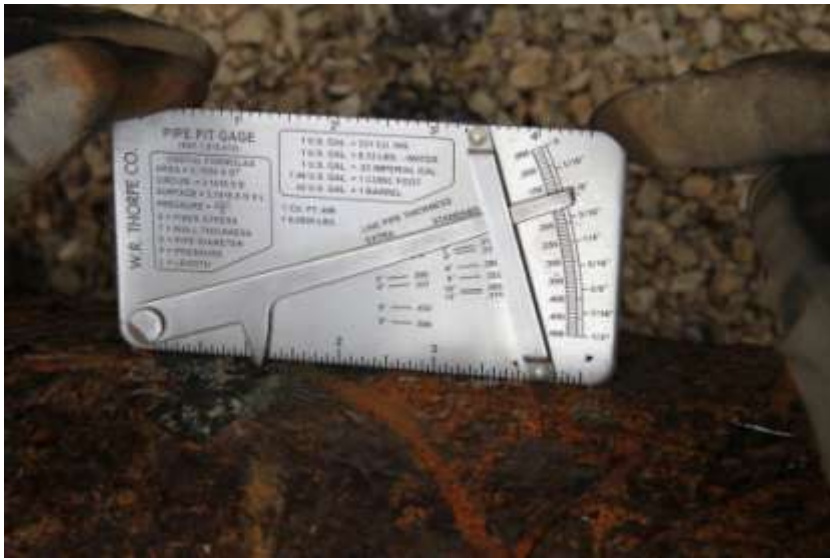
- Visual Inspection – Poly Wrap, No Cathodic Protection, Pre Sand Blast

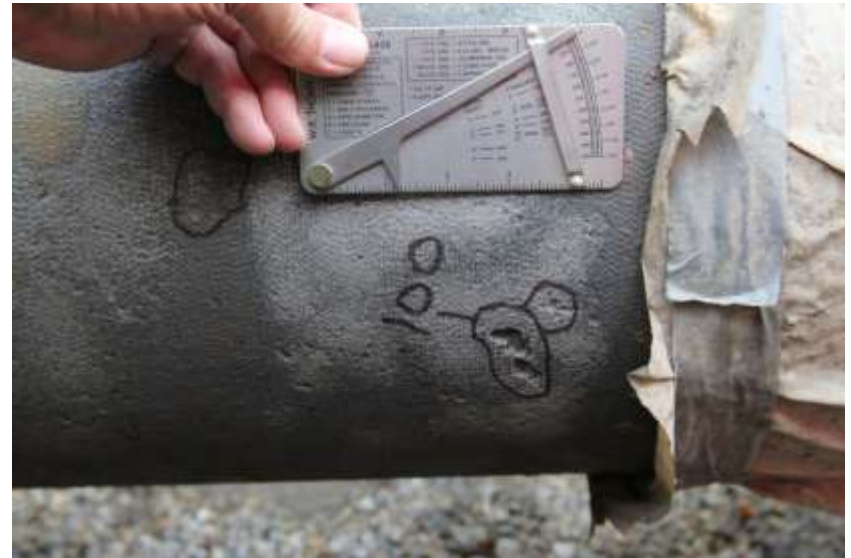
- Visual Inspection – Poly Wrap, No Cathodic Protection, Post Sand Blast

- Cathodic protected section of pipeline in good to very good condition, with 50 years or more of remaining service life.
- Implement repairs to the cathodic protection system, monitor its operation and performance
- The non-cathodic protected section of the pipeline on the SSWRF plant site will be repaired:
 - Use PICA “Dig Sheet” to locate and repair the 3 deep corrosion pits
 - Install cathodic protection system on the pipeline to mitigate further corrosion

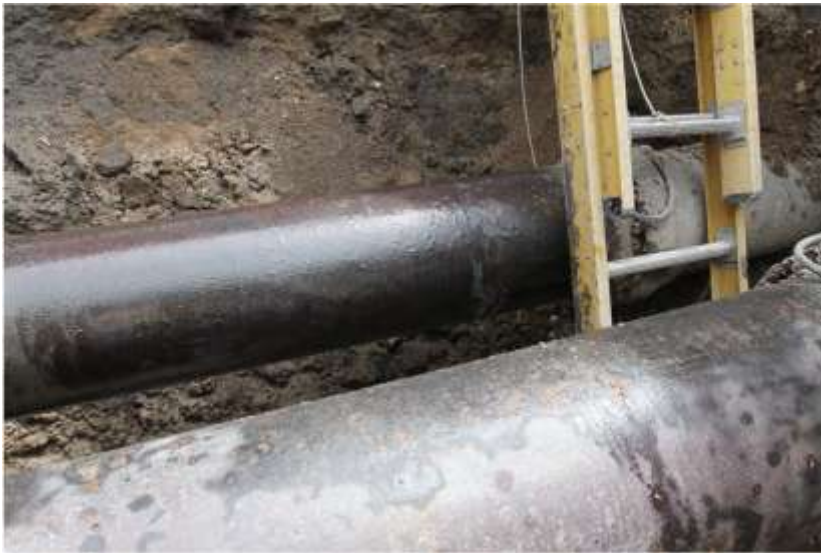
- Visual Inspection – Bonded (Paint) Coating, Cathodic Protection, Pre Sand Blast

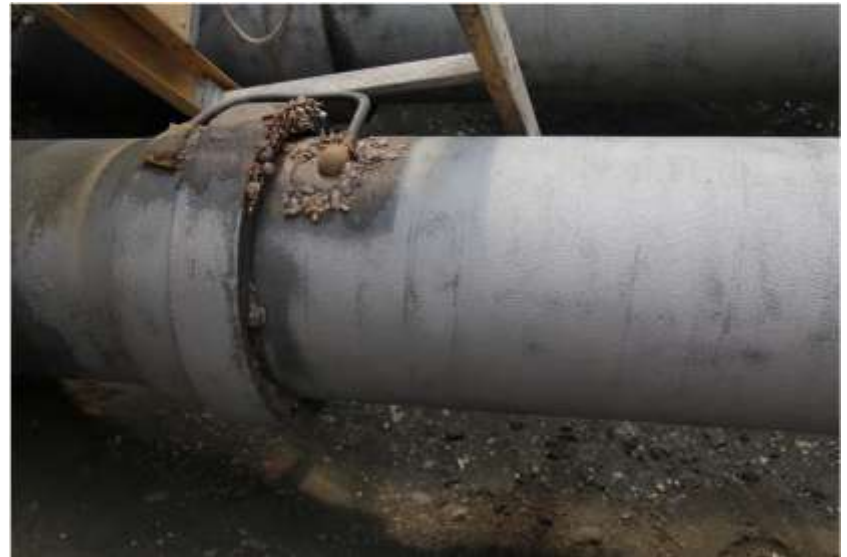
- Visual Inspection – Bonded (Paint) Coating, Cathodic Protection, Post Sand Blast

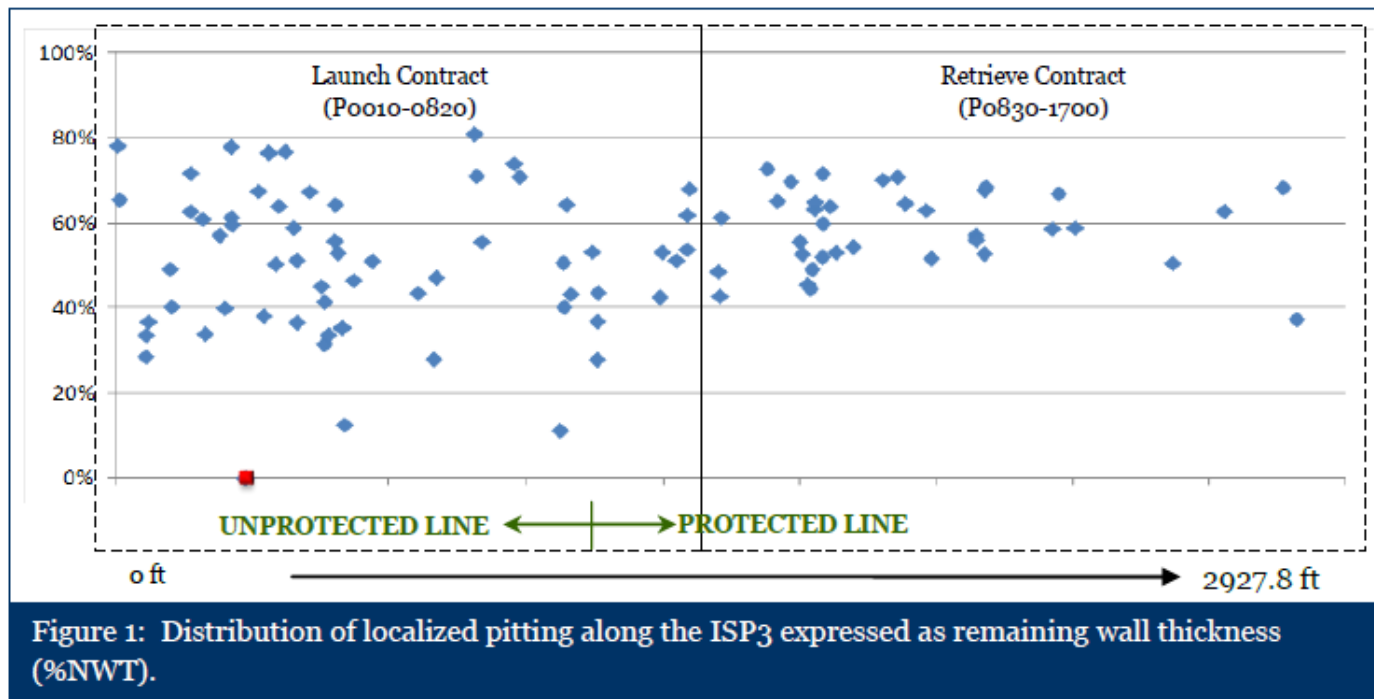
- The PICA inspection showed a significant difference in the number and depth of corrosion pits between the CP protected section and the non-protected section

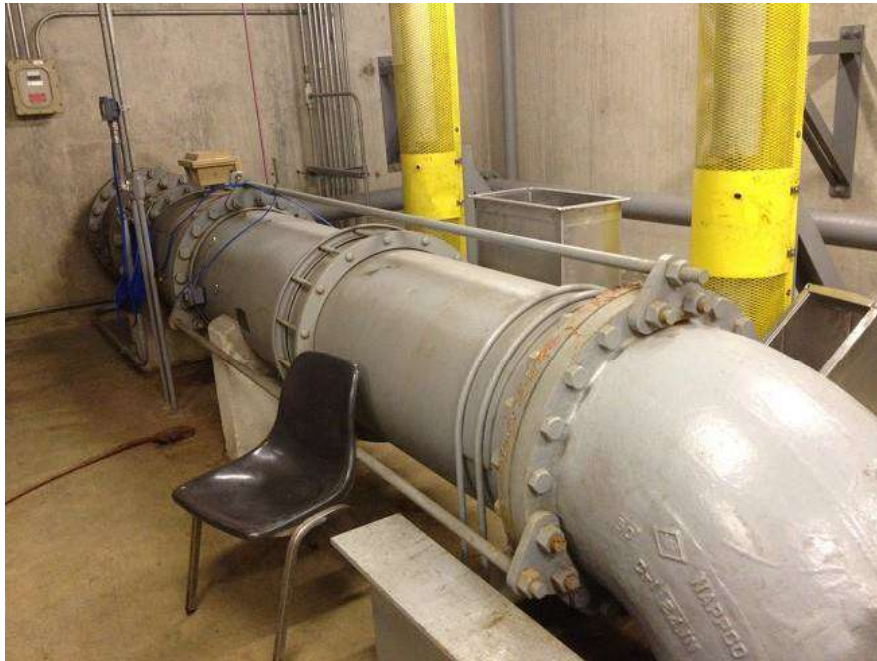
- Pump Sta. discharge pipe disassembled for inspection access

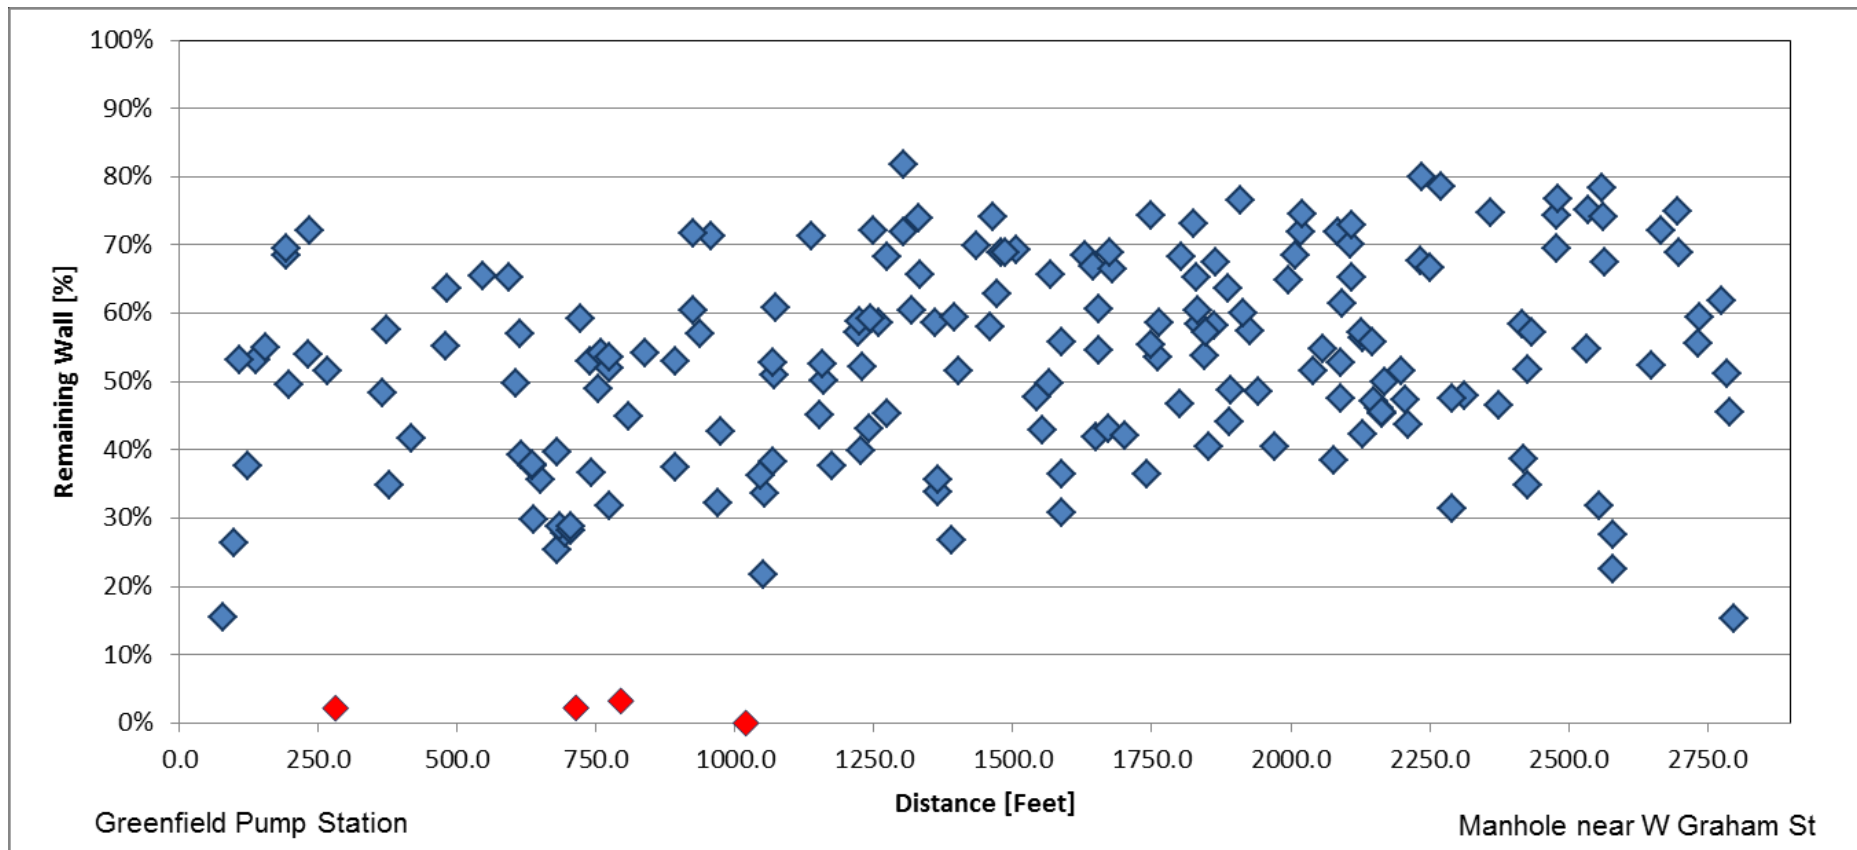
- The PICA inspection showed several corrosion pits of 20% or less remaining wall thickness

- The higher concentration of deep corrosion pits closer to the pump station suggest galvanic corrosion (pipe was not constructed with electrical isolation from the pump station).
- Corrosion pits at the pipe invert could be from microbiologically influenced corrosion (MIC) or from tears in the polywrap at the pipe invert due to careless installation.
- Root cause of corrosion cannot be determined without visual inspection.

- Several deep corrosion pits significantly raise the risk for pipeline leak
- Repair options include:
 - Use PICA “Dig Sheet” to locate and repair the deep corrosion pits or replace pipe segments
 - Electrically isolate the pipe from the pump station
 - Install cathodic protection system on the pipeline to mitigate further corrosion
 - Install CIPP liner system or slip lining

- If MIC corrosion, solution is pipe lining or pipe replacement (\$1.4M - \$1.9M).
- If external / galvanic corrosion, solution is spot repairs + electrical isolation + cathodic protection system (\$0.4M).
- Conduct excavation(s) with visual inspections to confirm the corrosion root cause.
- Design the pipe remediation based on the root cause.

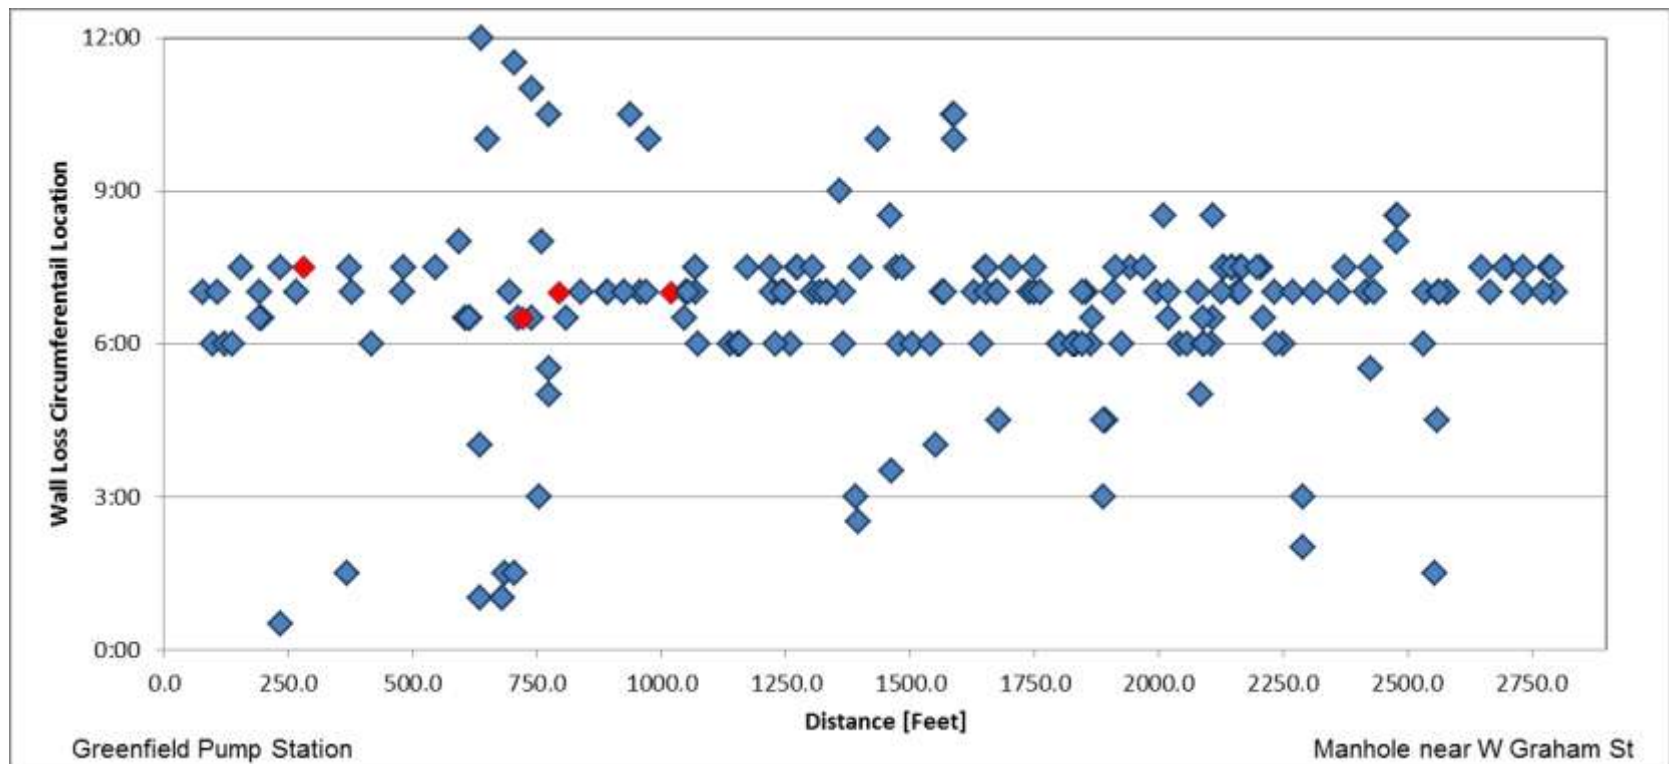
- This force main operates intermittently and residual solids lay in the bottom of the pipe. There is a high concentration of corrosion pits at the pipe invert.
