**North American Society for Trenchless Technology (NASTT)  
NASTT's 2014 No-Dig Show**

**TM1-T1-01**

**Discovering Actual Wall-Thickness in a 12-inch Steel Pipe in British  
Columbia, a 22-hour Journey**

William Jappy, PICA Corporation  
Martin, Korz, PICA Corporation  
John Kohut, BC Hydro

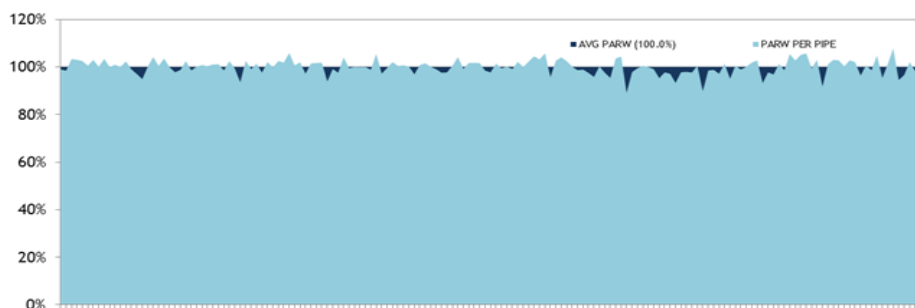
Figure 2: Pipe Average Remaining Wall (PARW) for each inspected pipe

The average remaining wall thickness ( $T_{avg}$ ) calculated over the length of the section is called the “PARW” value (Pipe Average Remaining Wall). A plot of each pipe’s individual PARW with the line’s average PARW is shown in Figure 3. Because no calibration standard was provided to PICA, a free-air calibration assigned an *average wall thickness* of 100% to the Burrard water line. This is generally a safe assumption when very little corrosion is observed as was the case in this instance.

The PARW value usually varies  $\pm 15\%$  due to tolerances in manufacturing. Variations outside the normal 15% spread can be an indicator of a different nominal wall thickness or pipe type, or point towards a problem like aggregate pitting or general wall loss.

A minimum circumferential thickness of 85.6% has been noted for the Burrard water line. This can signify early signs of corrosion and can be indicative of naturally thinner pipe. This value falls within manufacturing tolerances.

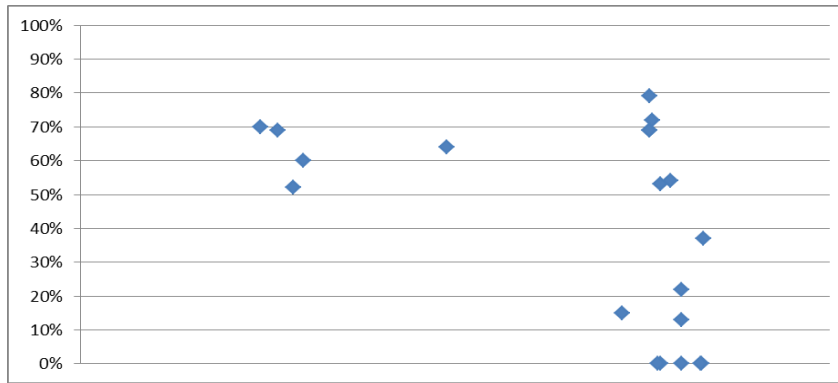
Figure 3: Plotting areas of corrosion and estimated pit depth along the pipeline (start – finish along x axis)

A total of 19 wall loss indications, spread over 12 pipes, were identified. Five of these indications measured as through holes with another three measuring less than 25% remaining-wall. Most corrosion appears concentrated in the area between air vent/vacuum brake #5 and the receiver.

The presence of through holes was suspected as surging water and air bubbles were observed at these sites during the inspection.

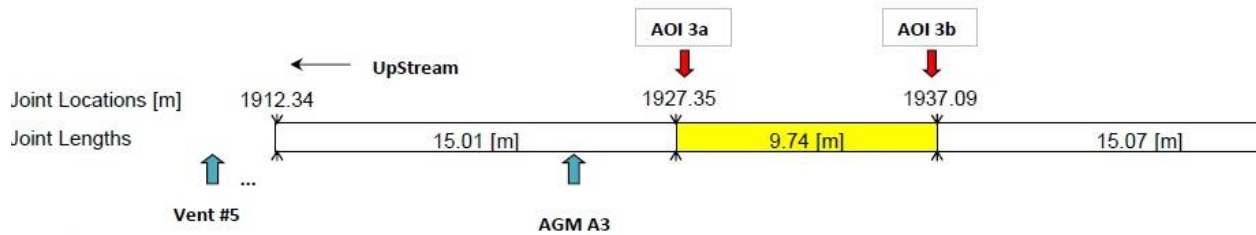
Figure 5: Dig sheet 1 identifying areas of to examine for evidence of corrosion

pipeline repair. Since all three reported areas of wall-loss were located in close proximity of each other BC Hydro decided to excavate all three. The first verification dig PICA identified two areas of concern (3a and 3b) shown in Figure 5. The first one was 3.4m from Above Ground Marker A3 and the second was 12.77m. In both cases holes were identified and in the proper clock position {circular anomaly and through-hole on 3a (Figure 7); 9 o'clock position and through-hole on 3b (Figure 8)}.

Indication	AOI #	Position [m]	Clock Position Looking DS	Estimated Depth	Distance From US AGM A3 [m]
Localized Wall Loss and Mechanical Stress measuring ~356mm in length.*	AOI 3a	1927.61	CIRC	100%	3.4
Localized Wall Loss Anomaly measuring ~150mm in length.*	AOI 3b	1936.98	9:00	100%	12.77

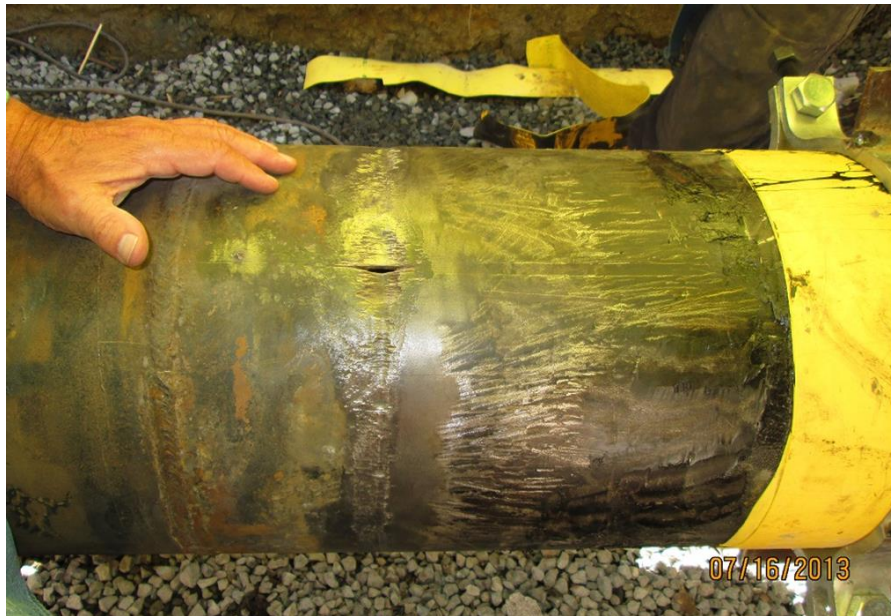
Figure 6: Examining AOI 3b showing a through hole at the 9 o'clock position

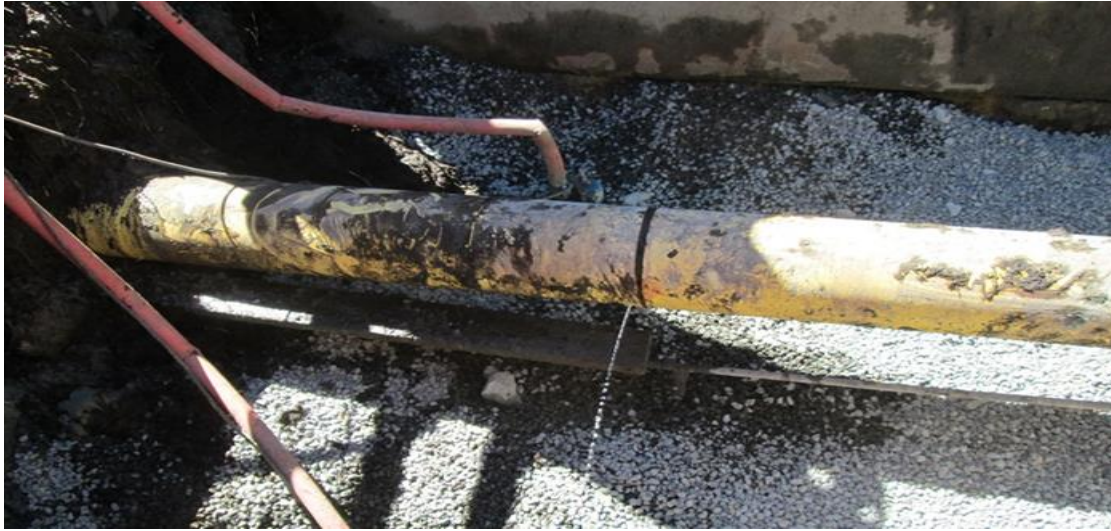
Figure 7: AOI 3a identifying a circumferential crack in pipe.

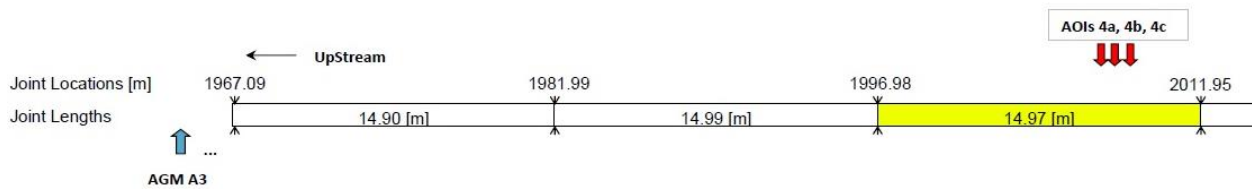
Figure 8: Dig Sheet 2 identifying 3 Areas of Interest (AOI's)

Indication	AOI #	Position [m]	Clock Position Looking DS	Estimated Depth	Distance From US AGM A3 [m]	Location of US AGM A3[m]
Localized Wall Loss Anomaly measuring ~96mm in length.*	AOI 4a	2007.8	6:30	87%	83.59	1924.21
Localized Wall Loss Anomaly measuring ~82mm in length.*	AOI 4b	2007.91	6:30	78%	83.7	1924.21
Localized Wall Loss Anomaly measuring ~153mm in length.*	AOI 4c	2008.07	6:30	100%	83.86	1924.21
