## **CORROSION FAILURE IN A LINED SOUR GAS PIPELINE - PART 1: CASE HISTORY OF INCIDENT**

L. Simon  
Shell Canada Energy  
Pincher Creek, Alberta

Copyright 2010 NACE International

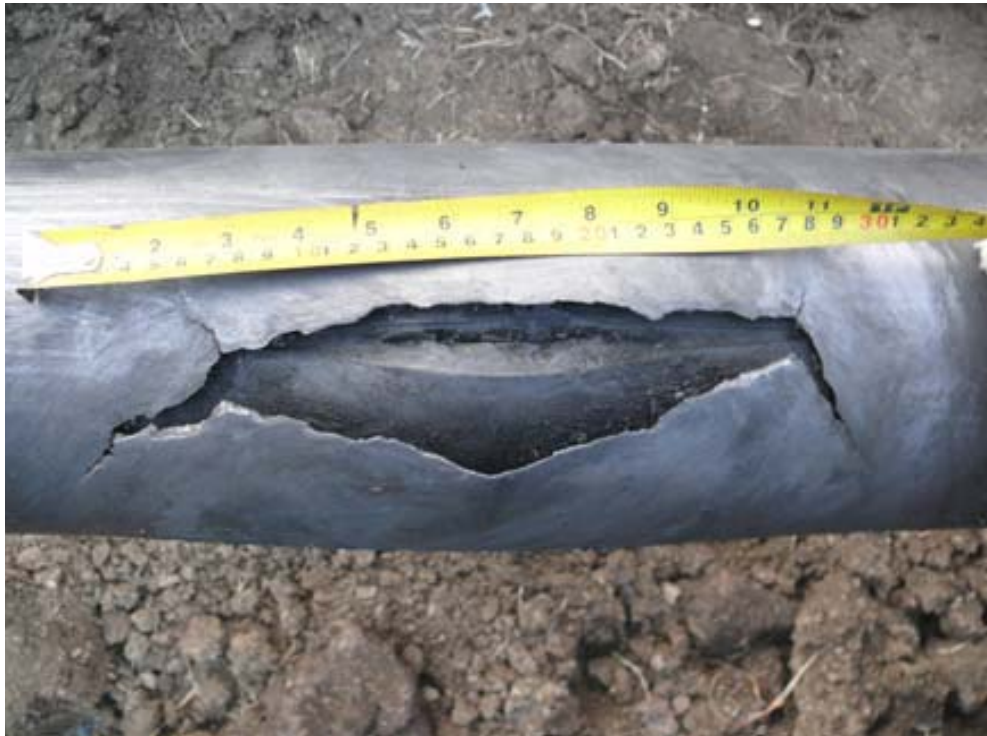
The pipeline failure was the result of an axial split in the steel pipe about 300mm in length with a maximum width of 60mm at centre. The failure occurred 27m downstream of Vent 6 as shown in the elevation profile (Figure 3). It was the result of tensile overload of the steel pipe in a localized area where internal corrosion had removed almost 90 per cent of the pipe wall (Figure 1 and 2).

**FIGURE 1 - Failure after insulation and coating removal**

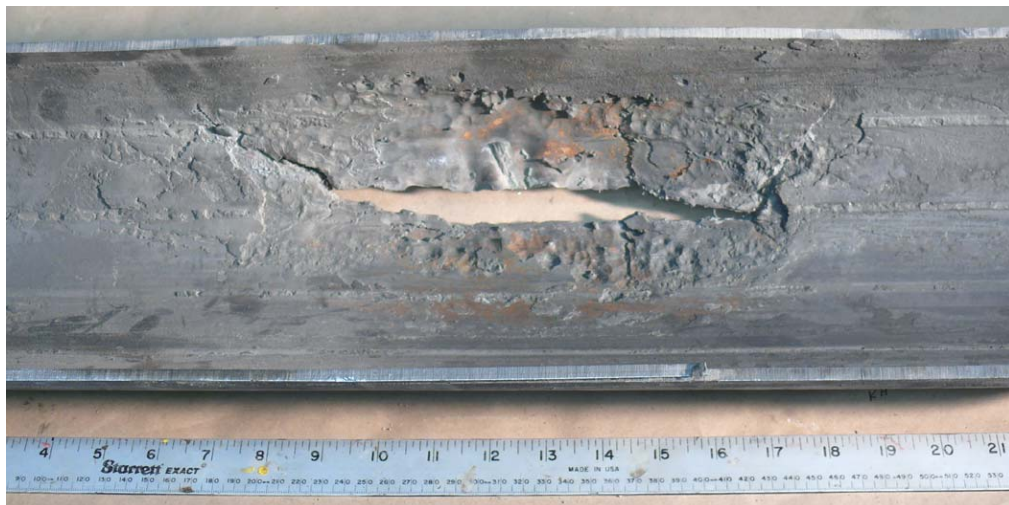
**FIGURE 2 - ID of the Steel Pipe at the Failure**

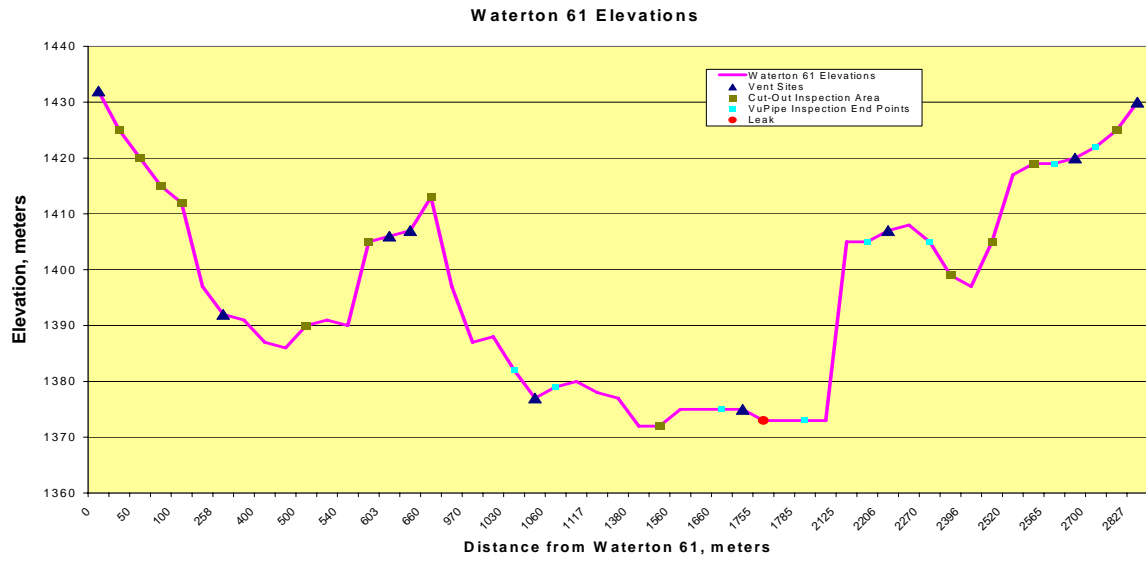
**FIGURE 3 - SC Pipeline Elevation Profile and Liner Vent Location Detail**

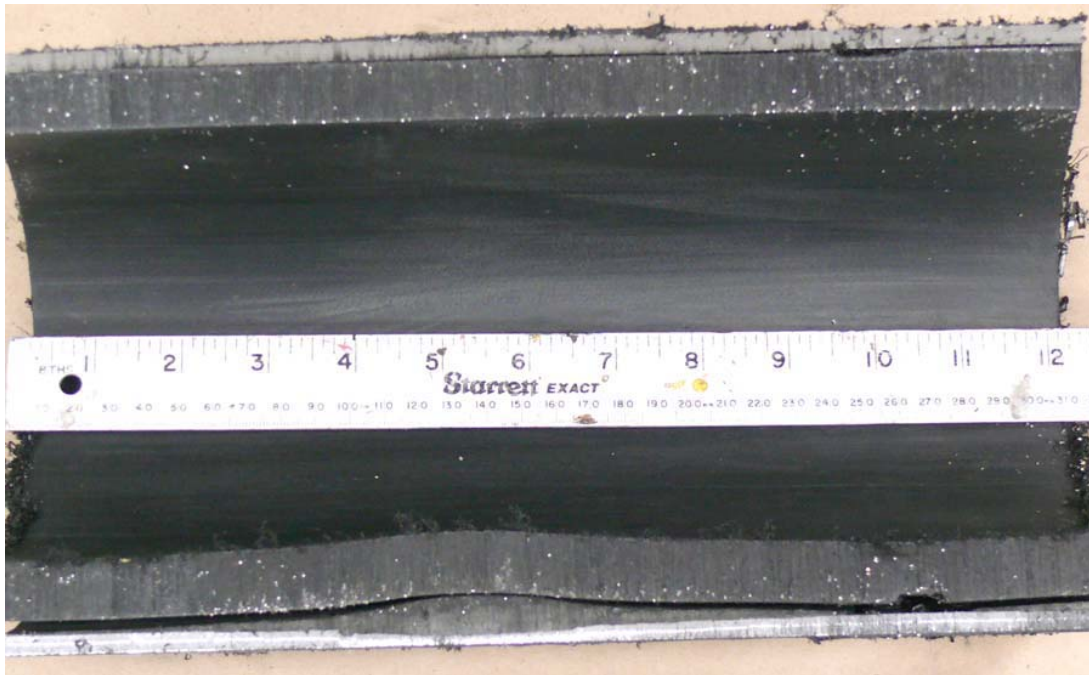
**FIGURE 4 - Scale build-up and Metal loss at Bulge in Pipe Cut Out**
