Nashville, TN
March 11-15, 2012

Paper A-6-05

NDE Techniques for Water and Wastewater Pipe Condition Assessment

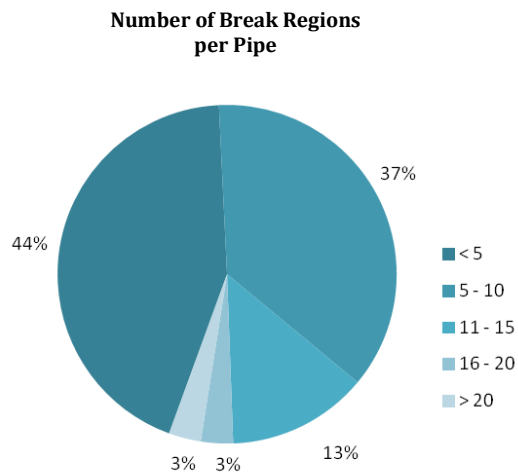
Notable is the discrepancy between Average Wall Thickness and the magnitude of localized pitting. The average wall thickness is 89% of nominal, meaning the pipe had corroded, on average, 11%. This 11% is of course not equally distributed throughout the 5,000 feet. Up to 30 locations experienced a measured 100% corrosion. Had average wall thickness been the sole determinant of future action, the pipeline owner would likely pursue an overly conservative approach towards pipeline life extension. Over half of the pipes experienced greater than five measured "pitting regions". The inspection also identified 30 localized spots where remaining wall is 20% or less. Many of these are believed to be close to through holes which are prevented from leaking either through the internal liner or the graphite matrix remaining as part of the graphitization process. Almost 40% of the pipes experienced at least one defect classified as "Deep" or "Advanced".

Figure 3: Number of Break Regions per Pipe

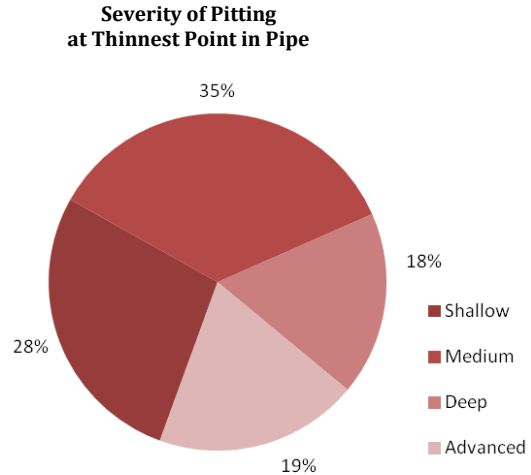
Figure 4: Severity of Pitting at Thinnest Point in Pipe
