**North American Society for Trenchless Technology (NASTT)  
NASTT's 2015 No-Dig Show**

**MM-T1-04**

**A Tale of Two Inspections: Using Condition Assessment to Manage  
Force Main Assets**

Chris Garrett, PICA Corp., Miami, FL  
Dennis Dineer, Donohue & Associates, Milwaukee, WI

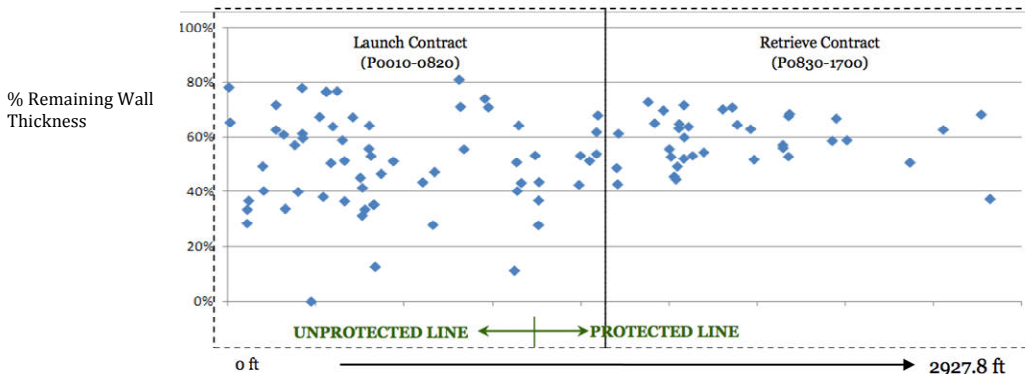
The analysis of the inspected portion of the 12” pipeline indicated the line was in generally good condition – over half of the pipes had a minimum remaining wall thickness greater than 75% of nominal wall thickness. Only 22 of the 155 analyzed pipes were in “poor” condition with a region where the minimum wall is thinner than 50% of nominal. One through-hole defect was identified at 307 feet from the launch location.

Figure 5. Graphical representation of the data from the 12” inspection. Blue diamonds denote registered defects.

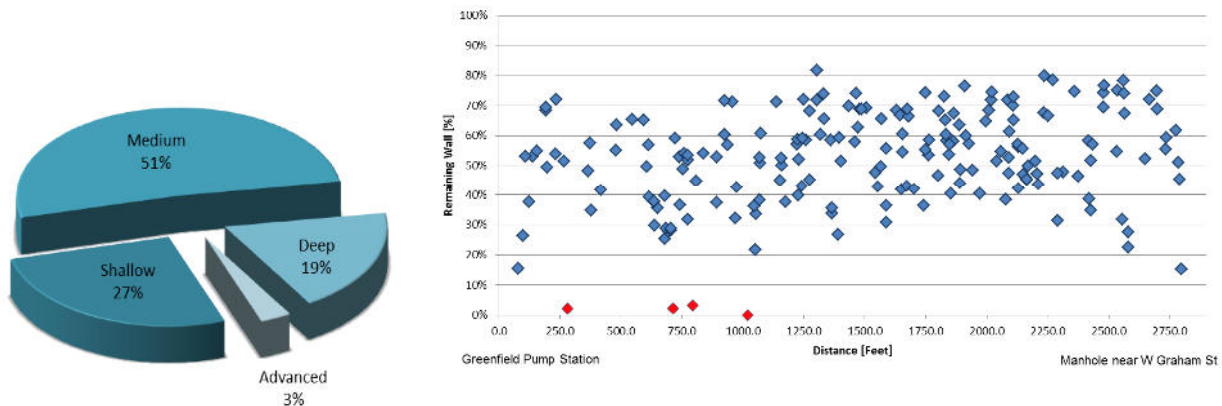
The analysis of the data collected from the Greenfield Park 24” force main indicates that the line is in “fair” to “good” condition. 36% of the analyzed pipes are in “poor” condition (<50% RW), 27% are in “fair” condition (50-74% RW) and 37% are in “good” condition (>75% RW). A total of four through-holes or near perforations were observed (Figure 8).

Figure 8. Pit depth distribution (left); location and depth of each pit with red diamonds signifying advanced corrosion (right)
