Case Study: 12” Force Main, sub-aqueous crossing, inspected using Remote Field Technology, summer 2008

During the summer of 2008 a new electromagnetic inspection tool was used to inspect an abandoned 12” force main for Pinellas County Utilities in Florida.

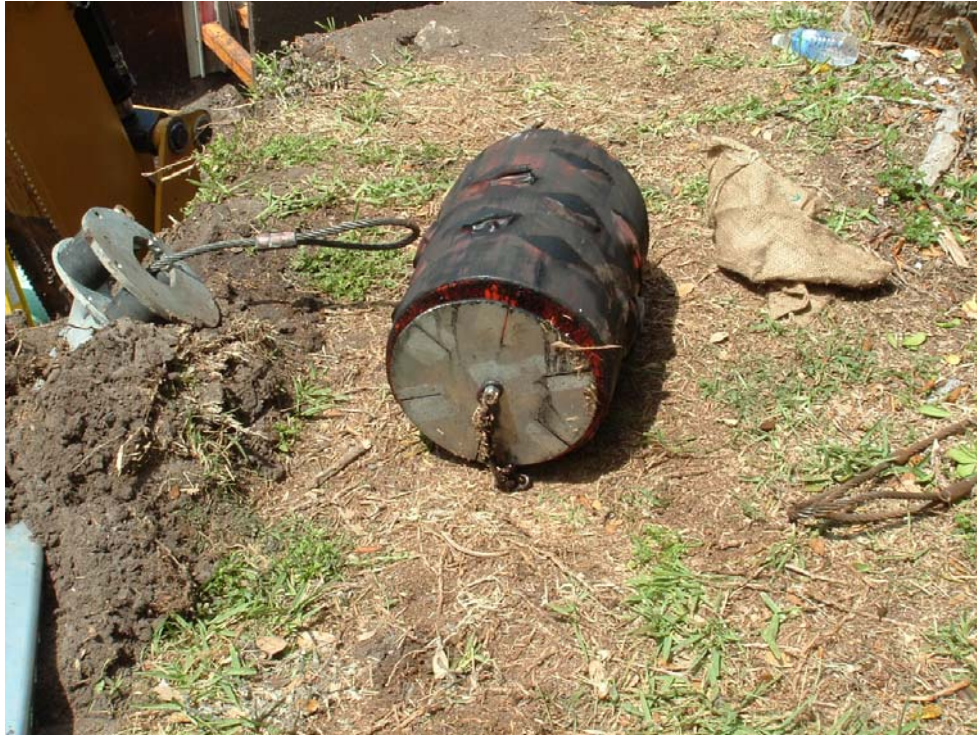
Fig-5: shows no damage on the sizing plates (that are slightly larger than the actual inspection Tool)

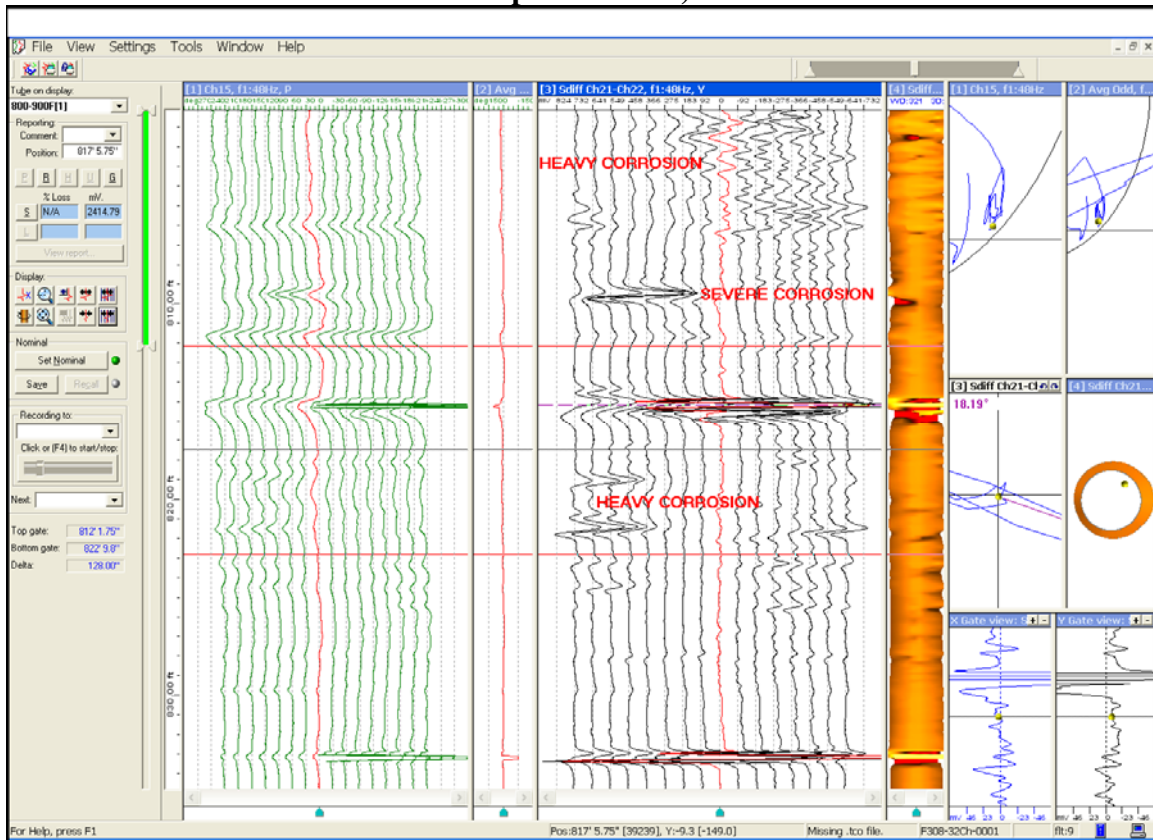
The inspection took approximately two hours to winch the Tool across and back while data was gathered in both directions. The data was downloaded to a P.C. and the analysis process began. The following day a preliminary report was given to the customer which reported that the line had considerable wall loss in several discreet pipes, with corroded areas at both sides of the crossing in the tidal area and on shore. Included in this damage was a 6' long through wall crack that was spiraling down the pipe on the east end, in the tidal area where the roots had been seen by CCTV.

Fig-6: Data showing severe corrosion signals
