60"-78" EMIT Inspection Tool

- Where: Southern USA
- What: 65 & 66-inch Raw Water Feeder Main Inspection
- When: 2017
- How: Tethered over 16 sections
- Why: Feeder main is over 50yrs old and identified as critical asset
- Distance: five miles (8 kms) in total; up to nearly 3000 feet/day (between MH access points)

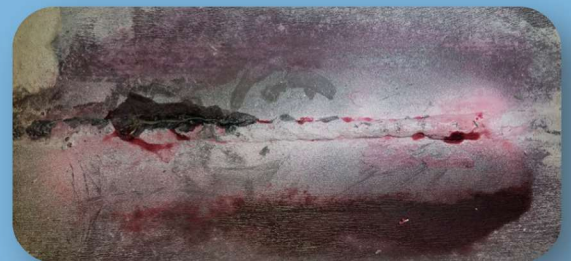
The inspection identified several areas of interest, such as partially threaded grout plugs, and seam weld defects. At one of the seam weld defects, cracking and water intrusion behind the internal cement liner were confirmed by the client; the extent of the weld defect was verified with a liquid penetrant inspection by the pipeline asset management team (image on right).
