Case Study: Using Direct Condition Assessment to Improve Your Infrastructure Asset Management Plan

By Edward Brain* and Chris Garrett**

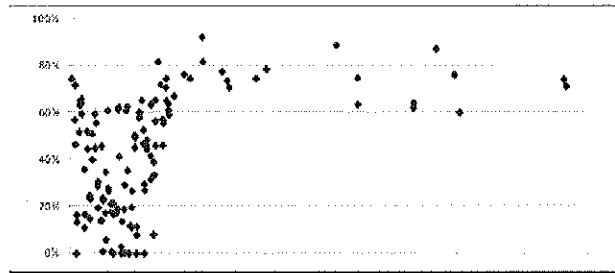
Figure 1: Location and depth of defects found in the Simmons Road force main

Although all expectations and reasonings were based upon sound judgement, the outcome of what was found in the pipeline was to be in almost the exact opposite. The pipe that was thought to be good was found to be heavily corroded and susceptible to failure. PICA found eight areas of through-holes or near through-hole corrosion pits along with a plethora of additional medium and deep-sized corrosion pits. The area with dense corrosion was uniform for the first ~550 feet then after that the deep corrosion subsided. The remainder of the pipe (approximately 3,650 feet) had superficial damage that was measured with a wall thickness of at least 60% of the original pipe wall.

A scatter graph representation of the corrosion can be seen in Figure 1, the depth and position of the corrosion pits is shown by the blue diamonds. The X-axis depicts the complete length of the inspected pipe ~4,200 feet with 0 feet at the left. The Y-axis represents the depth of the pit as a percentage of the remaining pipe wall with the dots on the x-axis constituting through holes or extremely deep pits. Presenting the data in this form it is very evident that the first ~550

has experienced a different environment than the remaining pipe.

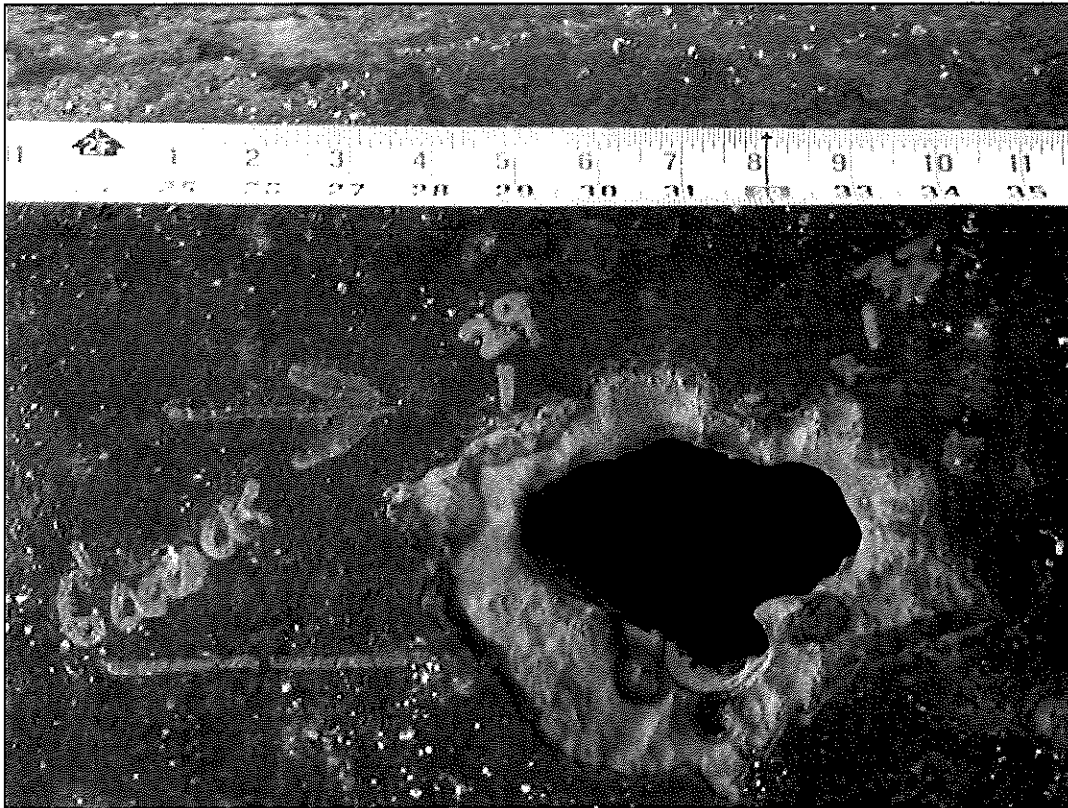
The pipe was exhumed by a local civil contractor and brought to the yard for cleaning and inspection. During the power wash a large graphitized plug fell out revealing a 2" x 4" hole within a few inches of the exact location indicated by PICA.

Figure 2: The through-hole located in Pipe 0030. While sludge and backfill had prevented any leaks here to date; the integrity of the pipe had been compromised due to corrosion

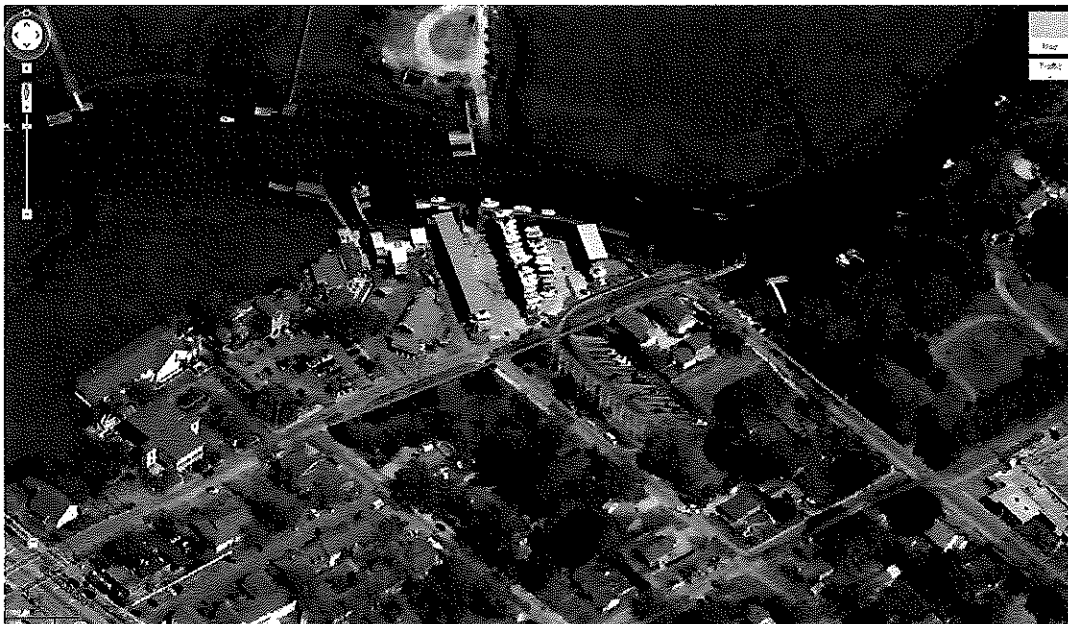
The outcome of the results meant that everyone had to go back to the proverbial drawing board to better understand the mechanism that causes the corrosion to be surprisingly prevalent near the low point of the line. Surveilling the surrounding landscape, it is noticeable that the area heavily affected by corrosion is near the marshlands and tidal estuaries, as seen in Figure 3, the section in red corresponds to the approximately 550 feet of heavily corroded pipe. The line highlighted in green is actually the line that experienced much less corrosion showing that as the line leaves the marshland the corrosion likelihood decreases. Without any finite analysis it is suspected that the surrounding soil has a high corrosive nature with the added change in tides accelerating the corrosion activity.

Figure 3: Satellite view of the 16" Force Main. The red section identifies pipe that is highly corroded; the green section identifies pipe that experienced minimal corrosion

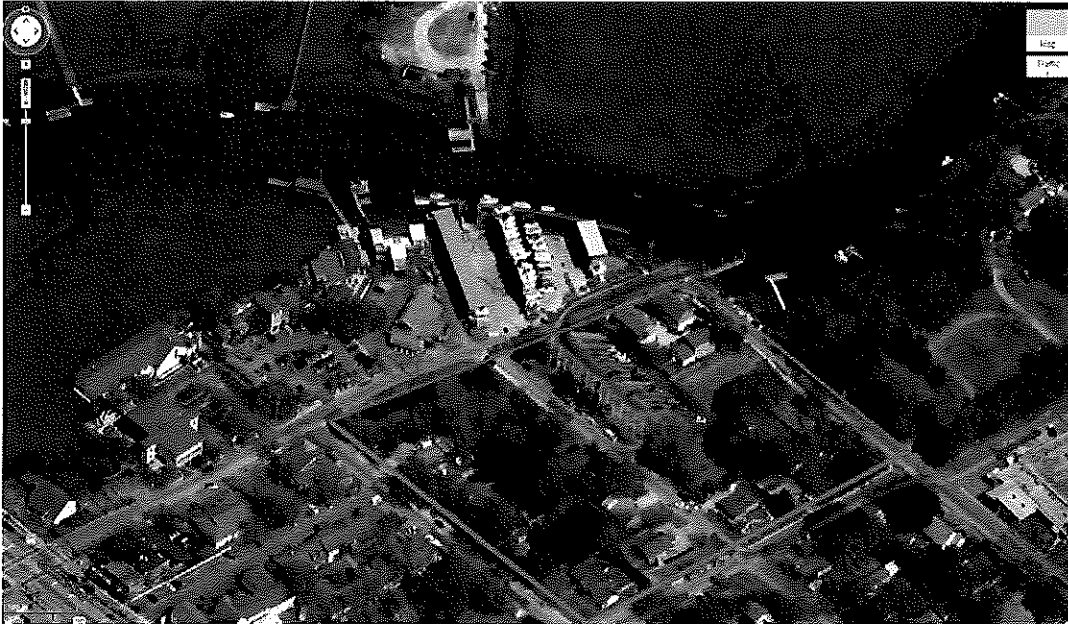
Figure 4: Satellite view of the new 20" PVC relative to the original DI pipeline. The PVC section is in blue

It was a simple solution for the City of Mount Pleasant to re-engineer the pipeline and reroute a new line that detours around the areas causing high corrosion rates. The replacement was a 20" PVC pipe and re-routed to be farther away from the marshlands. As seen in Figure 4, the new PVC line joins up with the original 16" force main in an area that recorded very little corrosion.
