**North American Society for Trenchless Technology (NASTT)
NASTT's 2014 No-Dig Show**

**Leveraging Condition Assessment to Improve your Asset
Management Plan**

Chris Garrett, PICA USA, Miami, FL
Kelly Derr, Brown & Caldwell, Raleigh, NC
David Niese, Mount Pleasant Waterworks, Mount Pleasant, SC

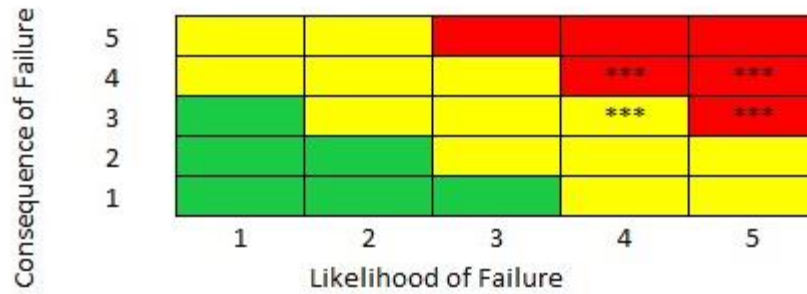
The Guidance Document highlighted the 16" Simmons Rd. force main as a good candidate for inspection. The force main was assigned a high likelihood of failure as it had already experienced six crown corrosion failures. Similarly, the consequence of a large failure could lead to significant effluent spillage and inconvenience for large clients.

Figure 2: Approximation of the MPW Risk Ranking for the Simmons Road FM.

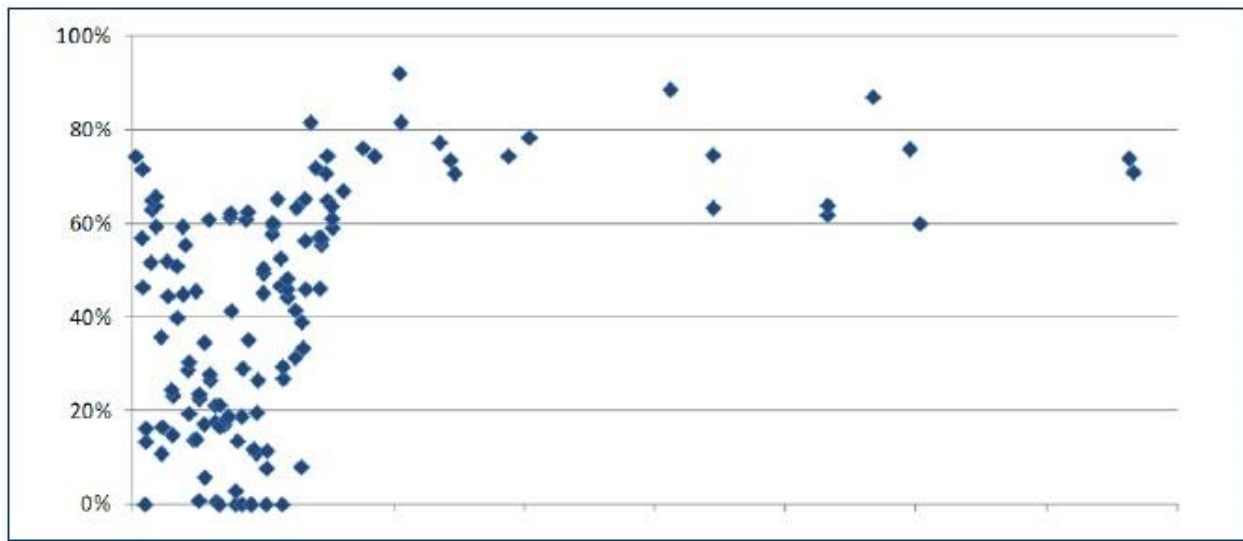
Despite the sound reasoning of the expectations, the pipeline was found to be in almost the exact opposite condition. The pipe near Mill and Lucas was found to be heavily corroded and susceptible to failure. PICA measured eight instances of through-hole or near through-hole corrosion pits, along with a plethora of additional medium and deep-sized corrosion pits. The heavy corrosion was consistent for the first ~550 feet of pipeline. At around 550 feet from the launch pit, the deep corrosion subsided. The remaining pipe (approximately 3,650 feet) saw very little pitting, and the corrosion that was measured left at least 60% of the original pipe wall intact.

A graphical representation of the corrosion can be seen in Figure 4. Each blue diamond represents an indication of corrosion as measured by the SeeSnake tool. The X-axis depicts ~4,200 feet of inspected pipe (with blue dots near the origin representing defects near the Mill and Lucas intersection). The Y-axis depicts the depth of any given pit as a percentage of the remaining pipe wall (with blue dots near the x-axis representing deep pits/through-holes). As seen from this graphical representation, the first ~550 of force main experiences significantly more corrosion than the remaining pipe.

Figure 4: Location and depth of defects found in the Simmons Road force main.

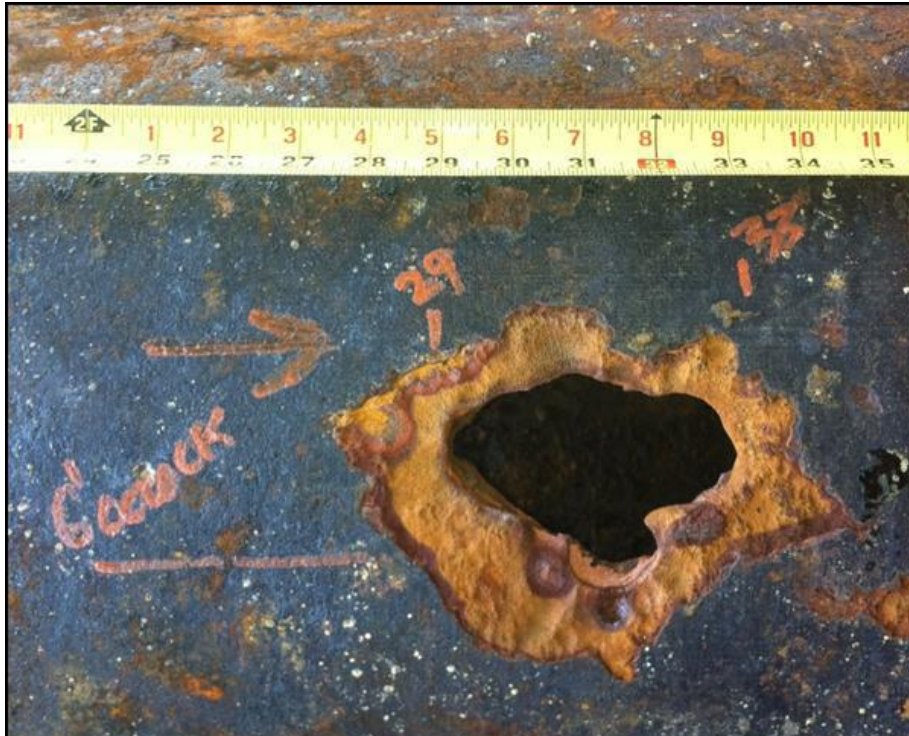
These results were no doubt a surprise to all parties. MPW and Brown & Caldwell decided to undertake verification digs to confirm the PICA data. PICA analysts put together dig sheets and sent a technician back to South Carolina to assist in the locating of certain defects. The pipe joint labeled “Pipe 0030” had registered multiple deep defects and was located in an area that could be excavated easily.

revealing a 2”x 4” through hole in precisely the location indicated in the dig sheet. PICA reported the hole at 32.8” from the upstream joint in the 6:00 position. Figure 5 shows the hole at ~31” in the 6:00 position.

Figure 5: The through-hole located in Pipe 0030. While sludge and backfill had prevented any leaks here to date; the integrity of the pipe had been compromised due to corrosion.

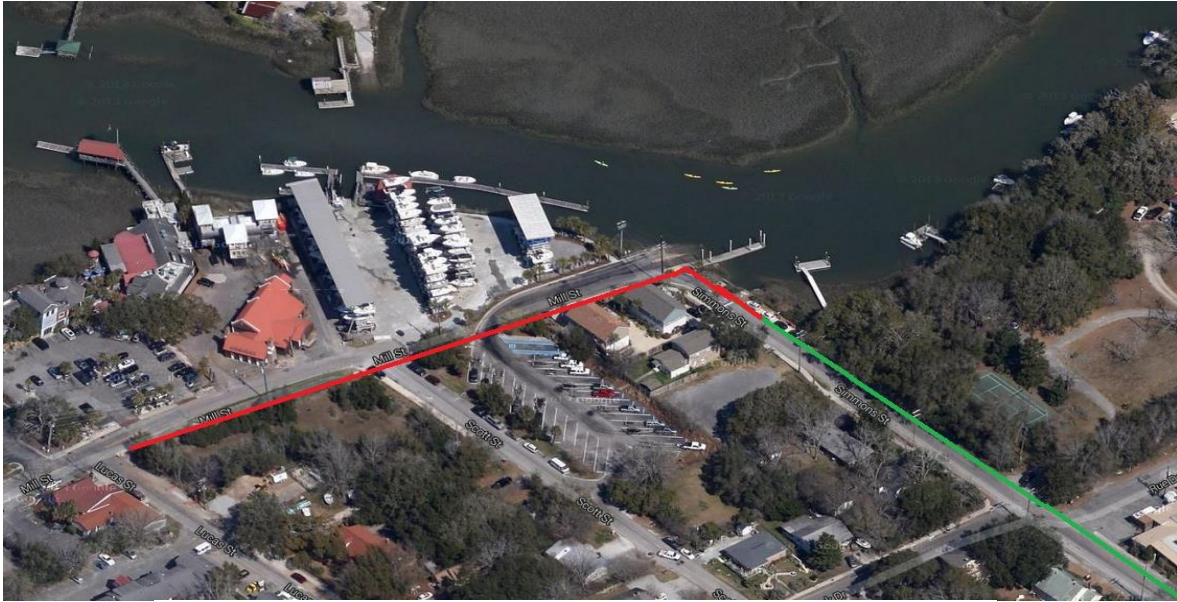
The results sent everyone back to the proverbial drawing board in hopes of better understanding why the corrosion was surprisingly prevalent near the low point of the line. When looking at a Google Earth view of the region, it is noticeable that the area heavily affected by corrosion is near some of Mount Pleasant’s most beautiful local scenery: the marshlands and tidal estuaries. As seen in Figure 6, the section in red corresponds to the approximately 550 feet of heavily corroded pipe. The section in green corresponds to the pipe that experienced much less corrosion. One of Mount Pleasant’s marshlands runs very near the location of this pipe. As the Simmons Road force main gets farther and farther from the marshland, the condition of the pipe gets better and better.

Figure 6: Google Earth view of the 16" Simmons Road Force Main. The red section identifies pipe that is highly corroded; the green section identifies pipe that experienced minimal corrosion.

The Project Managers suspect the soil composition in areas near the seawater has a relatively high corrosive nature and the changing tide levels also accelerate corrosion activity.

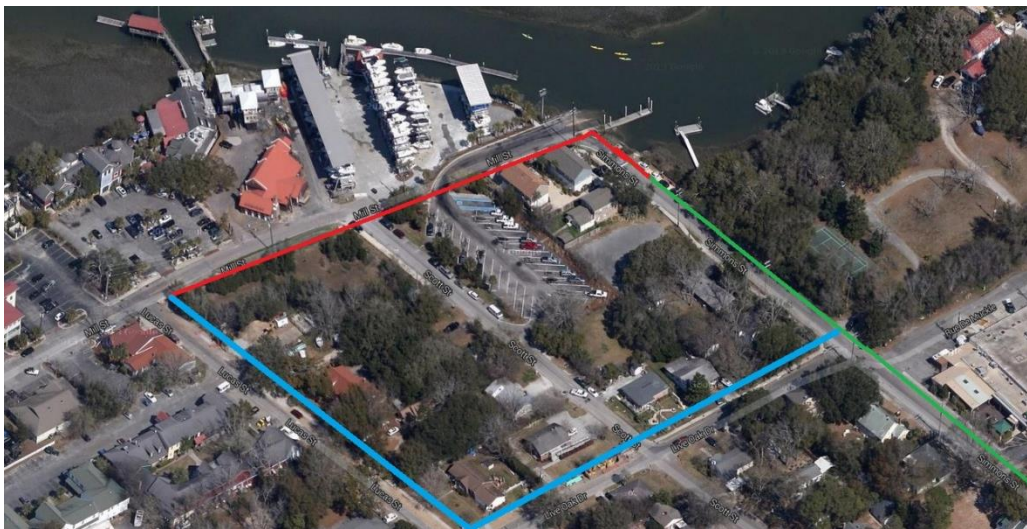
Figure 7: Google Earth view of the new 20" PVC relative to the original DI pipeline. The PVC section is in blue.

Based on the PICA report, Mount Pleasant re-engineered the pipeline to bypass the areas susceptible to failure. The new installation was 20" PVC pipe and placed farther away from the marshlands. As seen in Figure 7, the new PVC pipe ties into the original Simmons Road 16" force main at the intersection of Simmons Road and Live Oak Drive, in an area that recorded very little corrosion.
