High-Resolution Inspection of AWWA C303 Bar-Wrapped Pipe with Detailed Field Verification

ABSTRACT

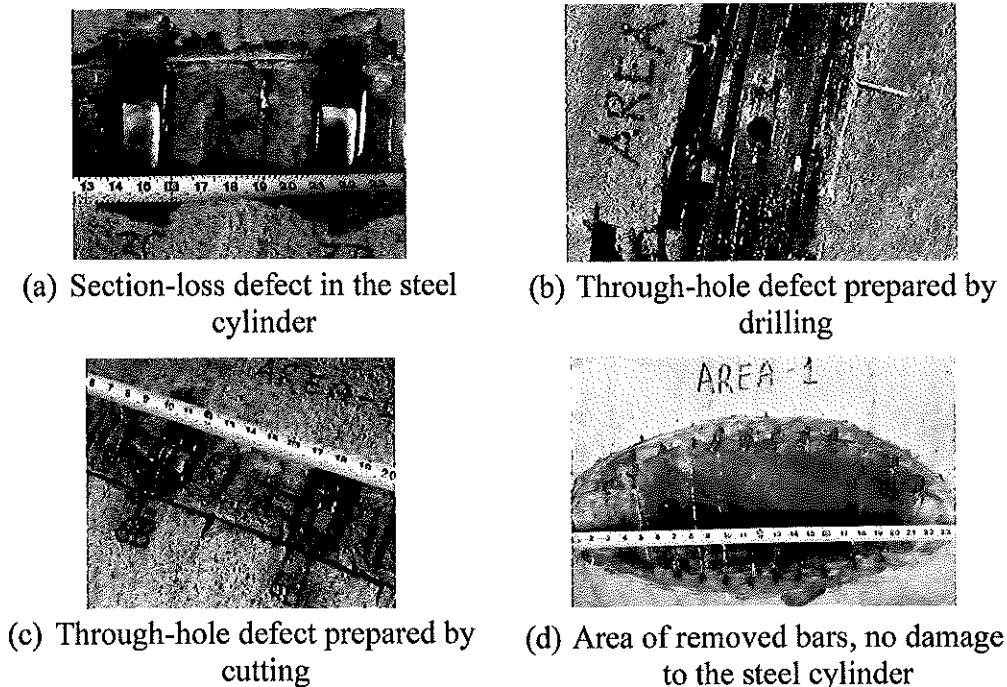
Most of the induced defects included localized section loss or through holes in the steel cylinder with varying sizes, spacings, and extents of loss, which were prepared by grinding, drilling, or cutting. In many cases, this involved locally removing reinforcing bars to provide access to the steel cylinder. In addition to studying the defects in the steel cylinder, one area was prepared by removing a significant amount of bars without damaging the steel cylinder to study the potential effect of such a condition on the RFT signals, although RFT is not intended to see behind the thick steel cylinders in BWP. The section losses were measured using an ultrasonic thickness (UT) gauge, and through-holes were measured with a digital caliper. All defects were documented by distance from the pipe end (offset) and clock position. Typical views of induced defects are shown in Figure 3, and a general comparison of the induced defects and EM results are presented in Table 3 for the 36-in. test pipe.

Figure 3. Typical views of defects induced in 36 in. test pipe

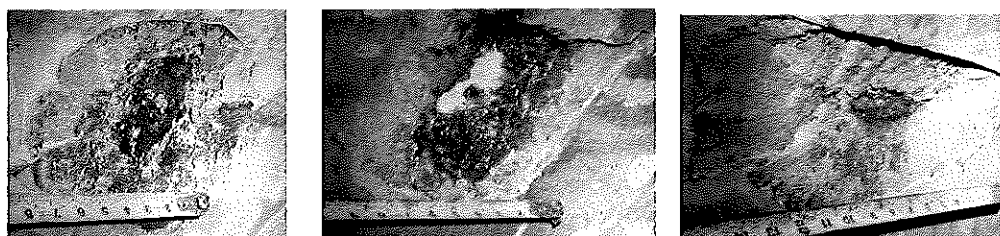
Visual and Sounding Inspections: SGH inspections in this pipeline revealed four pipes, each with an area of spalled mortar lining ranging in size from 25 sq. in. to 90 sq. in. near the crown of the pipes, bringing into question a potential external impact to the pipes at some point in the past (Figure 5). Three spalls were away from pipe joints, where the steel cylinder was exposed, corroded, and bulged at two locations. One spall was at a pipe joint, where only the joint ring was exposed and corroded. UT measurements on exposed steel surfaces indicated up to 50% section loss in the steel cylinder of one of the pipes and no measurable loss in the other pipes.

Figure 5. Areas of spalled mortar lining and exposed/corroded steel cylinders

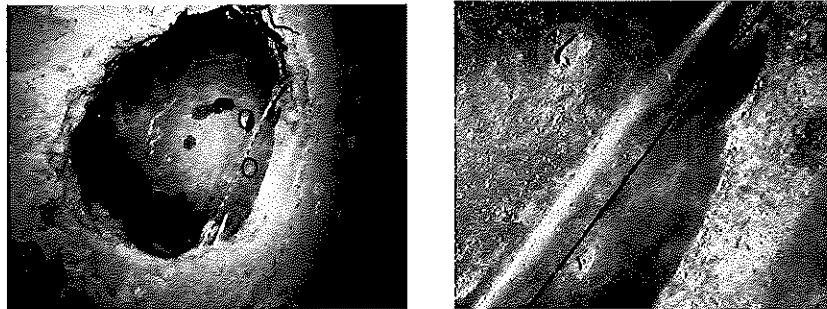
- In the pipe with two areas of estimated 70% section loss, SGH located an existing mortar patch, removal of which revealed a corroded and bulged steel cylinder with two through-holes ($<1/4''\varnothing$) adjacent to a lap-weld in the cylinder and up to 50% section loss in the vicinity of the through holes (Figure 6). This is a major observation because these defects could have gone unnoticed without detection by EM.
- In the six pipes reported with mechanical stress, 6 in.x6in. windows made in the mortar lining revealed a lap-weld joint in the steel cylinder in three pipes and no other visual anomalies or section losses.

Figure 6. Pipe with two through holes in the steel cylinder detected by EM and not by V&S (red dotted line: spiral weld in cylinder, blue circles: through holes)

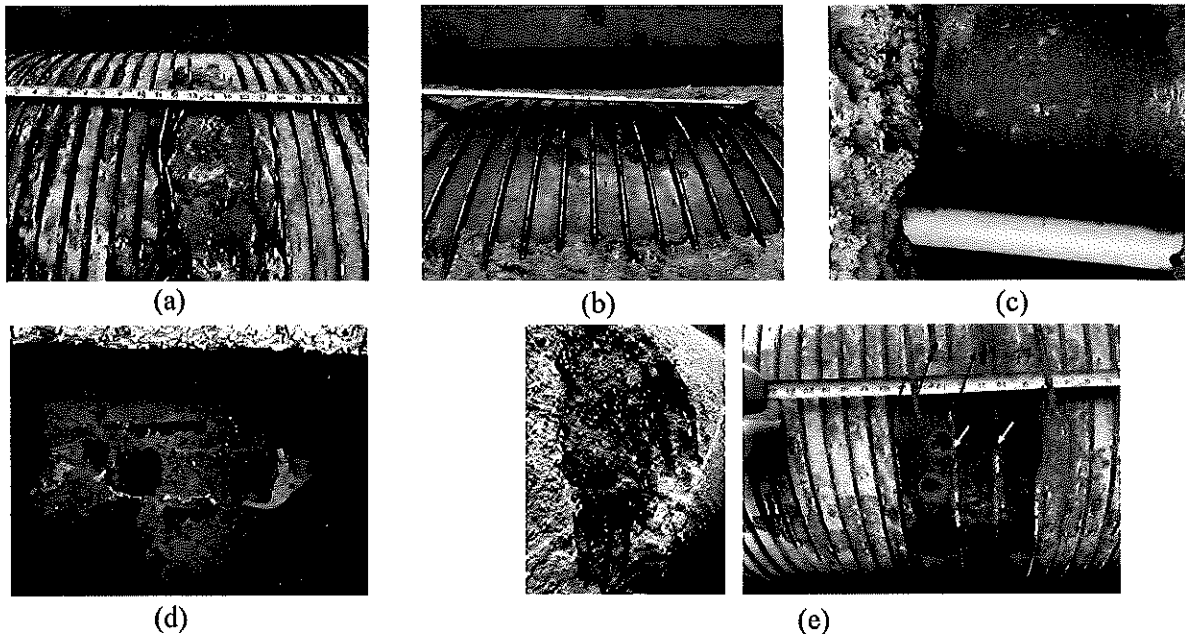
- One pipe with section loss in the cylinder identified by both internal V&S and EM inspections was found to have an existing previous repair in the mortar coating on the outside. Upon removing the mortar coating in this area, a depression in the steel cylinder and several broken bars were found (Figure 7a).

- One pipe with spalled mortar lining but no measured section loss during internal inspections was found to have local damage under the mortar coating with the local wires bent radially inwards (Figure 7b).

- One pipe with spalled mortar lining but no measured section loss during internal inspections was found to have no visible damage on the mortar coating (Figure 7c).

- One pipe with spalled mortar lining near a joint and limited section loss in the joint ring identified during internal inspections had no visible damage around the joint on the outside (Figure 7d).

- One pipe with two through holes identified by EM and not by V&S (internal condition previously shown in Figure 6) had damaged mortar coating, with multiple broken bars (blue arrows in Figure 7e), thinning bars (yellow arrows), and a depression in the steel cylinder with through holes (green circles for holes identified internally; red circle for a new uncovered hole).

Figure 7. External condition of pipes identified with defects via internal inspections
