In-line Inspection Experience with Lined Upstream Pipelines

ABSTRACT

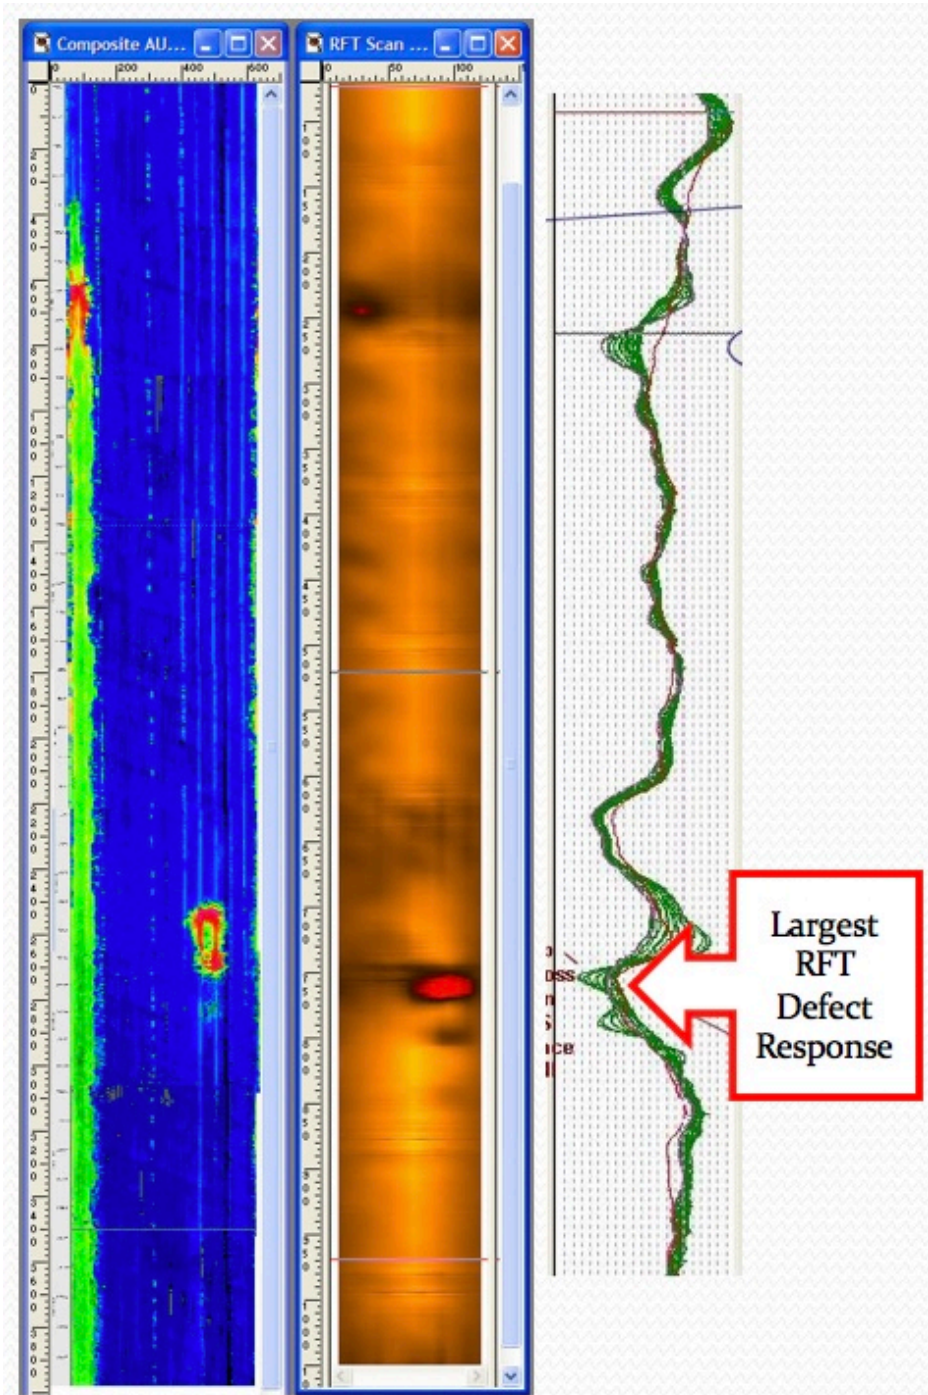
In addition to calibration pipes, a section of NPS6 pipe from the 2007 failed pipeline that contained CBL damage was retained for the verification of inspection tools. The new NPS6 RFT ILI tool was pulled through this section of pipe and the results compared to automated ultrasonic testing (AUT) results. The pipe section with actual corrosion damage was helpful in demonstrating the tool's ability to detect actual CBL (Figure 4).

Figure 4: Corroded Section of NPS6 pipe from upstream of the 2007 failure
Left to Right: AUT scan; RFT scan; RFT signal response

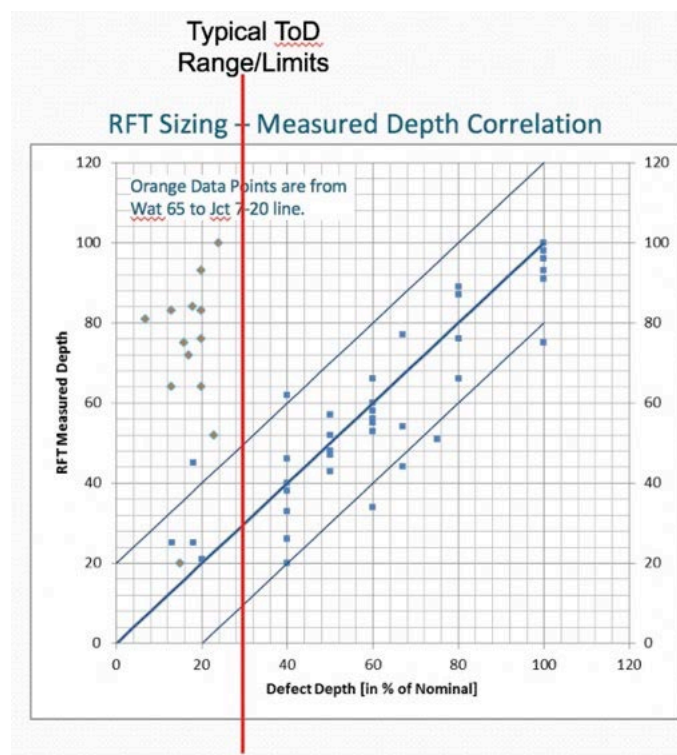
The calibration pipes and subsequent inspection verification dig results were used to determine the RFT ILI tool's defect sizing accuracy for Shell's "thick walled" HDPE lined pipelines (Ref. 3, 5). Figure 5 compares the RFT ILI reported depth (vertical axis) to the measured (dig verification UT) depth (horizontal axis). Data in blue on the graph on the right is based on five years of calibration and dig verified data for defects above the ToD. Defects below the ToD are detected, conservatively sized, and monitored for change (as shown by the orange data points).

Figure 5: RFT Tool Defect Sizing Accuracy

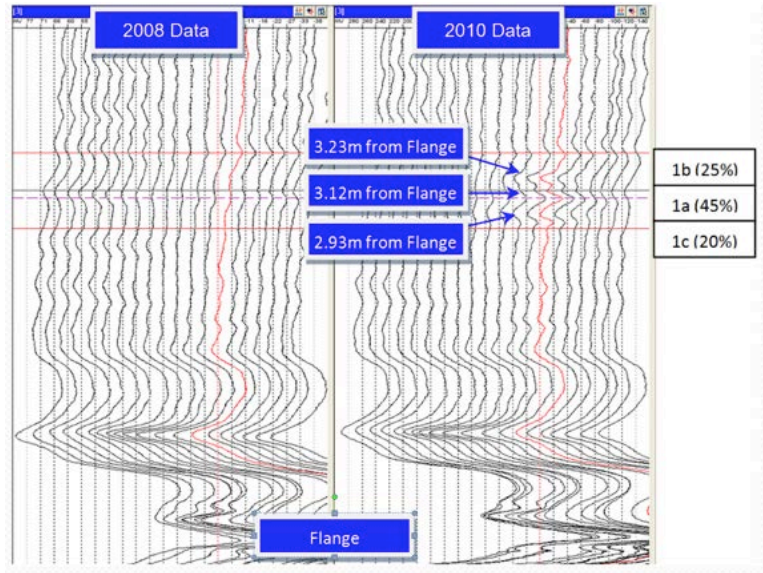
One such location where the RFT ILI tool detected CBL activity for a short time after restart, demonstrated the ability of RFT ILI to detect wall loss defects. Figure 6 illustrates the RFT ILI data from before restart in 2008 and in 2010 when the inspection shows wall loss anomalies. The 2010 ILI report indicated 3 anomalies at 45%, 25% and 20% deep. Later Dig Verification NDE confirmed the depths to be below that, at 18%, 16% and 14%; demonstrating the ability of RFT ILI tool to detect anomalies below it's ToD.

Figure 6: 2008/2010 RFT ILI Log Comparison – Corrosion Pitting Detection

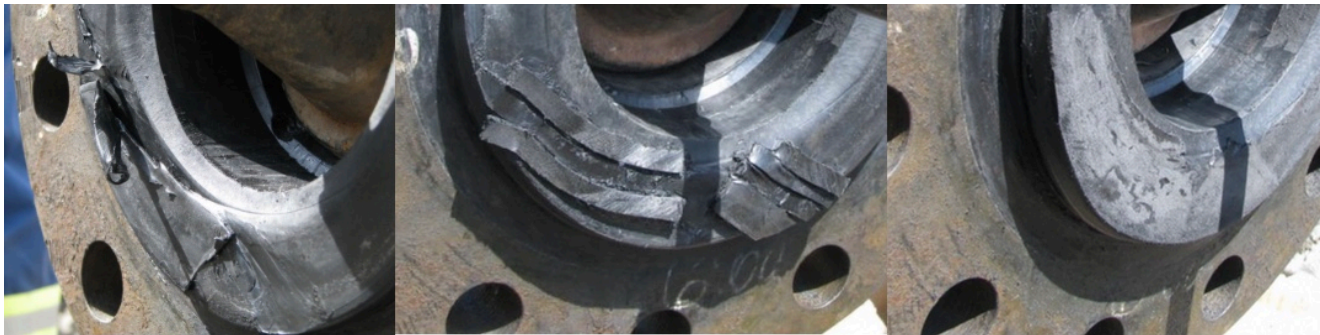
In some cases when making or breaking flange pairs damage, such as scratches or gouges to the liner flange faces can occur. The solution to this is often to pull out and then cut replace the liner flange stub end. Shell avoided this due to its concern for the effect of absorbed hydrocarbon liquids in the existing liner on the new stub end flange fusion. Shell chose to develop a procedure for an in-situ repair of gouges by melting new HDPE material into the gouge followed by machining or sanding the repair flush to the stub end flange face (Figure 9). By doing so, Shell avoided cutting the liner flange stub end off and the risk of having a poor HDPE fusion.

Figure 9: Left to Right; Damaged liner flange stub end, HDPE filler strips applied to fill areas of material loss and Finished stub end after sanding

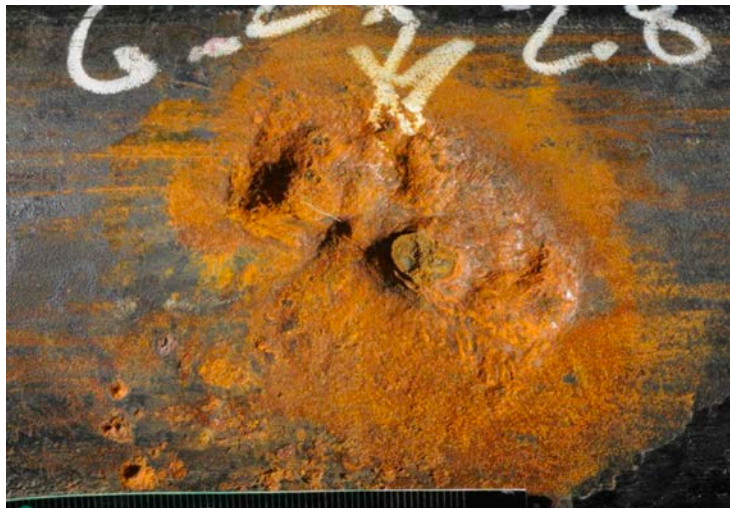
The first 4 dig verifications were restricted to “Imminent Threat Indications” that were verified during the Plant outage. Significant external corrosion was detected at each, with through-wall pits in three locations and 86% wall loss at the fourth location. The external coating had been damaged or disbanded. The cement lining was in good condition at the through-wall pits and withstood the low operating pressure to maintain the pipeline integrity without leaks. Eventually this corrosion mechanism would have resulted in a produced water spill. Figure 11 shows one of the through-wall pits. Coincidentally these 4 primary sites happened to all occur within the 5.6mm WT pipeline segment (i.e. first 2500m of pipeline).

Figure 11: Through-Wall External Corrosion Pit from CML Pipeline.
