# CORROSION FAILURE IN A LINED SOUR GAS PIPELINE - PART 1: CASE HISTORY OF INCIDENT

L. Simon  
Shell Canada Energy  
Pincher Creek, Alberta

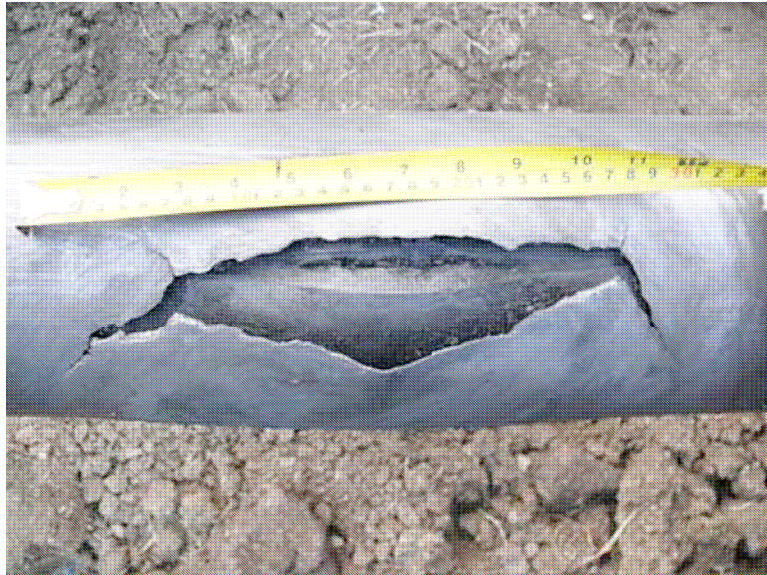
The pipeline failure was the result of an axial split in the steel pipe about 300mm in length with a maximum width of 60mm at centre. The failure occurred 27m downstream of Vent 6 as shown in the elevation profile (Figure 3). It was the result of tensile overload of the steel pipe in a localized area where internal corrosion had removed almost 90 per cent of the pipe wall (Figure 1 and 2). There was no evidence of a breach in the liner prior to the failure of the steel portion of the pipeline.

**FIGURE 1** - Failure after insulation and coating removal

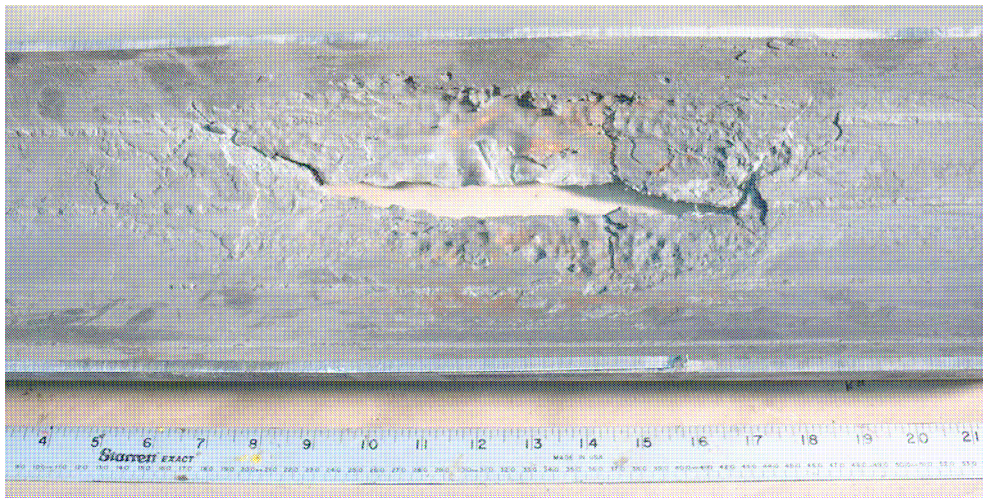
In this case, it appears that the protective iron sulphide scale had not existed in a uniform manner, and as a result corrosion was able to occur in localized patches. In those locations, a paste-like mixture of iron sulphide corrosion product suspended in an acidic liquid, was found sandwiched in the annulus between the HDPE liner and the steel pipe (like the example shown in Figure 4). The liquid component was believed to be primarily methanol, which is used in the pipeline for a variety of purposes, including hydrate control. Methanol was continuously injected into the production fluids to prevent hydrates and also was used occasionally to flush parts of the annulus vent system of the pipeline, thus establishing its presence in the liner annulus. There was no evidence that chlorides, bacteria, or elemental sulphur played a role in the corrosion process.

**FIGURE 2** - ID of the Steel Pipe at the Failure

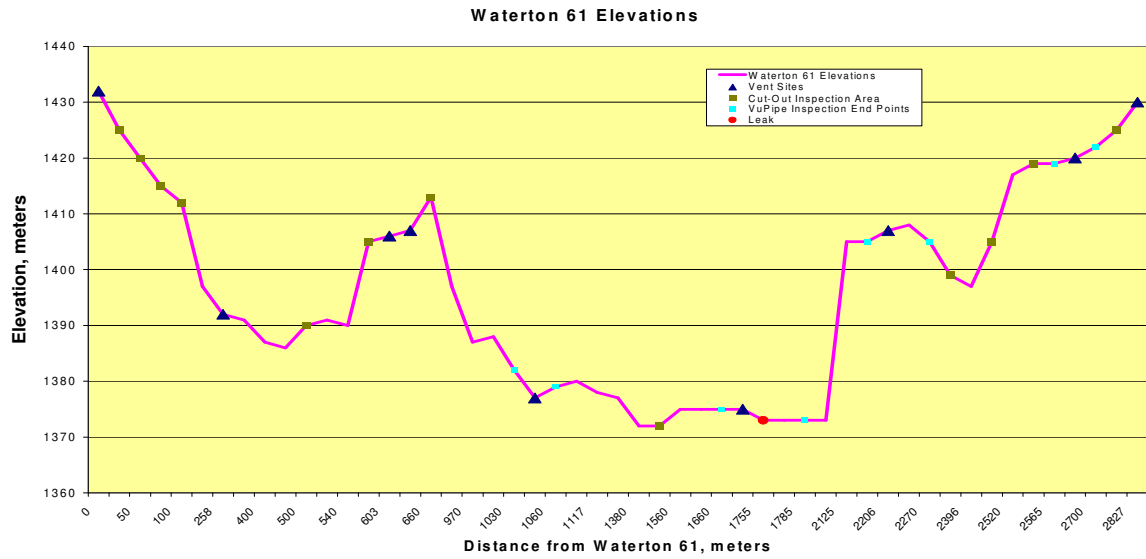
**FIGURE 3 - SC Pipeline Elevation Profile and Liner Vent Location Detail**

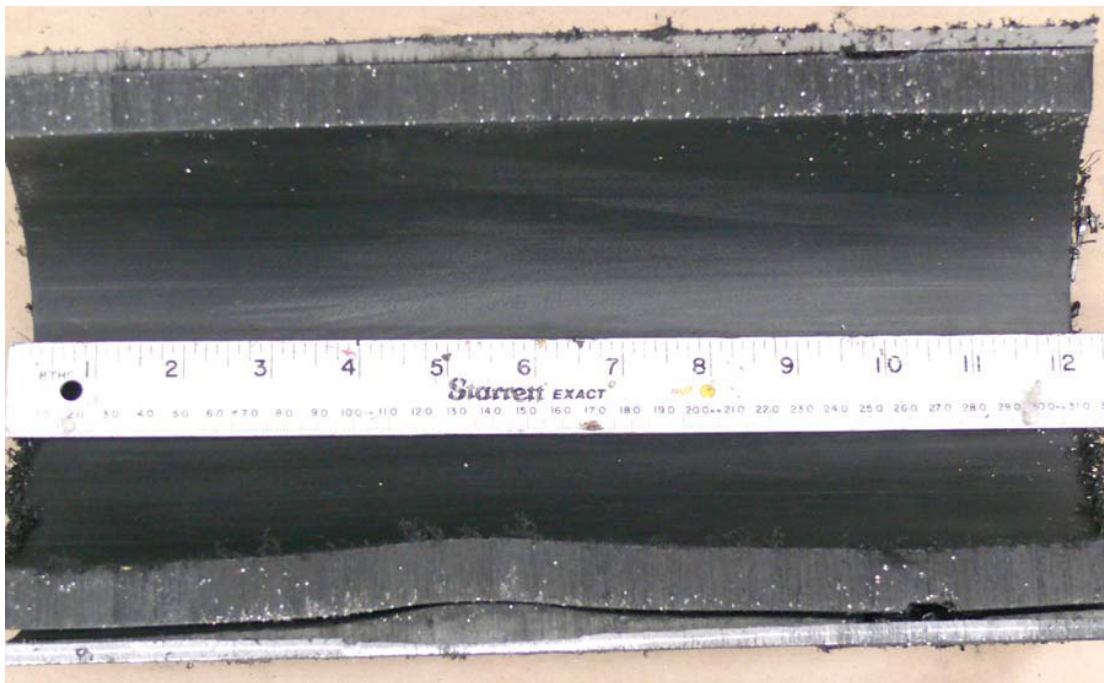
**FIGURE 4 - Scale build-up and Metal loss at Bulge in Pipe Cut Out**

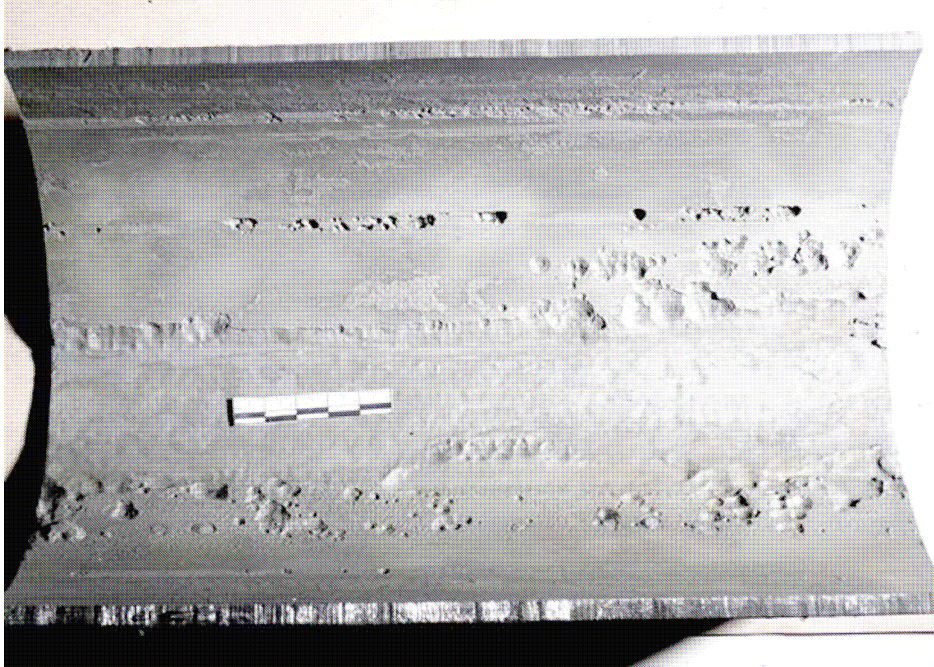
During log verifications and bell hole inspections minor isolated pitting adjacent to the external grooves in the HDPE liner was noted in a number of pipelines. This type of damage has been found in lined pipelines of varying age, ie; from 2 to 7 years and all to similar depths. The depth of such pits was as much as 28% of the pipe wall in one pipeline. This pitting is like the axial pitting shown in Figure 5 which is approximately 30% of the pipe wall and adjacent to the external grooves on the HDPE liner.

**FIGURE 5** - Band of General Wall Loss (50% Loss) and Isolated Pitting (25-30% Loss) adjacent to external grooves in the HDPE liner

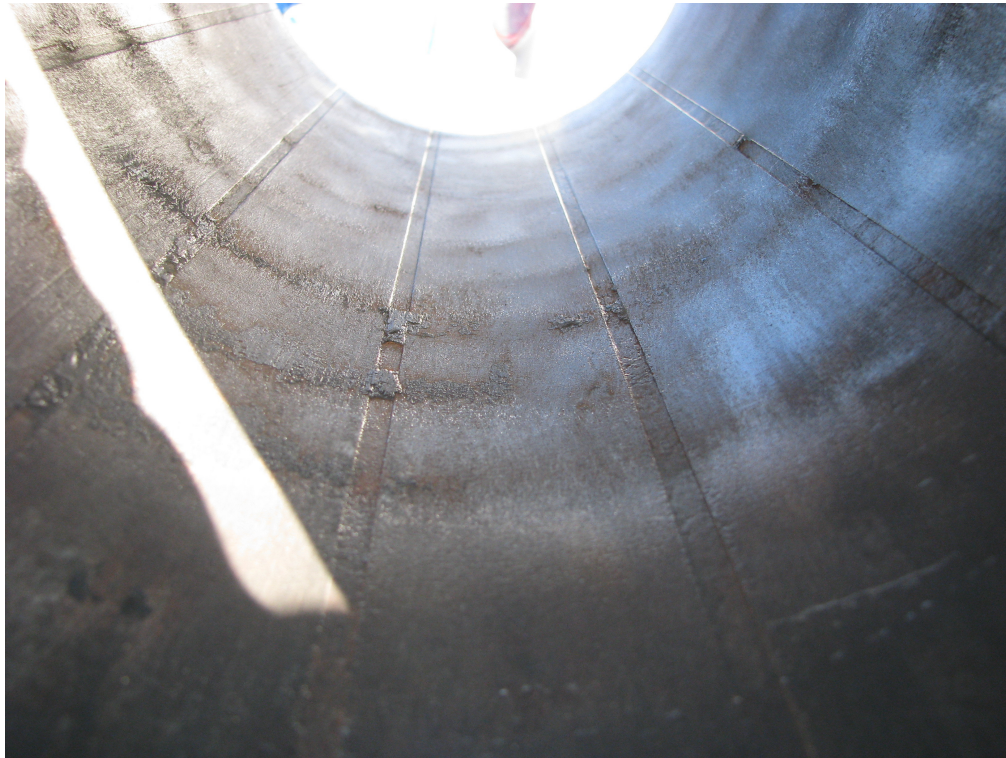
The verification dig findings confirmed corrosion activity on recently lined pipelines that had received continuous methanol injection into production fluids for hydrate control. In one segment of HDPE lined pipeline that had less than one year of service, shallow (4%WT) grooving was detected adjacent to the external grooves in the HDPE liner (Figure 6). This suggests that, while different than the corrosion mechanism that caused the SC pipeline failure, corrosion behind HDPE liners in sour gas pipelines can be a threat where methanol is continuously injected into the production fluids. Consideration should be given to taking steps to properly assess and manage the risk of such corrosion.

**FIGURE 6** - Shallow Corrosion on Steel Pipe ID Adjacent to External Grooves in HDPE Liner
