Kristopher Embry, PICA Corp.

# Nashville Metro Water Services 4.7-mile 8" Whites Creek DIP Sludge Force Main Inspection

#### Overview 8" Whites Creek DIP Sludge Force Main Inspection

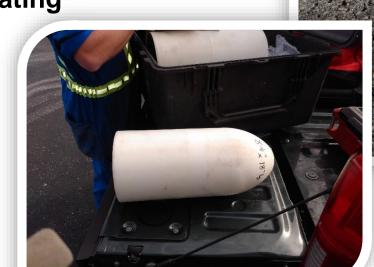
- All pigs were removed in satisfactory condition
- Launched gauge 4.5 hours
- The gauge plates had minimum bending, indicating no major bore restrictions.
- After the pig and gauge runs
   Nashville MWS now has a clean pipe!

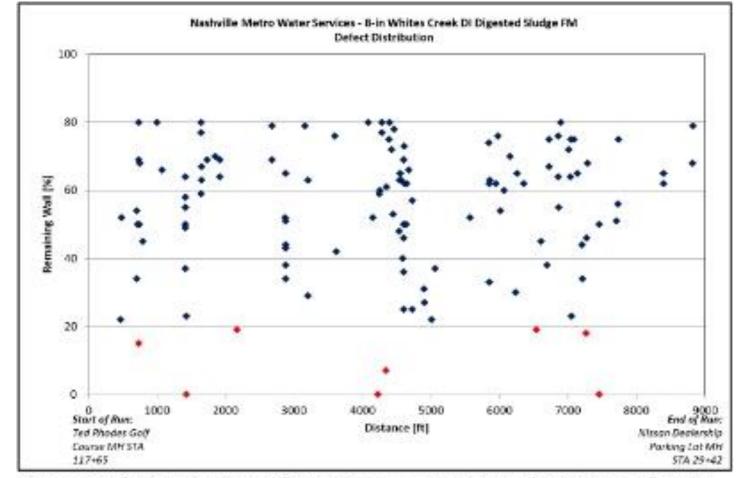
Figure 1. Distribution of localized wall loss with respect to remaining wall for the inspected portion of the 8" Whites Creek DI Digested Sludge Force Main.

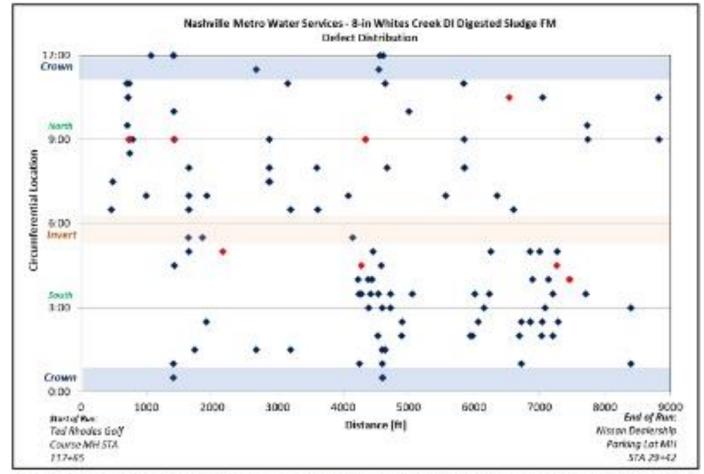
Figure 2. Distribution of localized wall loss with respect to circumferential location for the inspected portion of the 8" Whites Creek DI Digested Sludge Force Main.

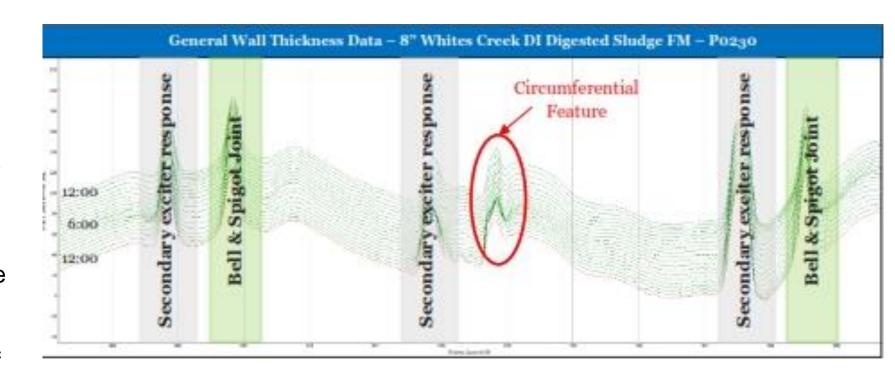
RFT strip chart data highlighting a circumferential signal located in P0230, 397.75 ft from the launch barrel. This signal was unique in the RFT data and did not correlate with any pipeline features in the provided drawing records. PICA suspects the signal is the result of a previous pipeline repair, or undocumented pipeline feature.
