**CCTV-LASER PROFILOMETRY OF XXXXX RAW HEADER “B”
DN1200 Concrete Raw Water Intake Pipeline
XXXX Water Treatment Plant
XXXXXXXXXX**

Prepared for
XXXXXXXXX

Prepared by
L. Olchove and D. C. Lingnau
PICA, Pipeline Inspection and Condition Analysis Corporation

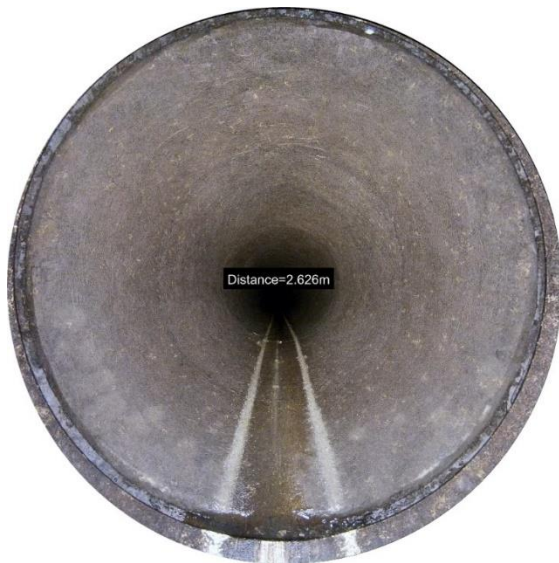
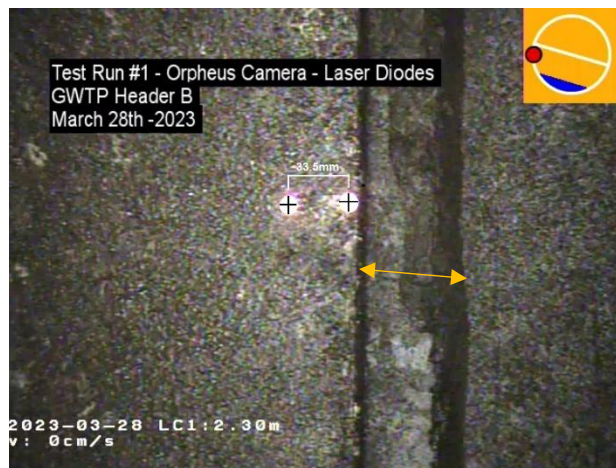
A dresser adapter that transitions the spiral steel pipe to an unknown type of concrete pipe, was located 2.66 m-2.70 m, upstream of the valve chamber. What is unusual is that at this transition the gap between pipe ends is approximately 50 mm. The median internal diameter of the gape was measured 1244.7 mm by the laser profilometry (inside the gap) at the location 2.6 m upstream of valve chamber VC7501.

Figure 1 – Both top and right images show the area of the joint gap spacing with measurements.

The Orpheus camera head, dual diode laser measuring determined the gap spacing along the circumferential of the dresser adapter is 50mm in width.

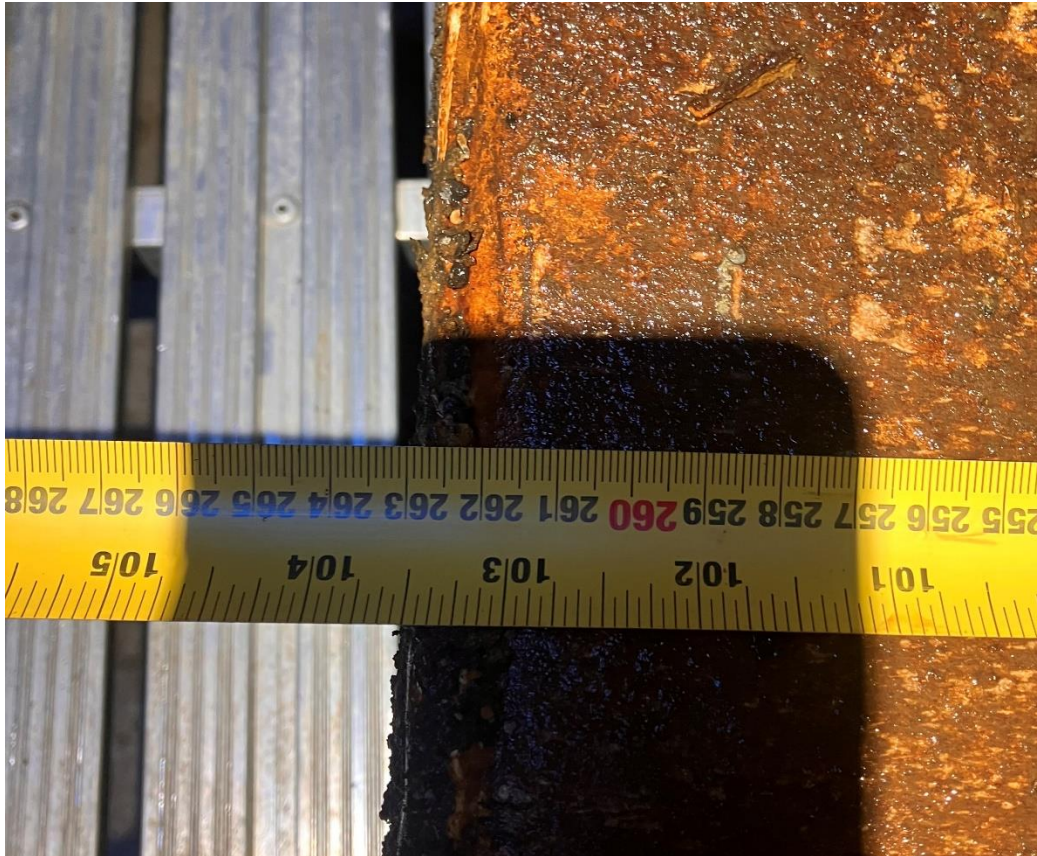
Prior to beginning the CCTV & laser survey, a measuring tape verified the gap start was located 2.62 m upstream of the pipe end opening, in valve chamber VC7501.

Figure 10 – Confirmation of the joint gap spacing begins at 103.5-inches (2.62m)

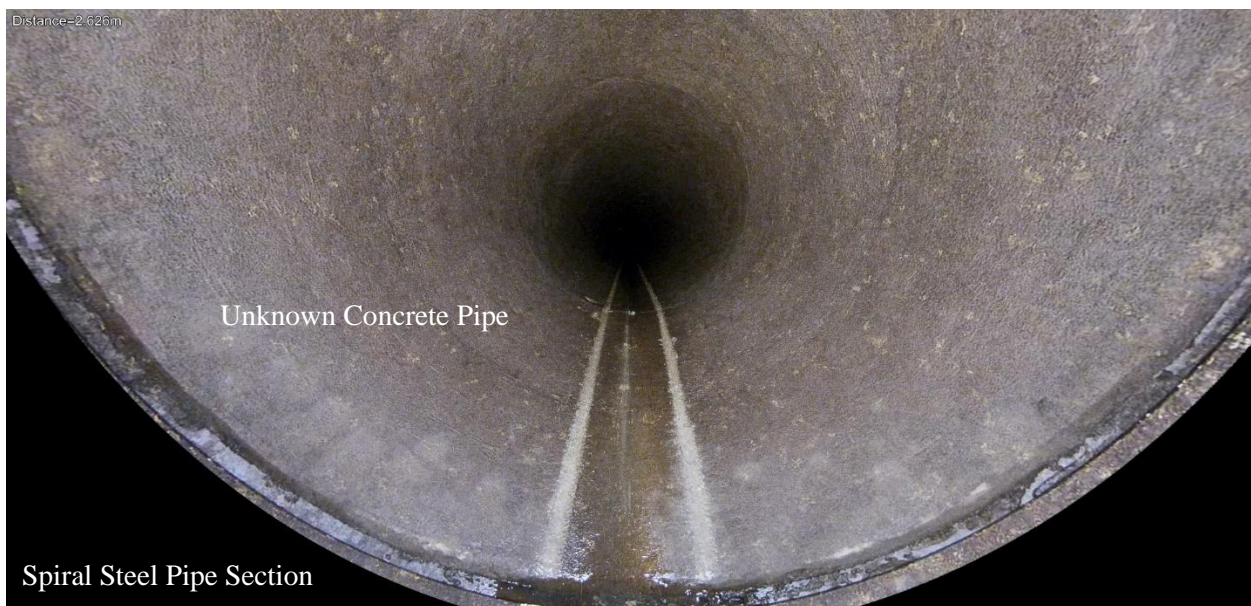
Figure 11 – Confirmation of the joint gap spacing within the video begins at 2.62m

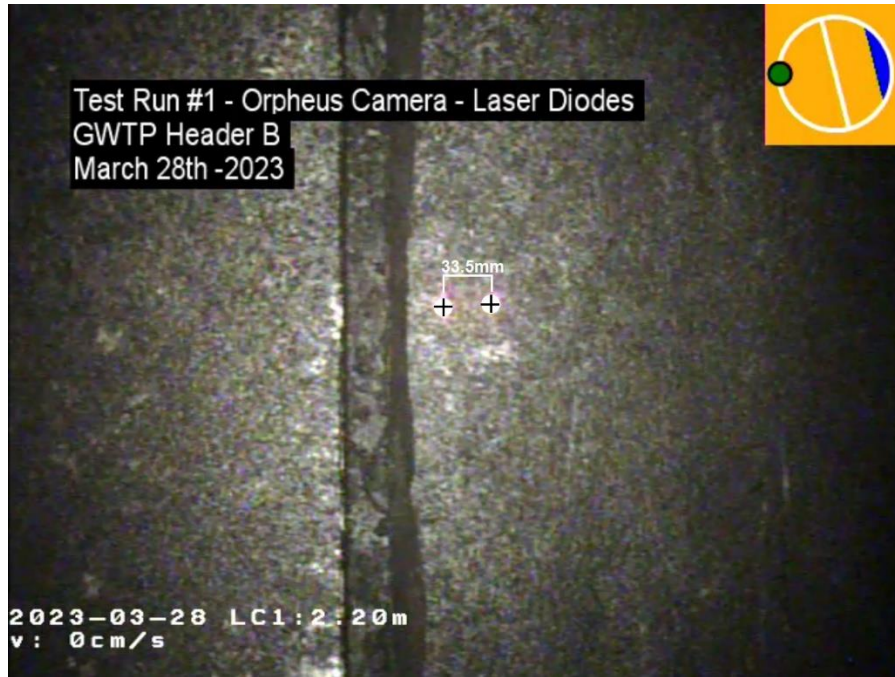
Width measurements of this joint gap, at various locations around the circumference, ranged between 40 mm to 60 mm. The 6:00 position appeared to have the largest gap measurement where signs of minor erosion of the cement mortar liner of the adjacent concrete pipe (unconfirmed concrete pipe type) were observed. The median diameter bore within the first gap was measured at 1244 mm.

Figure 12 – Laser Diode Measurement of Gap at the 1:00 position - 40 mm

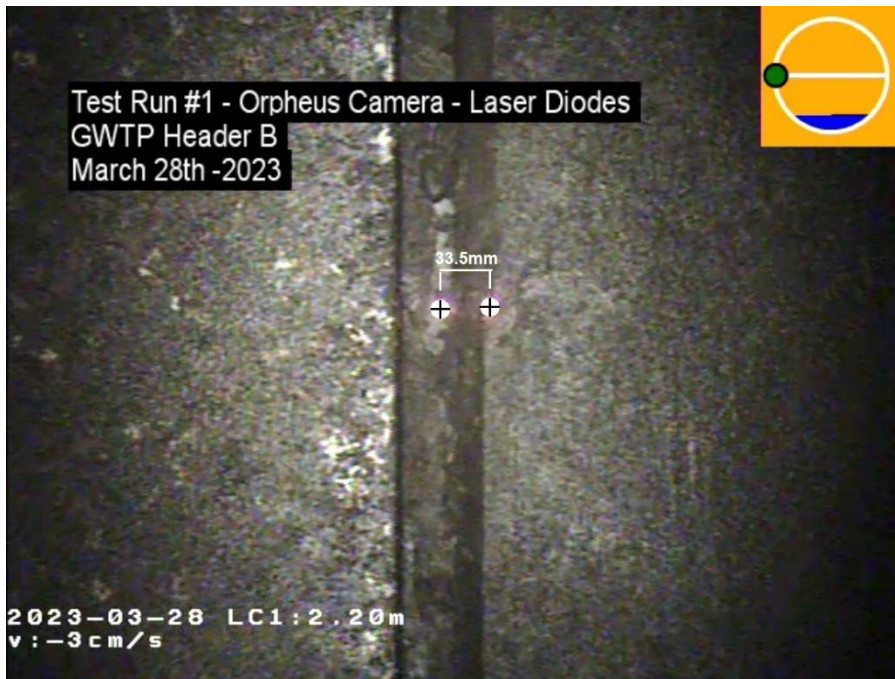
Figure 13 – Laser Diode Measurement of Gap at the 9:00 position -50 mm

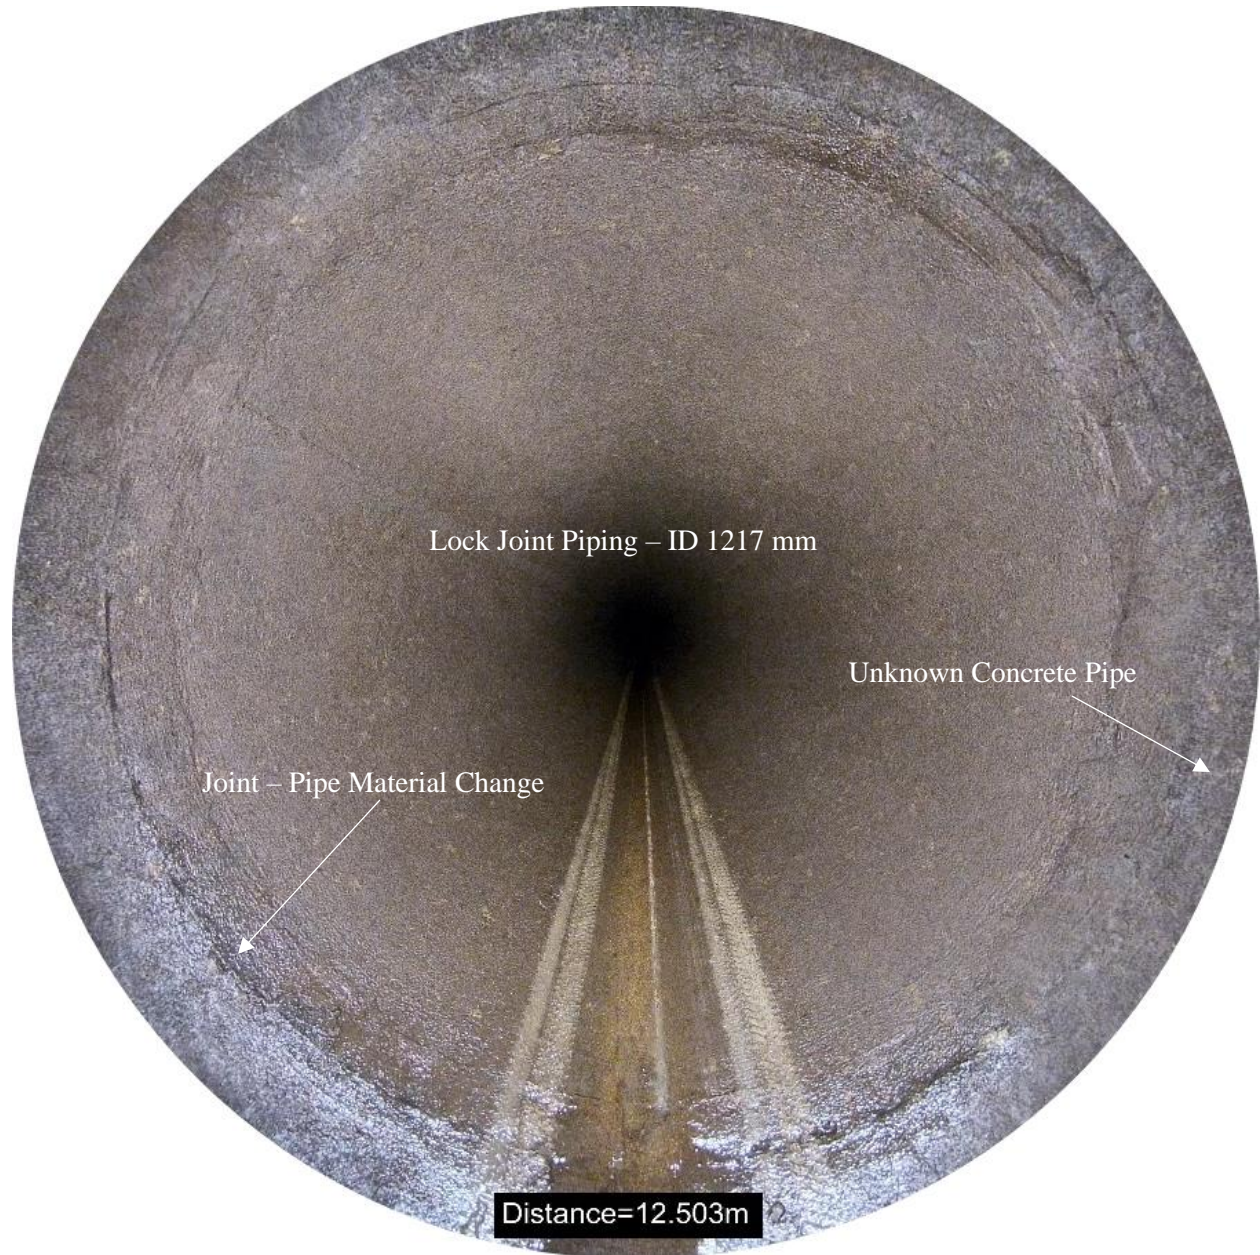
The second unknown concrete pipe has a bore measurement ranging between 1230 mm - 1235 mm at this location. There does not appear to be any signs of significant stress at the transition

Figure 15 – Transition area from Unknown Concrete Pipe to Lock Joint Pipe

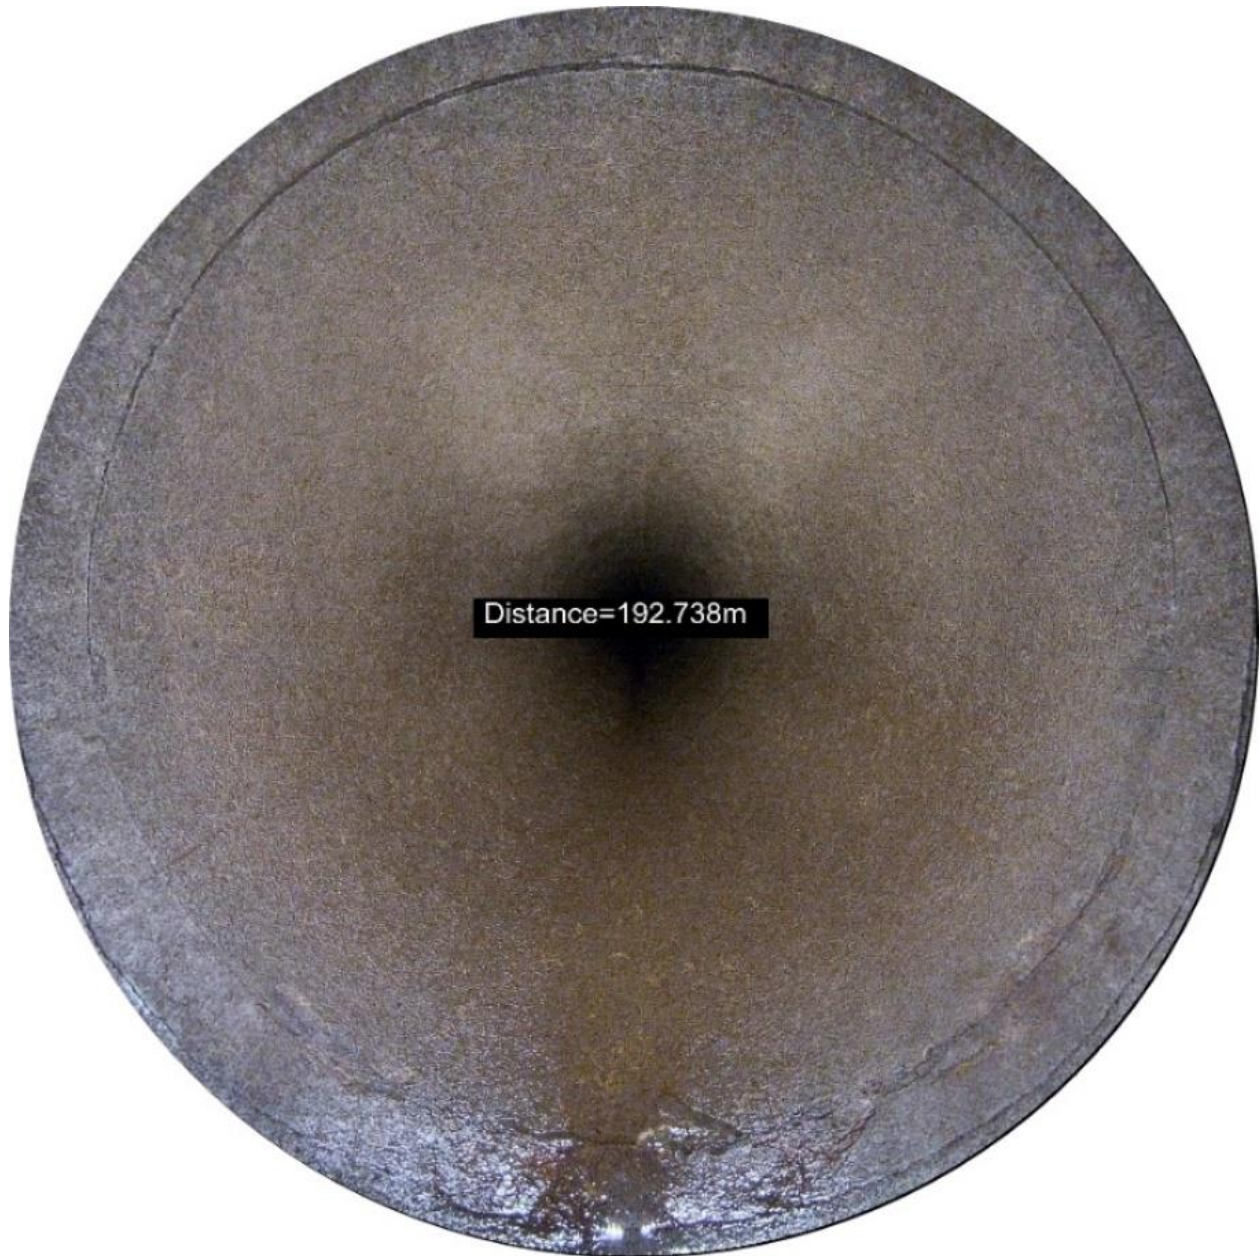
Figure 17 – Sample observation of minor grout cracking at joint

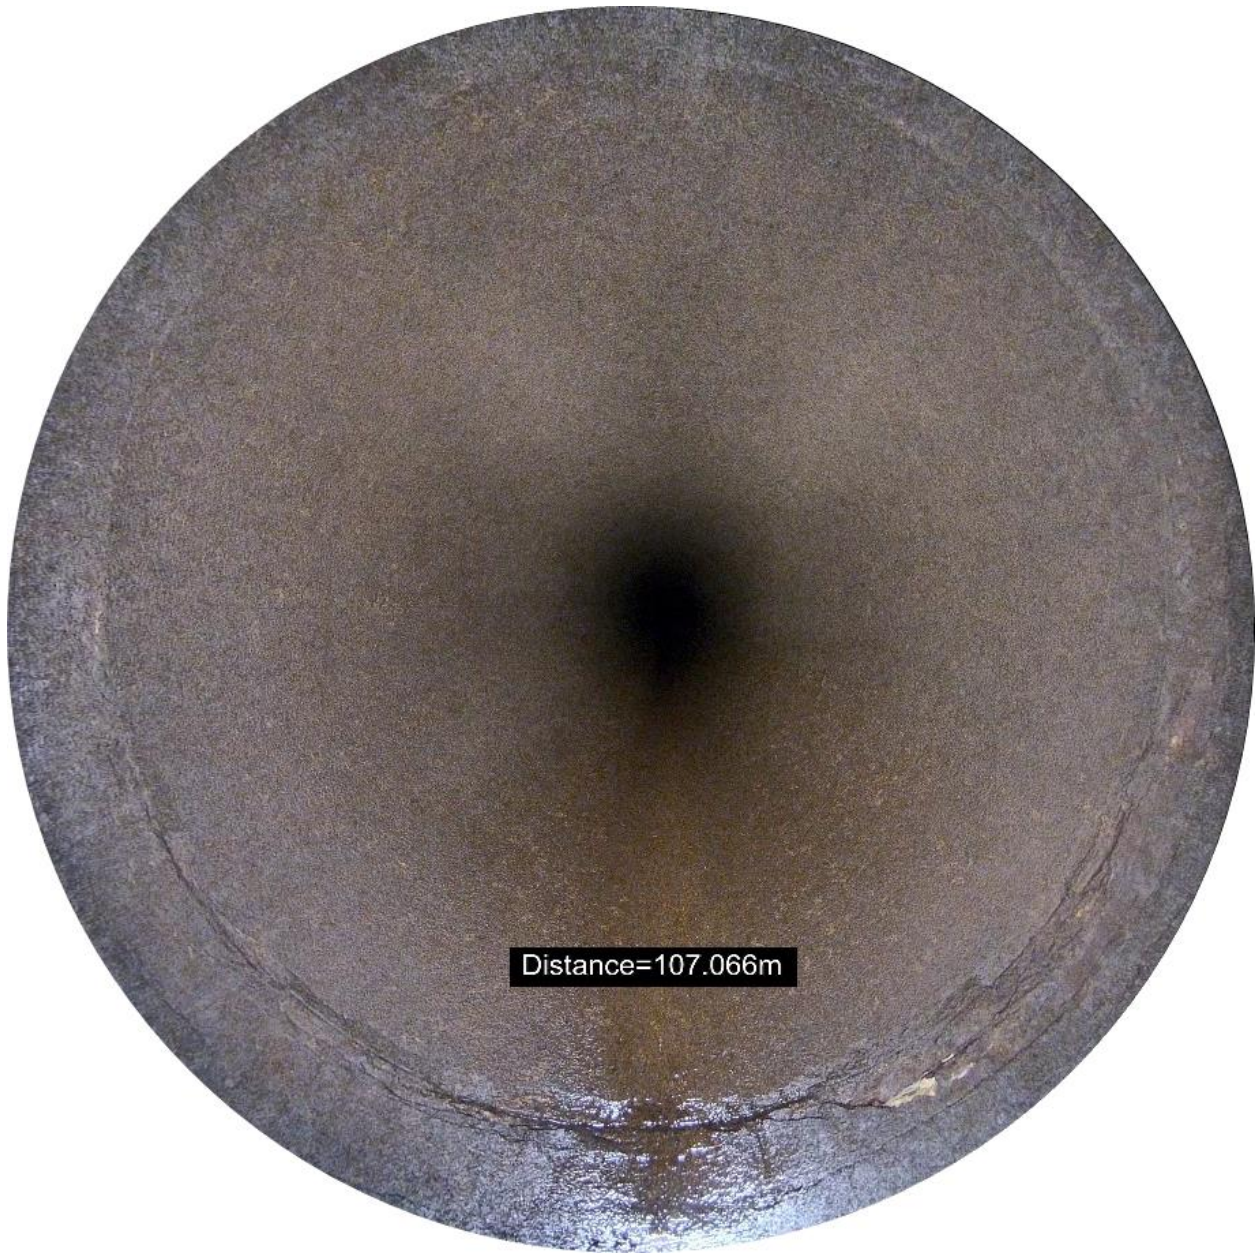
Figure 18 – General observation of the grout cracking at the pipe joint with minor spalling

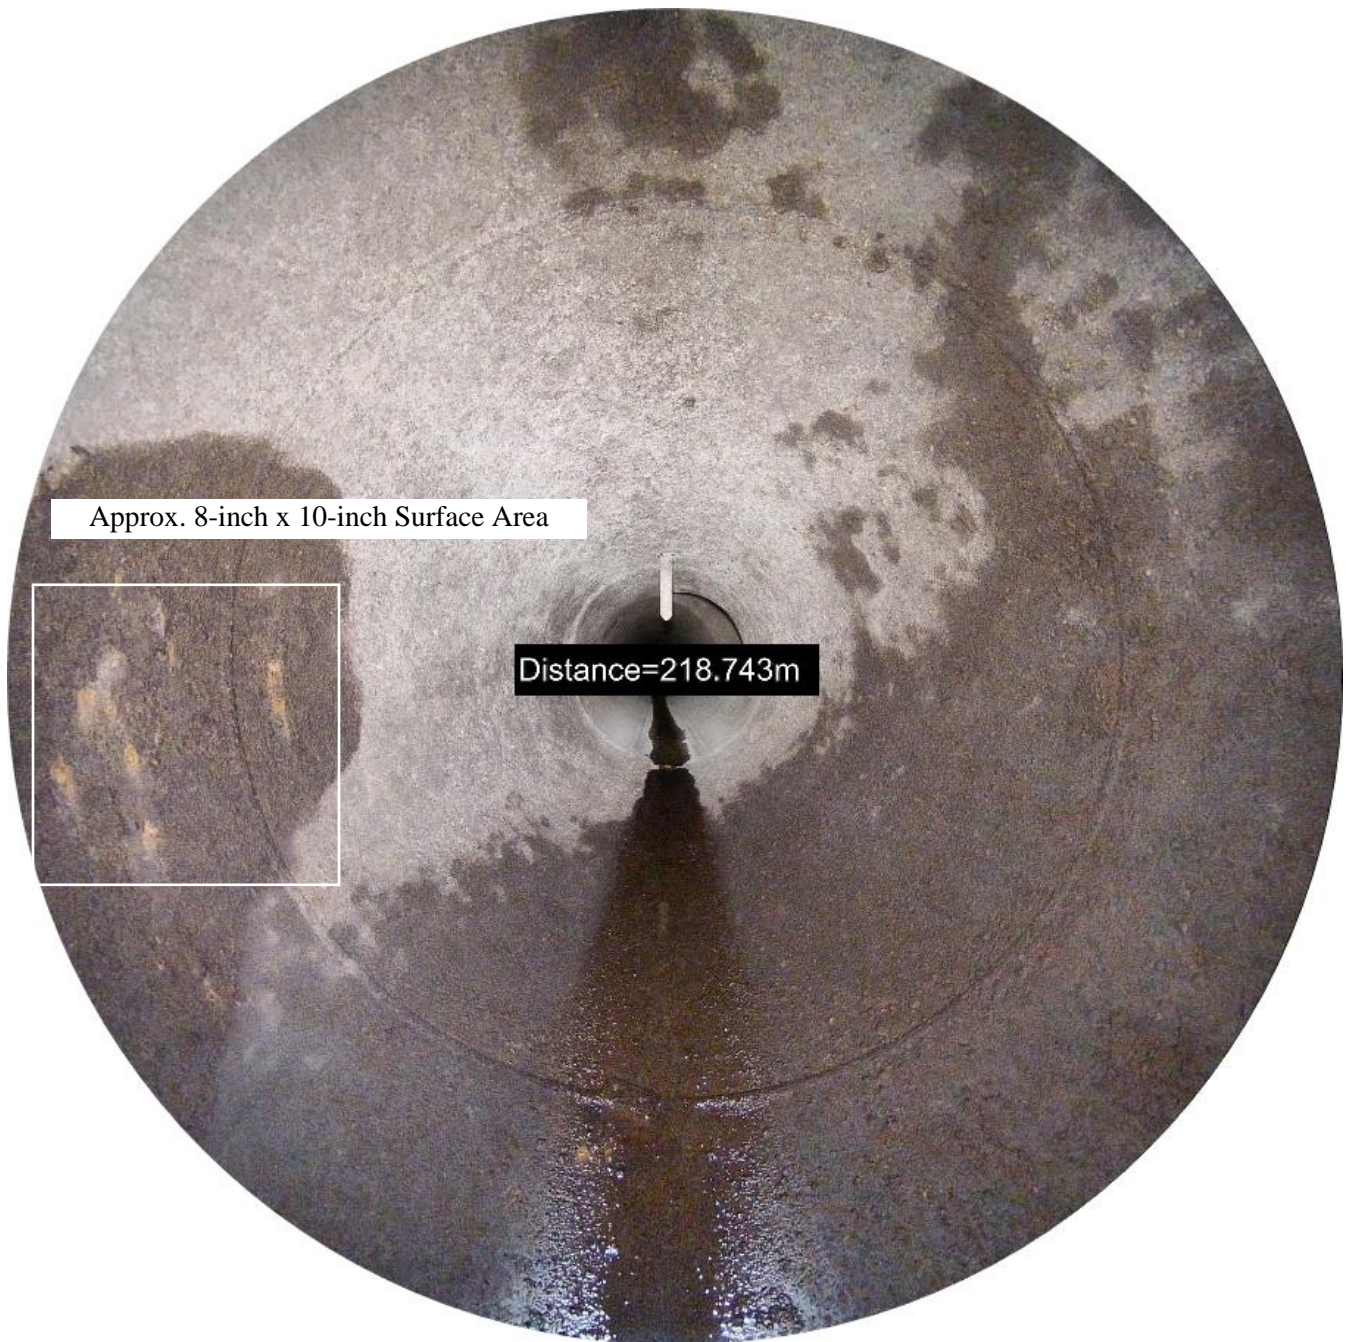
Figure 25 – Suspect area of discoloration run-off on the pipe wall at 9:00 located at 218.7m towards the pump station. The wet saturation staining on the pipe wall is greater in appearance that may indicate potential pinholes.

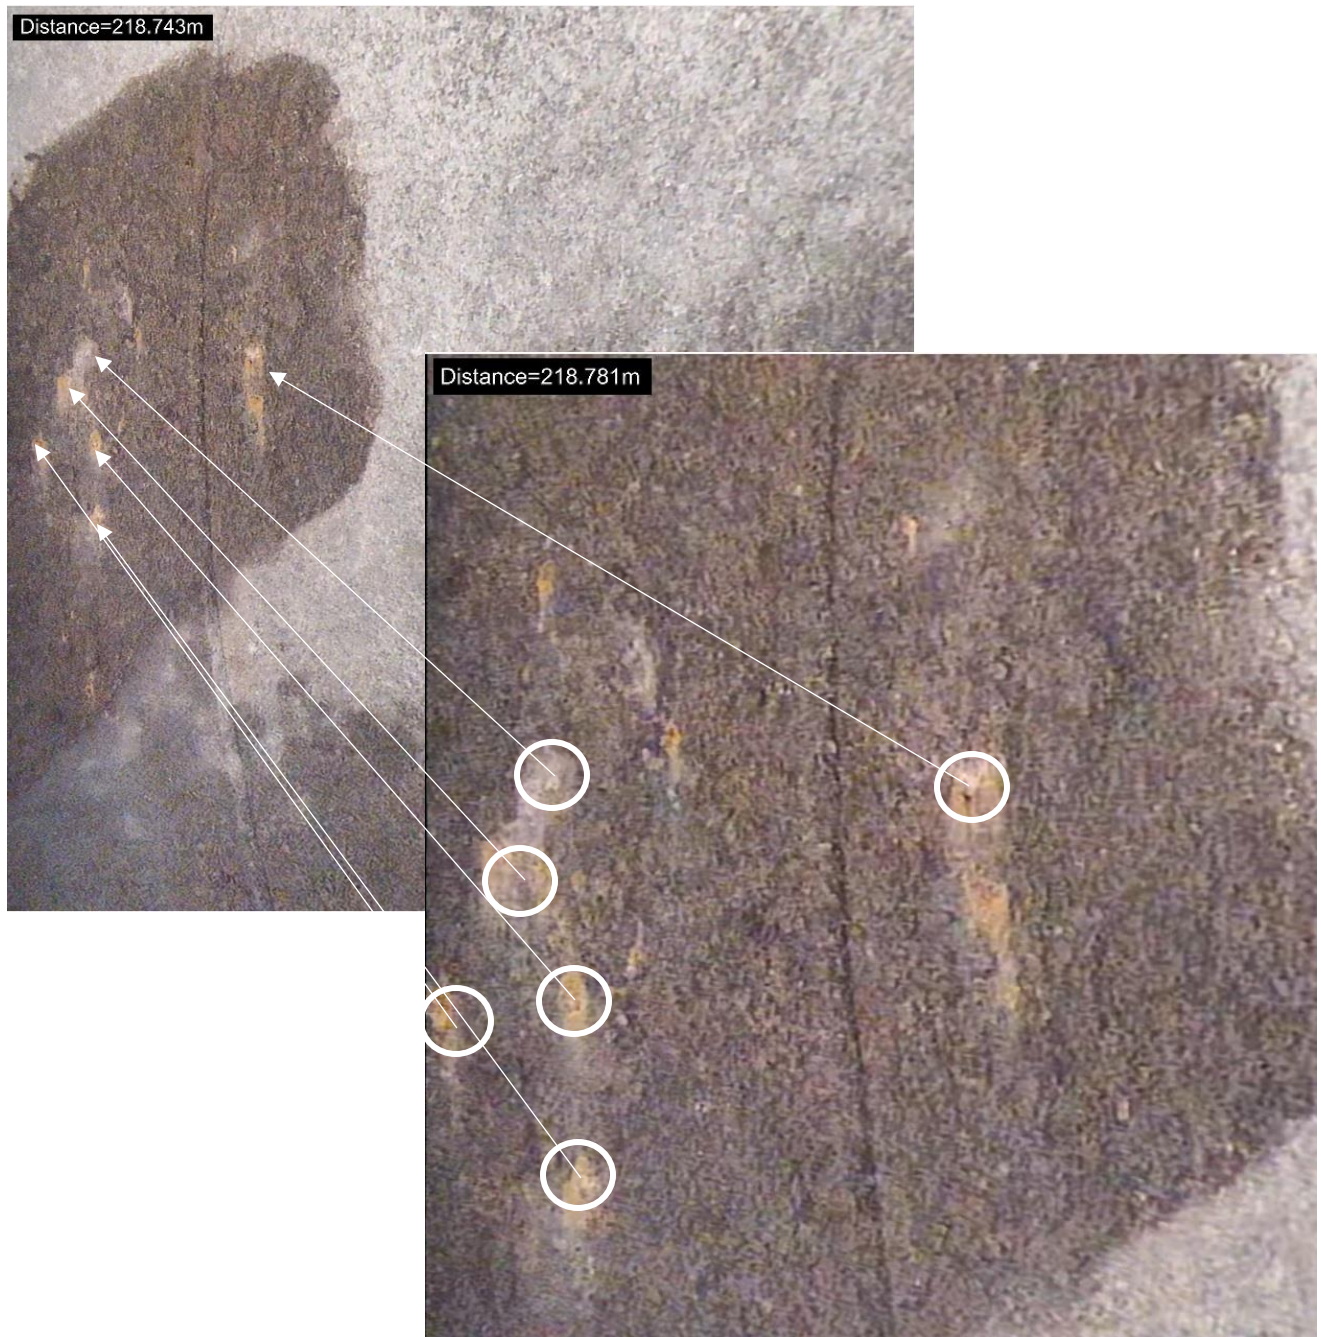
Figure 26 – (6) potential pinholes are observed with discoloration circular stains that weep downwards as a run-off pattern. This could be an indication area of ground water penetrating through the seam weld steel pipe.

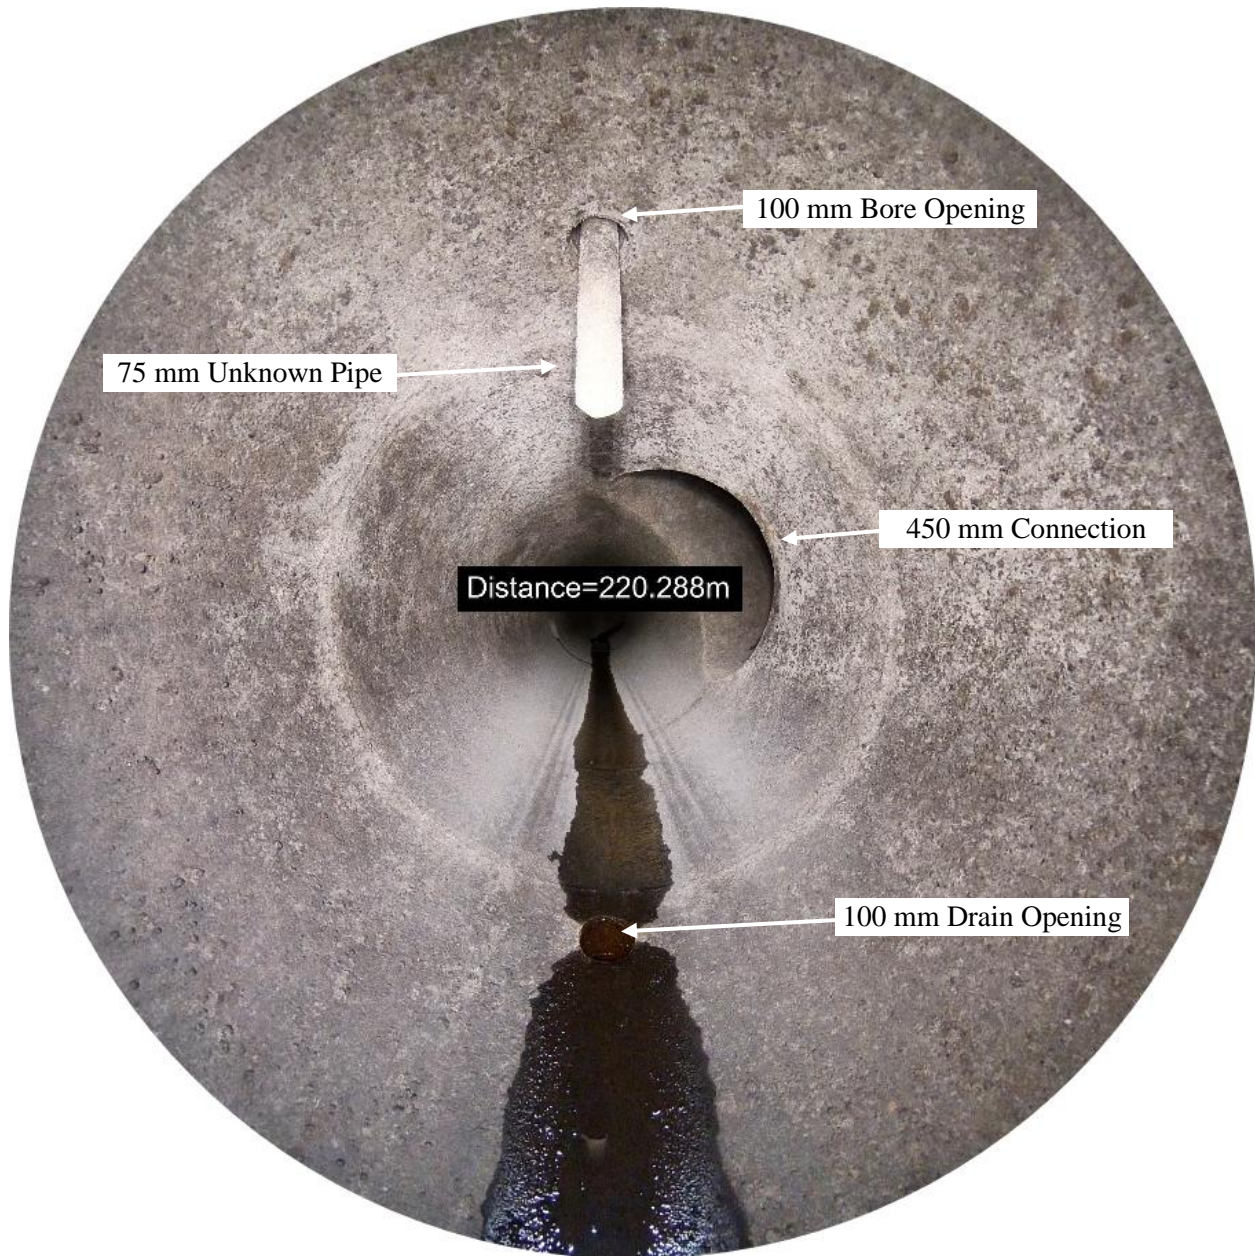
Figure 27 – The following pipe feature sizes are beyond the extent of the CCTV survey at 221.1m. The drain location along with bore opening at the crown is best calculated located at 225m. The 450 mm connection at the 3:00 position would then be located at 230m.

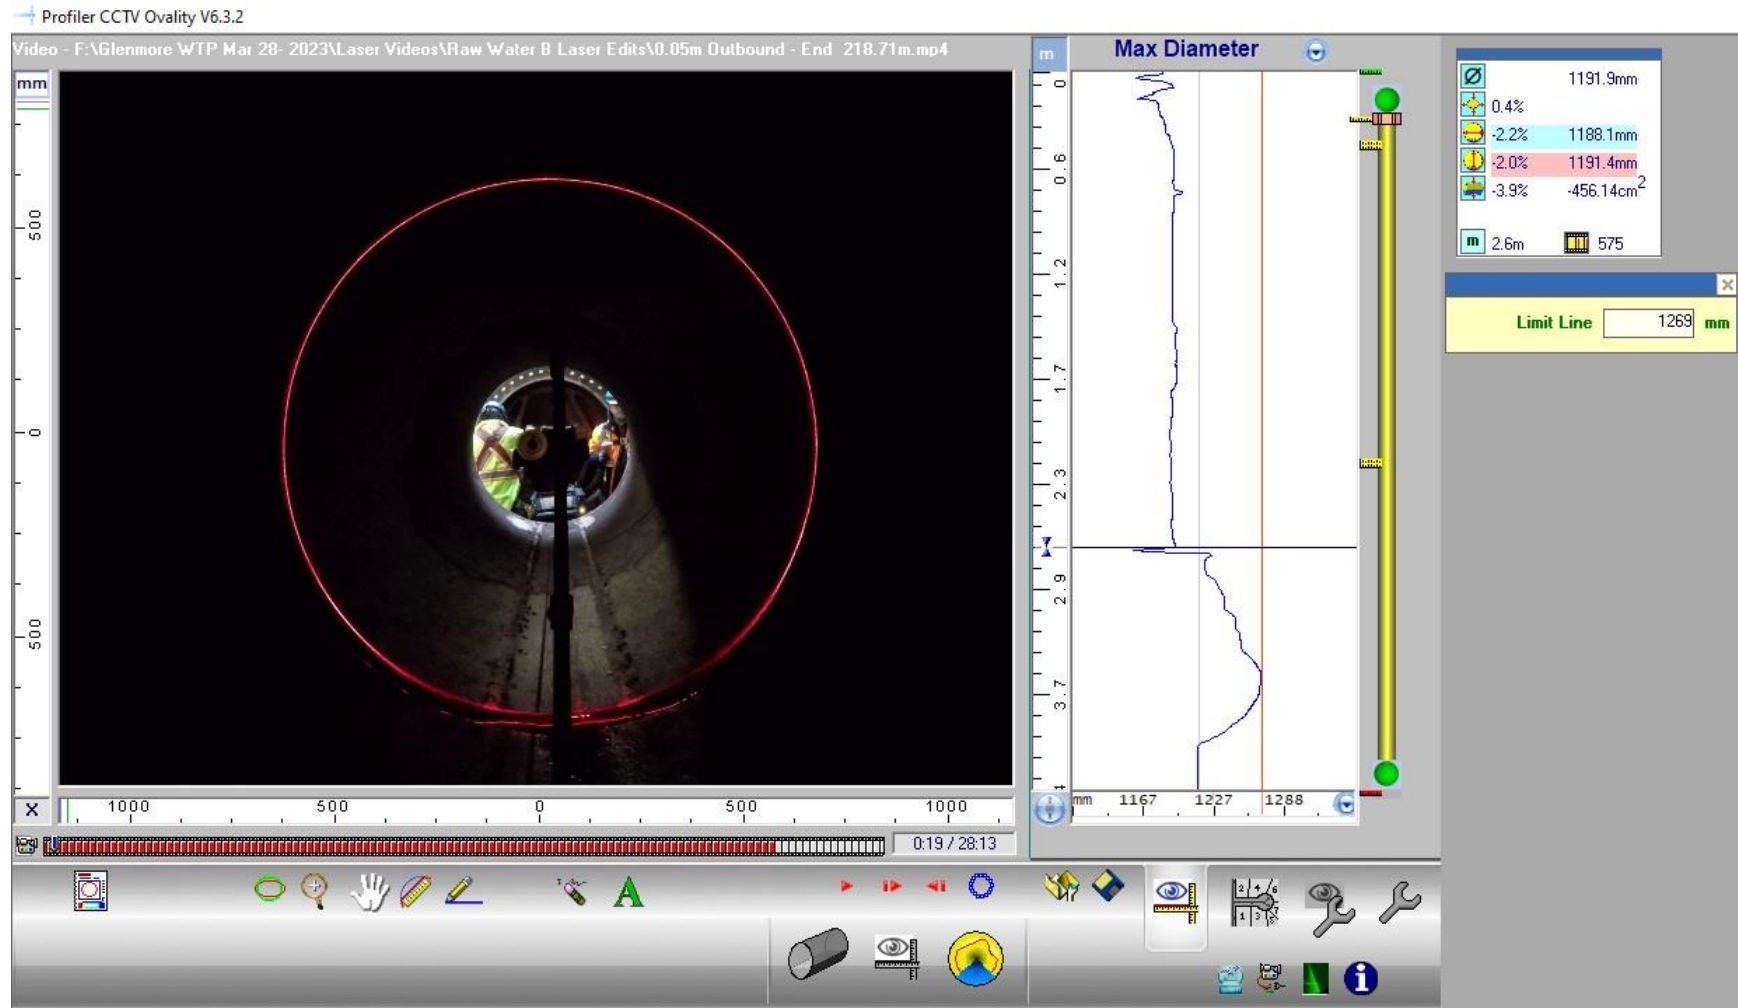
Figure 29 – Sample of Laser Software viewing area at a Gap in Segment 1

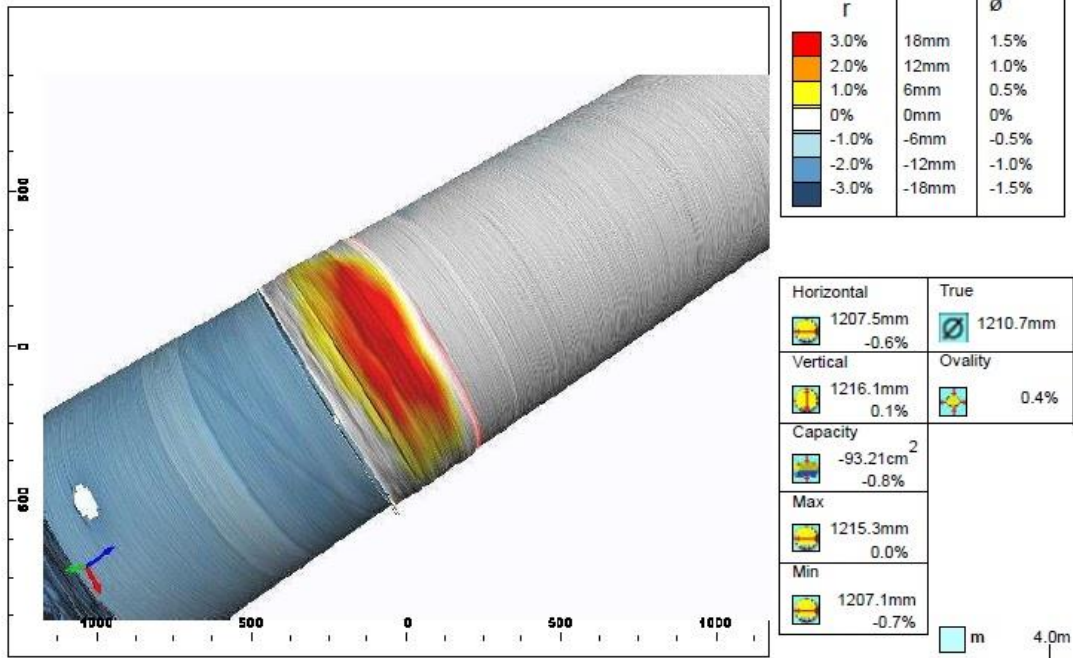
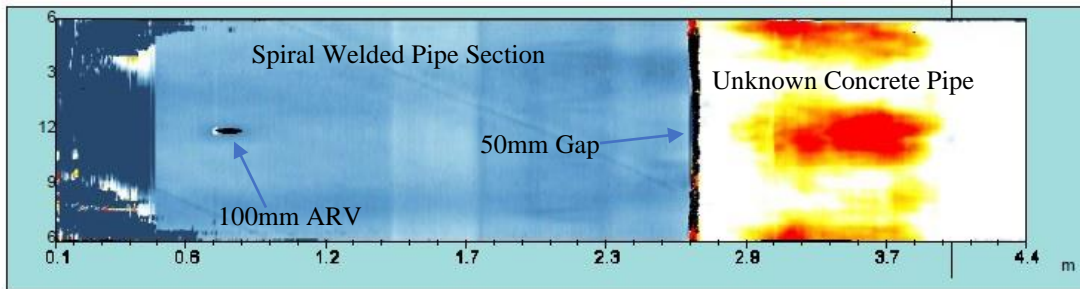
Figure 36 – Several pipe features are noted in the flat profile within the first 4m from VC-7501 opening.

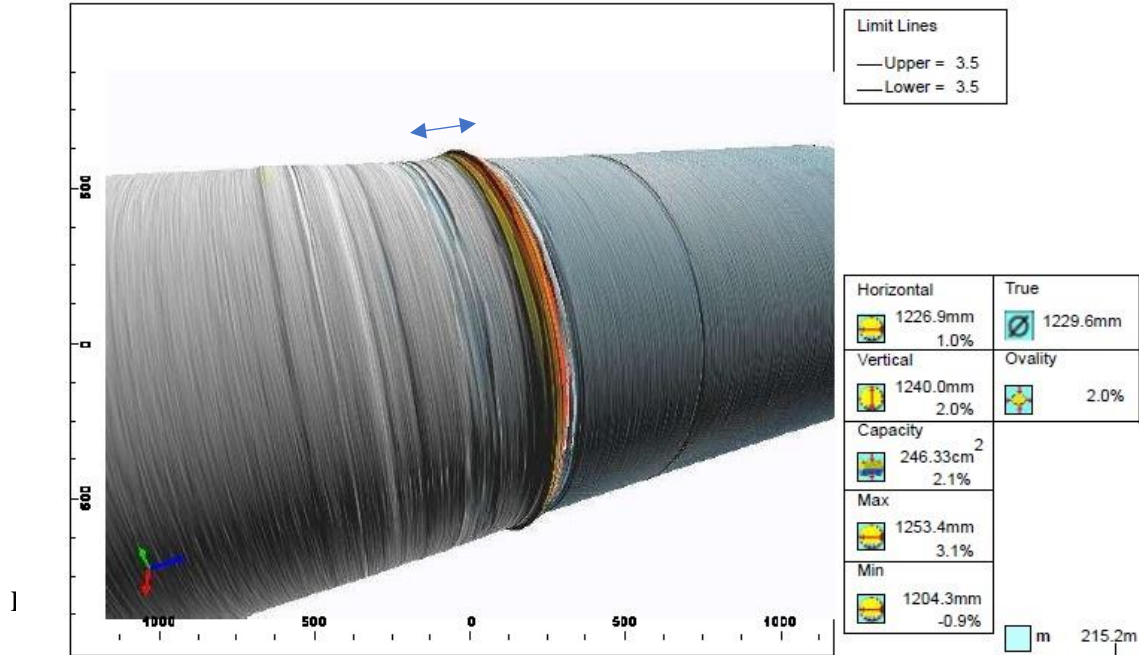
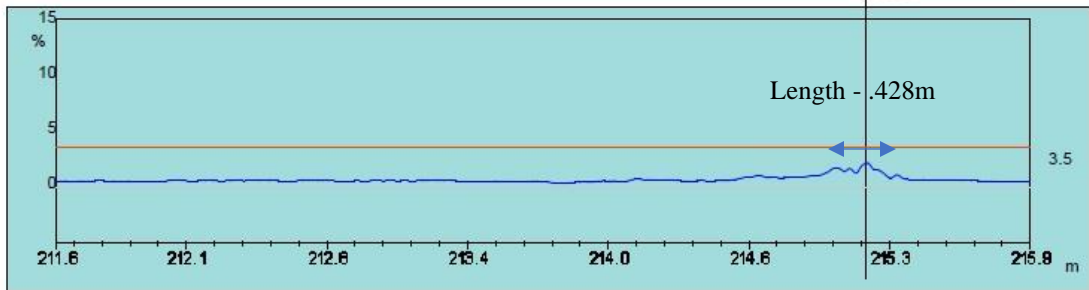
90% - Fractile: 0.9%, Exceeded limits: 0.2%
 Comments: Ovality 'q' (as per ASTM F 1216 Standard Practice) as a percentage of original pipe versus distance

Figure 37 – The reducer / adapter length section that transition from concrete to steel is measured at .428m.
