Sample CCTV & Laser Report

Laser Profilometry Assessment

Project: XXXXX

Project Summary

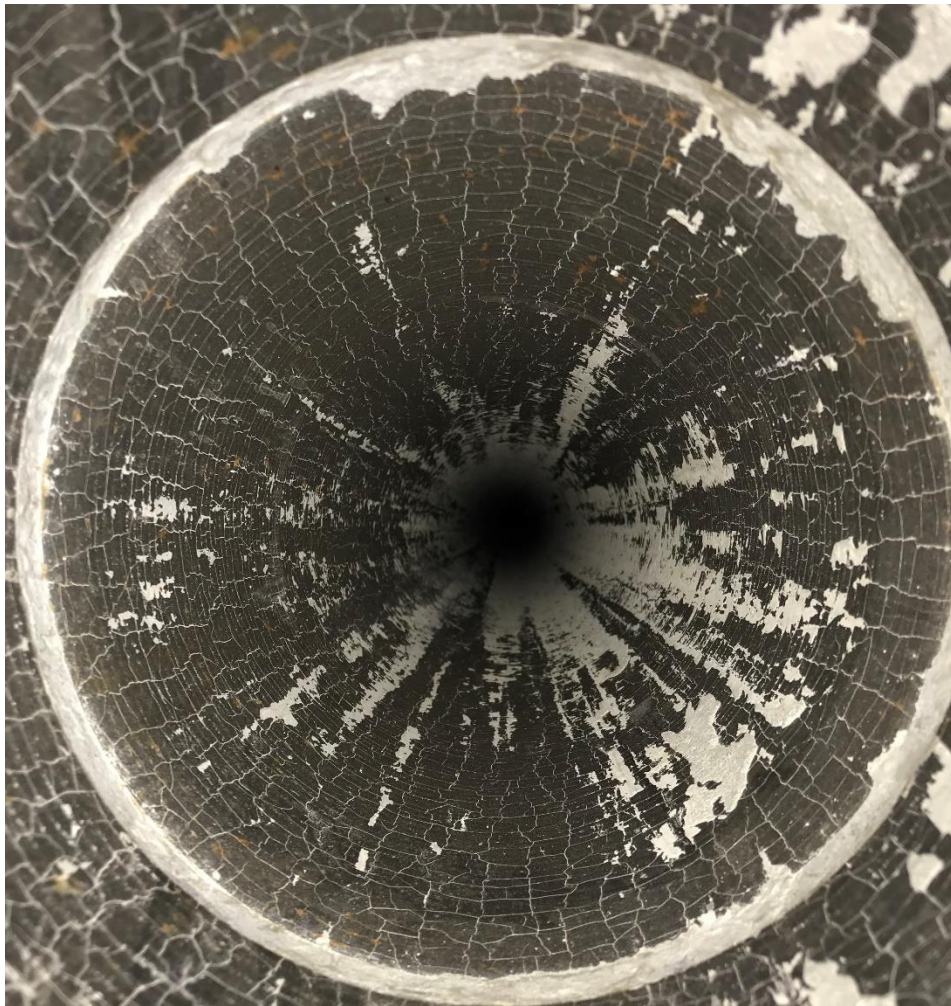
Figure 3. Both Slick Lines #1 and #2 internal hard-facing liner shows that the original weld caps have been worn smooth leaving a crazing effect. The crazing effects of the carbide liner are common to see as minor stress relief cracking during the post weld cooling process.

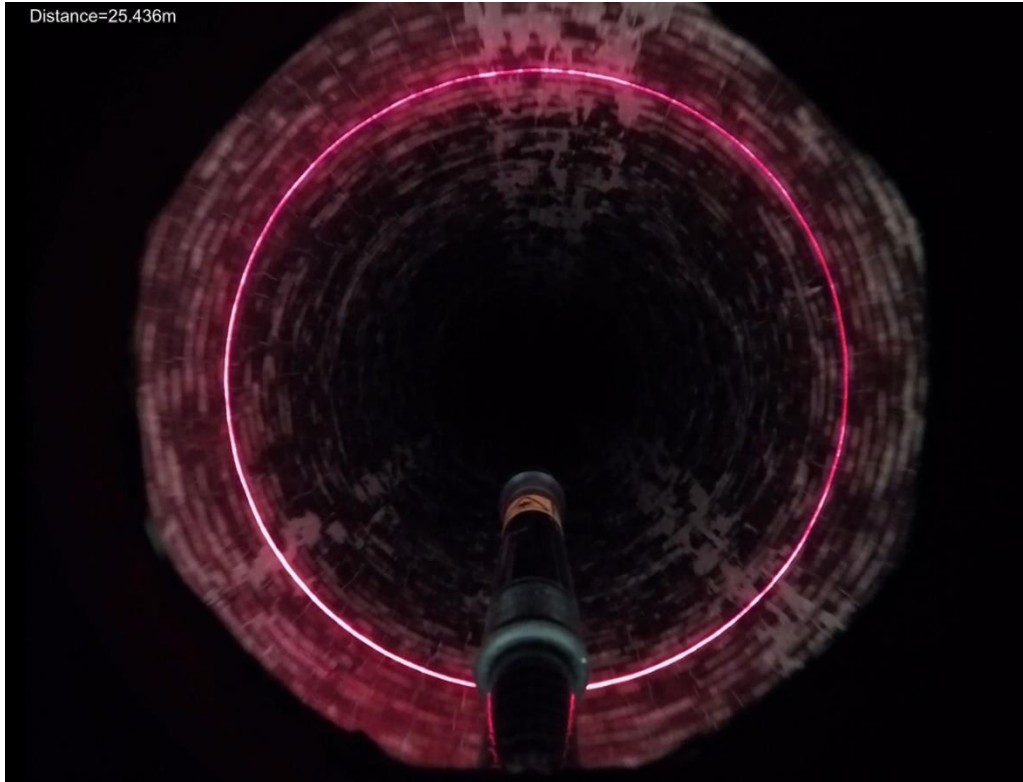
NOTE: The hard-facing carbide liner on Slick Line #1 is noticeably thinning based on the CCTV footage from 450 meters to the bottom extent of the pipe that exits into the mine at 530 meters.

Top Image: Hard-facing material on the pipe wall is clearly present with light concrete in adhered between the convoluted weld caps

Bottom Image: Hard-facing material appears to be eroded between the 6 to 10 position S.E to W of the pipe wall. Indications at the wall may suggest the path of the mixed concrete when poured into the pipe from the surface

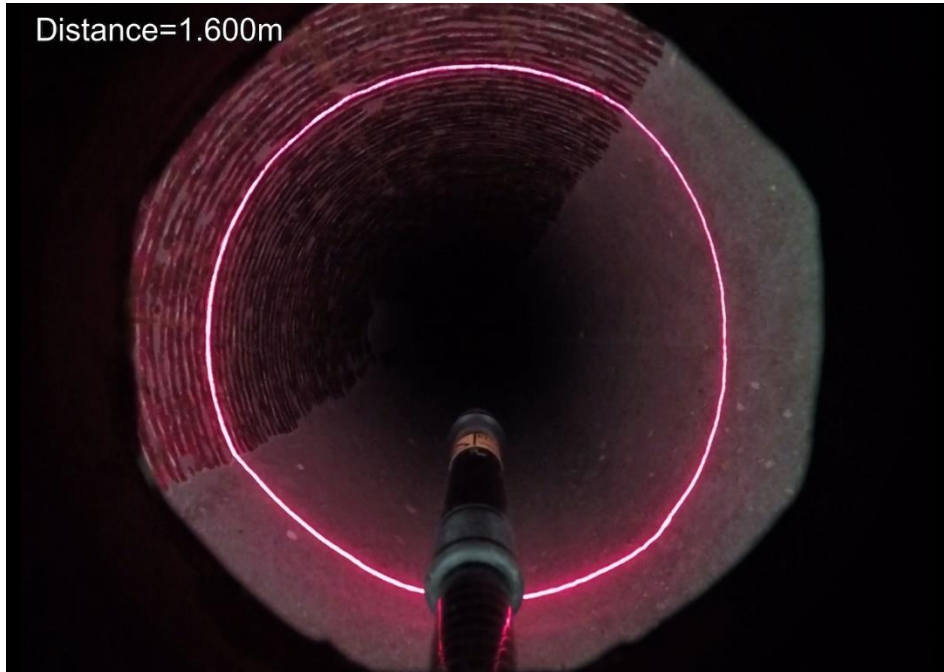
Top Image: The inspection start location at 1.6 meters shows light concrete film over the hard-facing liner on Slick Line #2

Bottom Image: The hard-facing liner is easily seen before exiting at the bottom at the mine

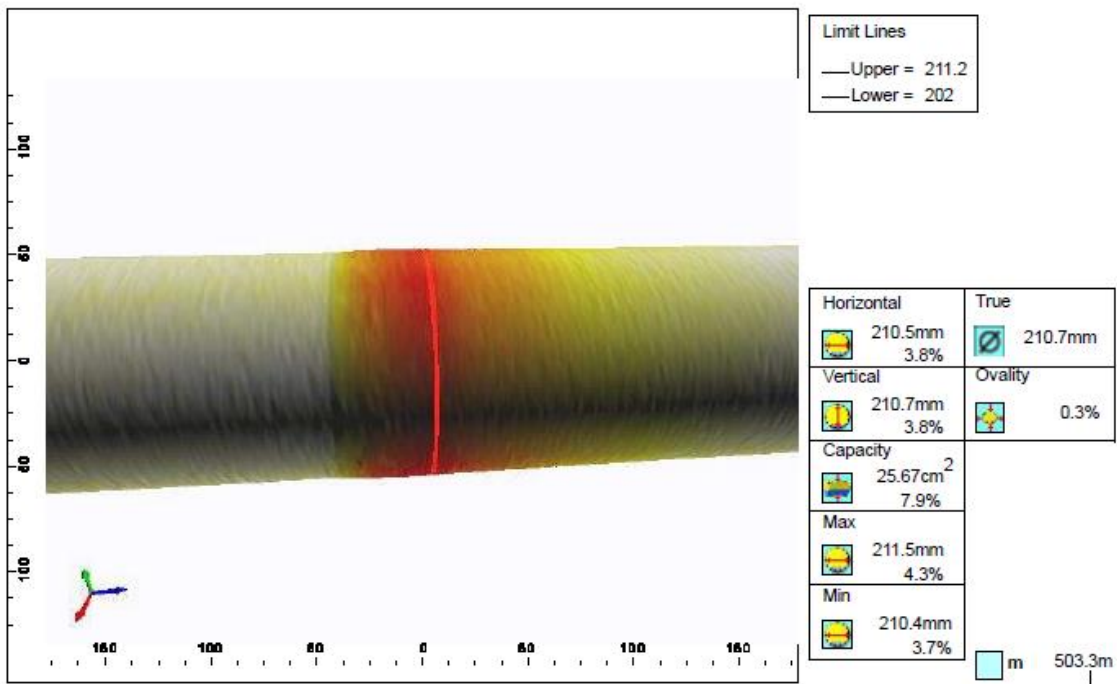
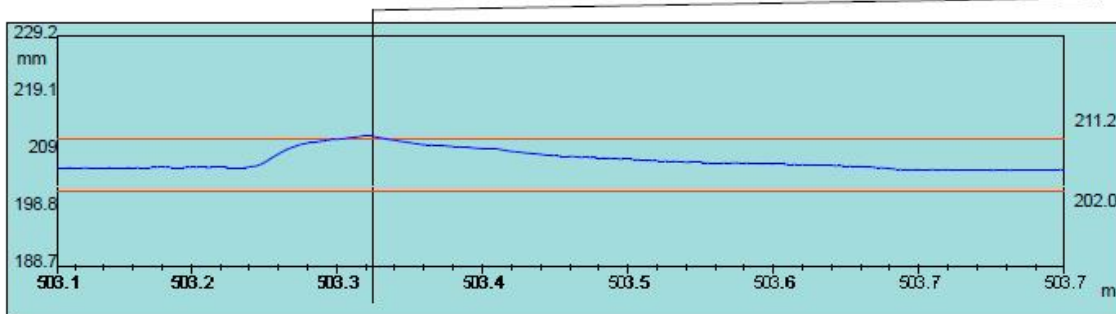
Figure 12. Profile report on the maximum internal diameter captured at 503.3 meters

503.4	503.7	0.3	210.6	3.86	17.02	3.15	44.90%	55.10%	Circumferential
510.5	517.8	7.3	207.1	2.11	18.77	4.90	69.87%	30.13%	NE / NW / SW

The area with the largest reported percentage of wall loss (30.62% at 503.4 m) is shown in Figure 12 on the following page.

The maximum diameter profile report below shows an area located at 503.3 meters with circumferential erosion on a segment joint.

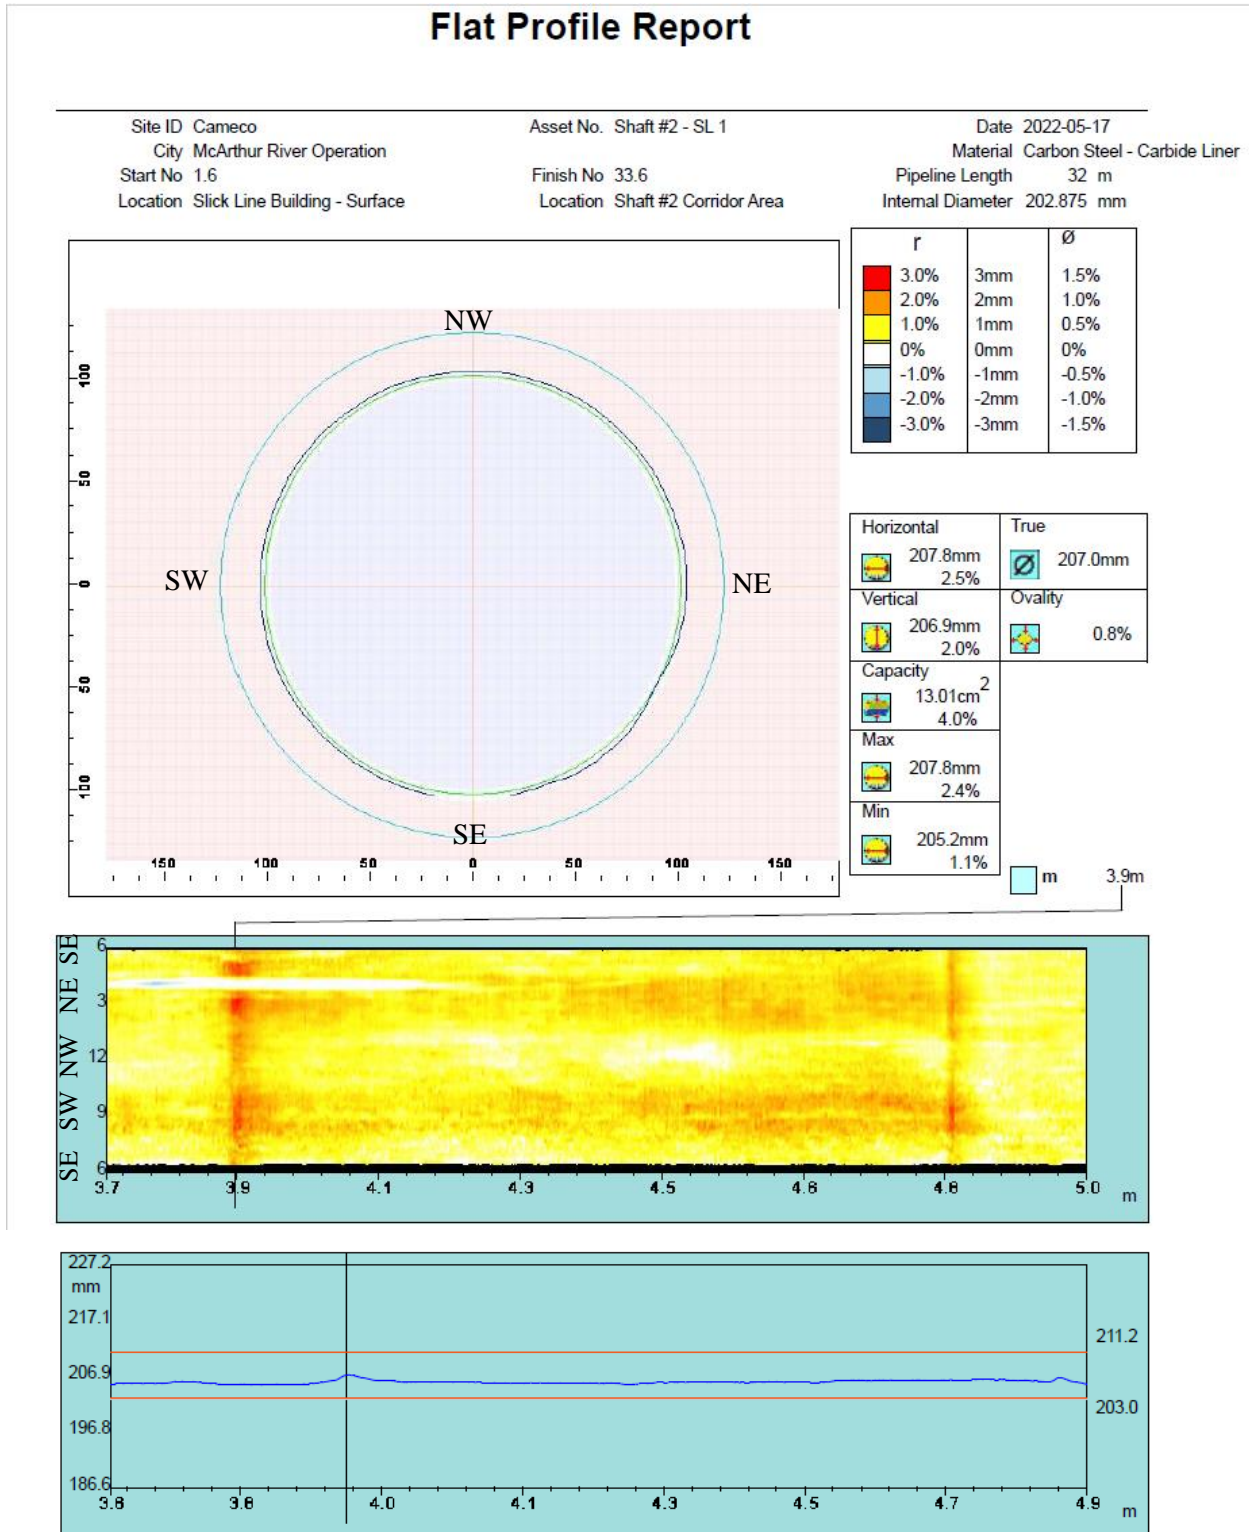
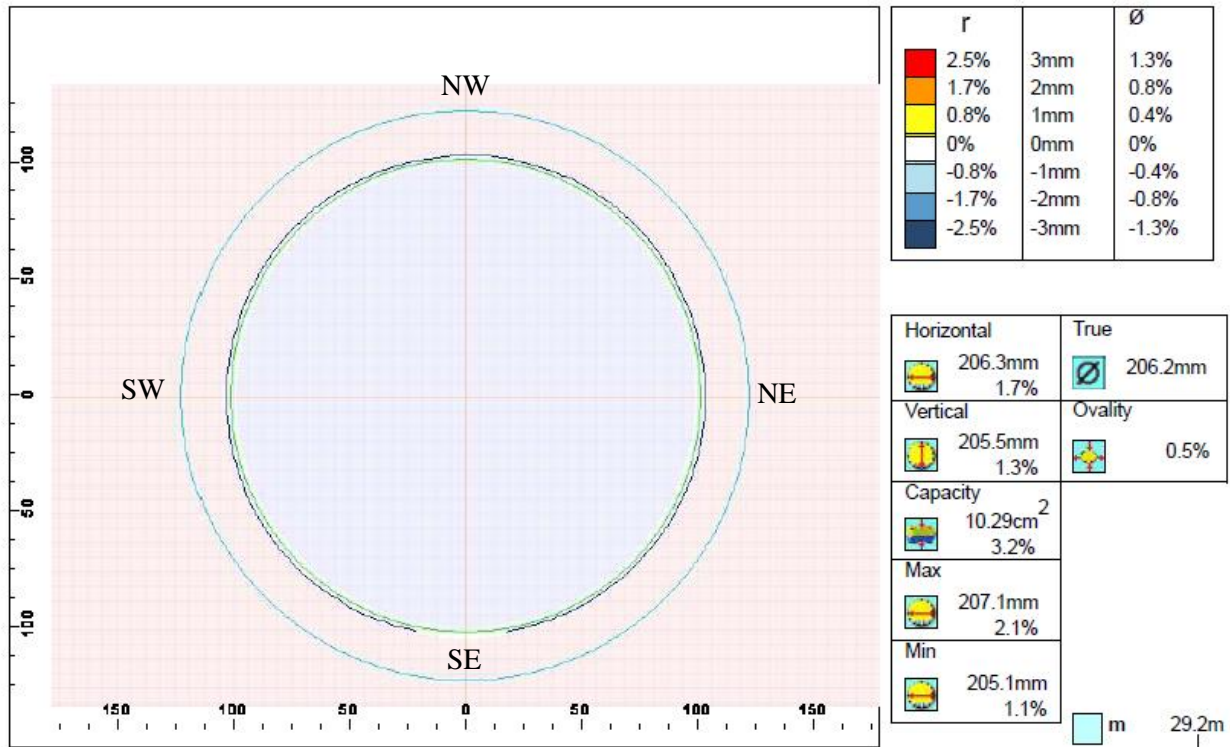
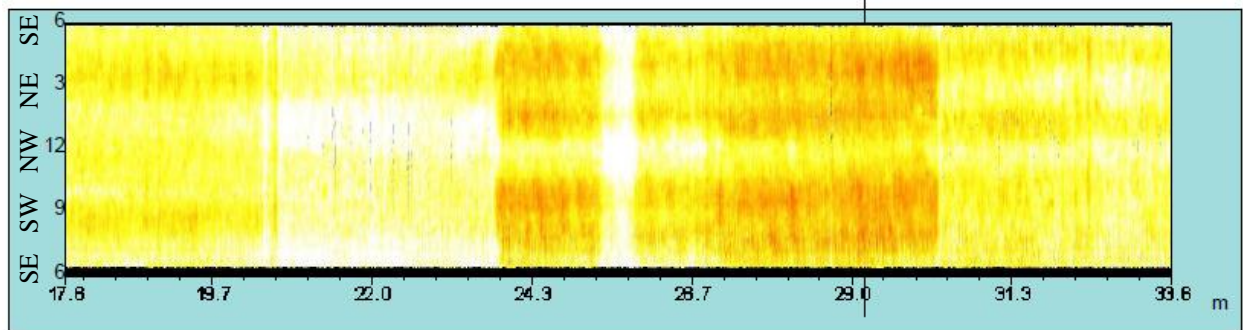
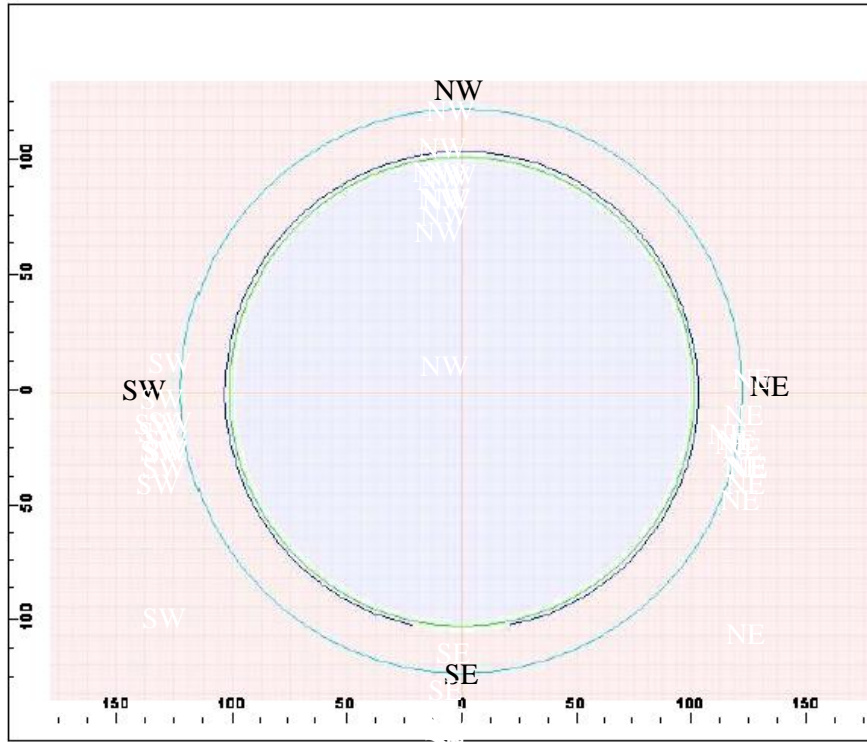
Slick Line #1 – High Resolution Flat Profiles

The following captured flat profile graphs outline paths of the abrasion and erosion on the hard face carbide liner.

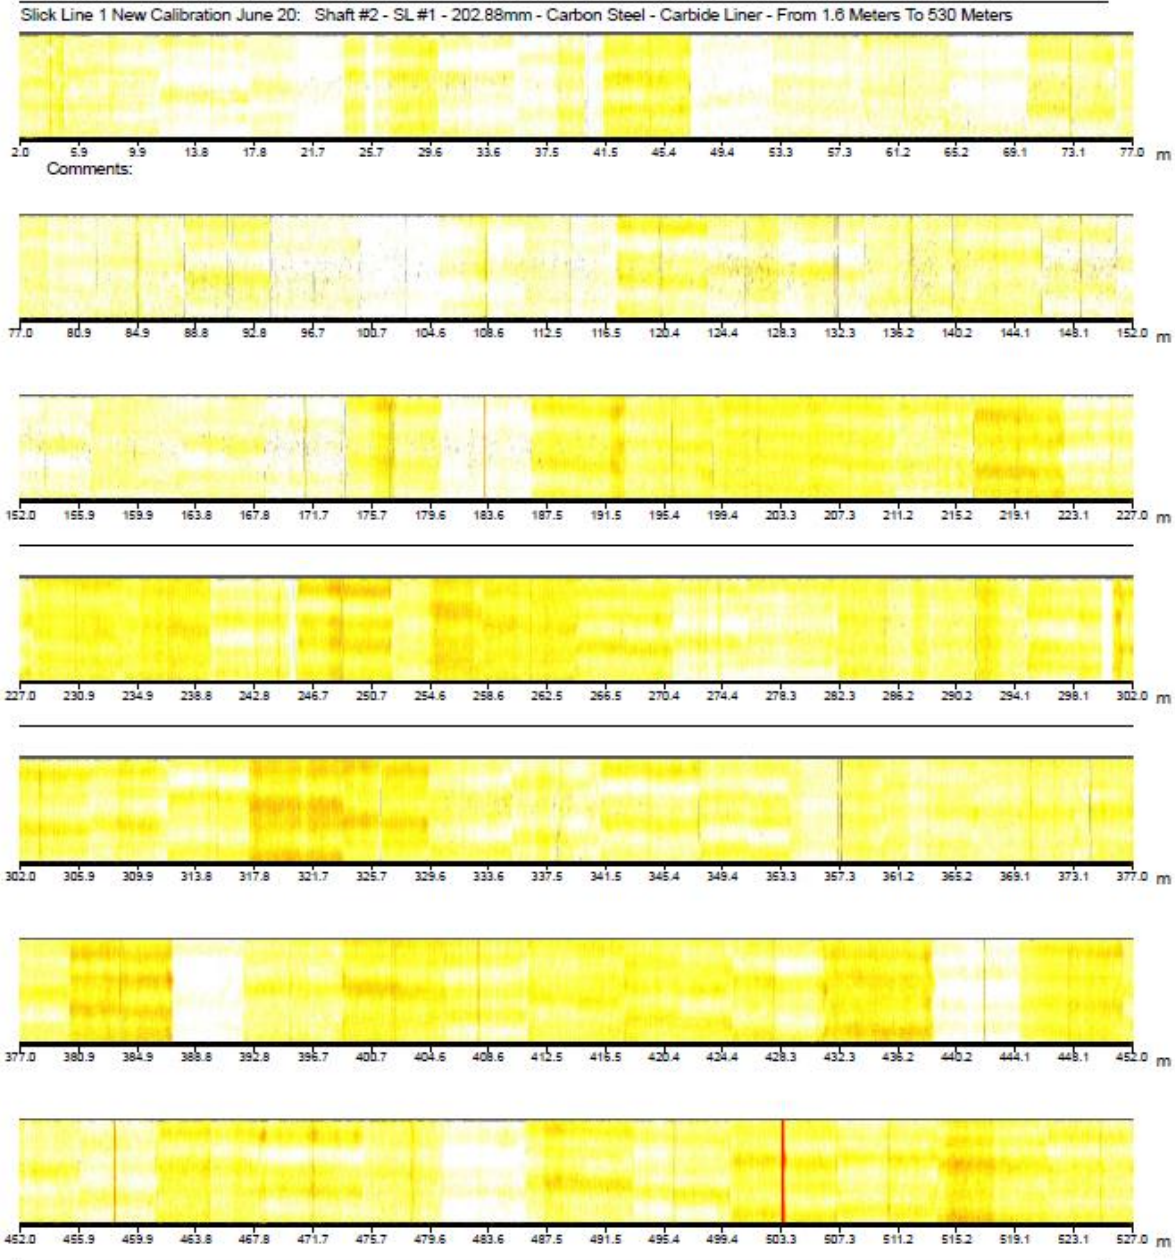
Slick Line #1 Unfolded Snapshot Profile

Light to darker shades (yellow → orange → red) represent increase of the pipe internal diameter with the hard facing liner

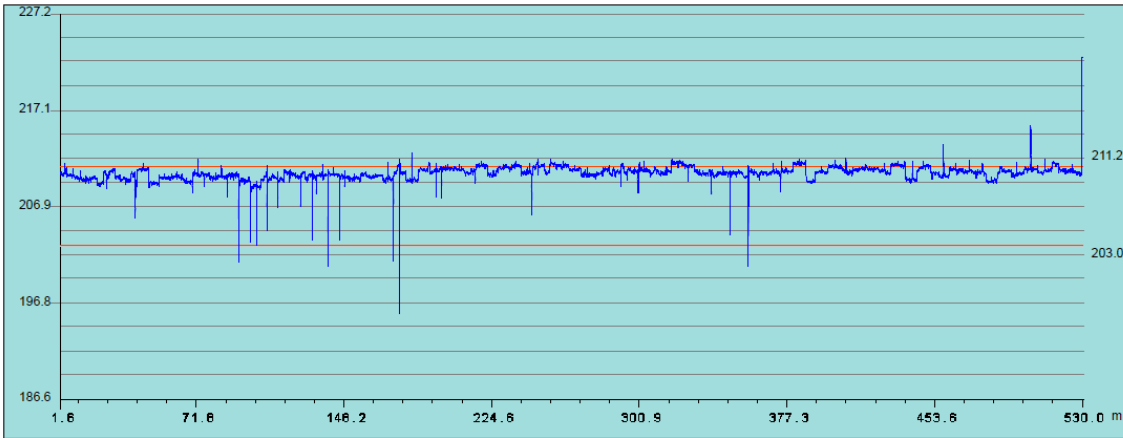
Median Diameter Summary Report Slick Line #1

mm 90% - Fractile: 211.3mm, Exceeded limits: 13.6%

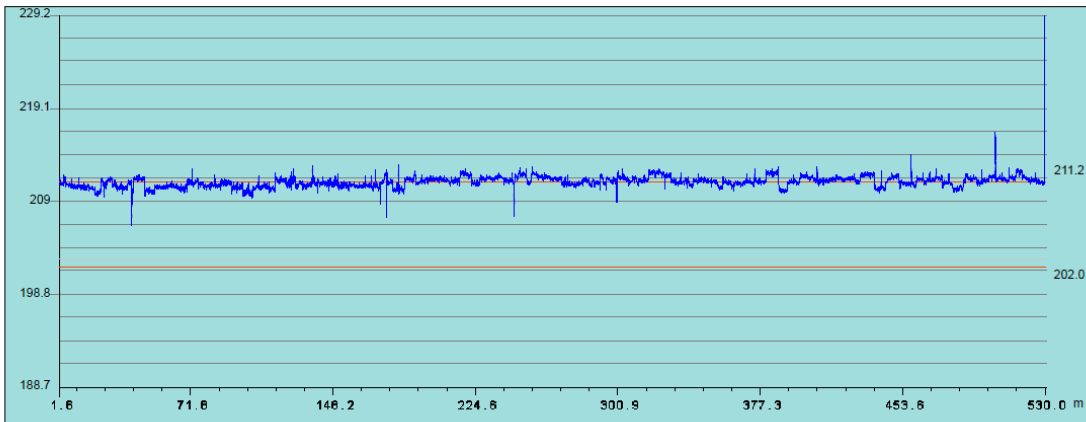
Max Diameter Summary Report

mm 90% - Fractile: 211.9mm, Exceeded limits: 50.9%

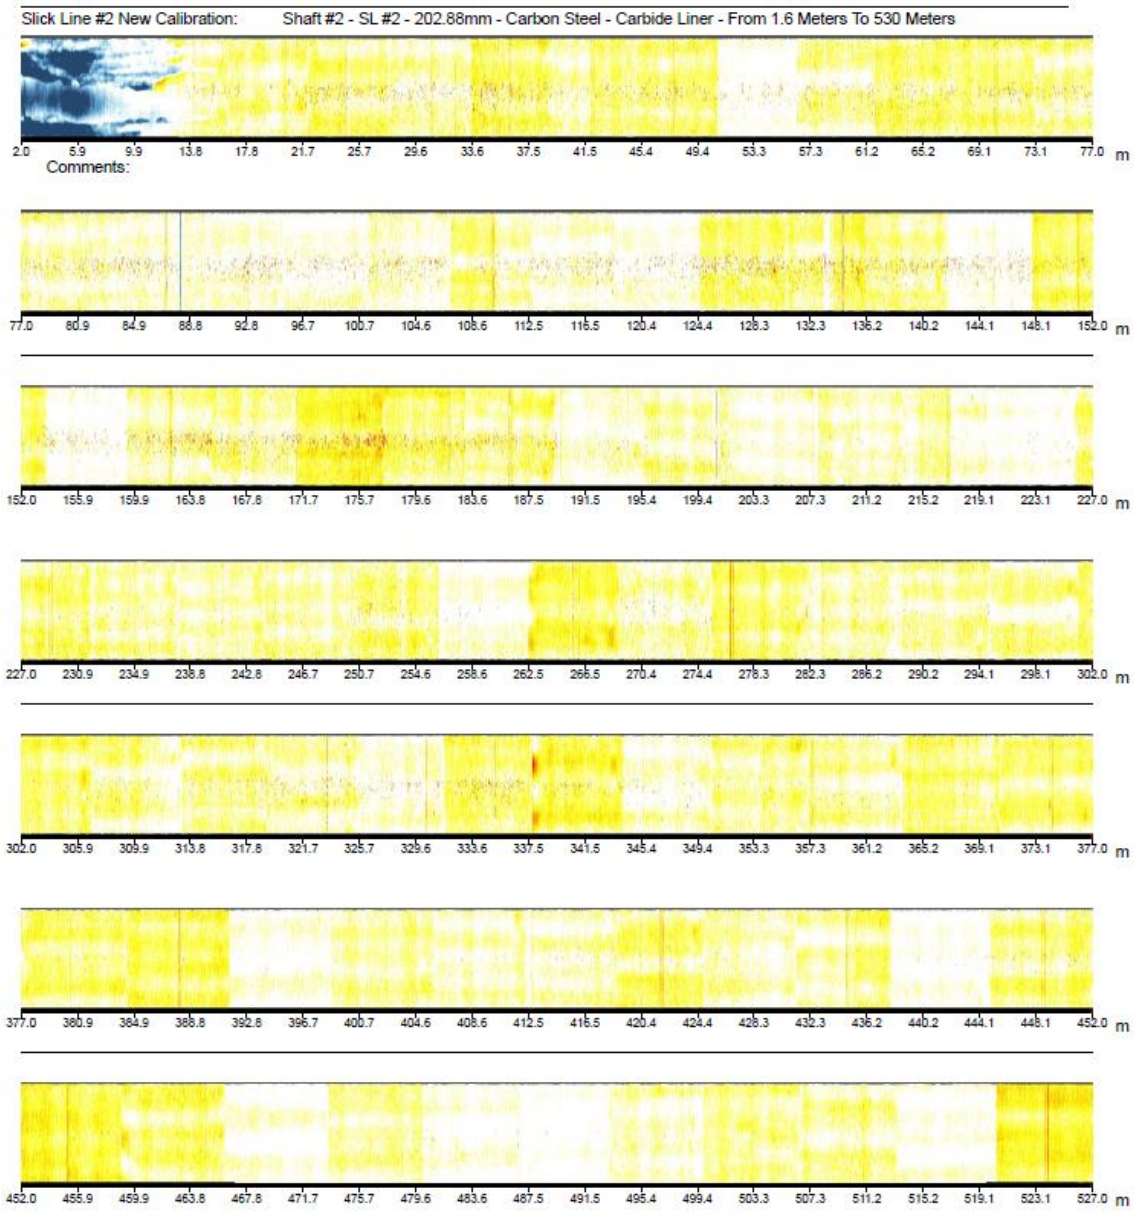
Slick Line #2 Unfolded Snapshot Profile

Light to darker shades (yellow → orange → red) represent increase of the pipe internal diameter with the hard facing liner

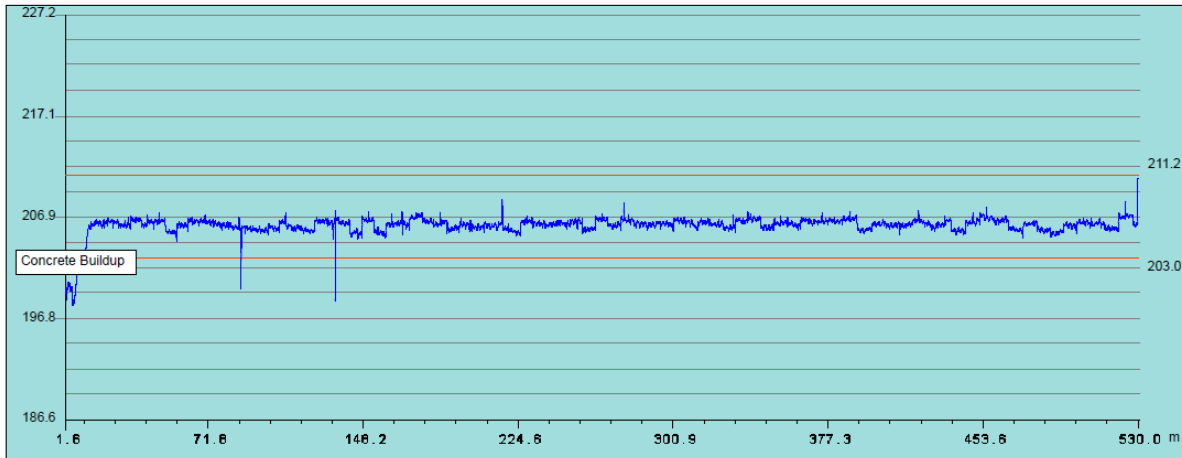
Median Diameter Summary Report

0-15 meters = Concrete remaining on pipe wall after pigging

90% - Fractile: 206.9mm, Exceeded limits: 1.6%

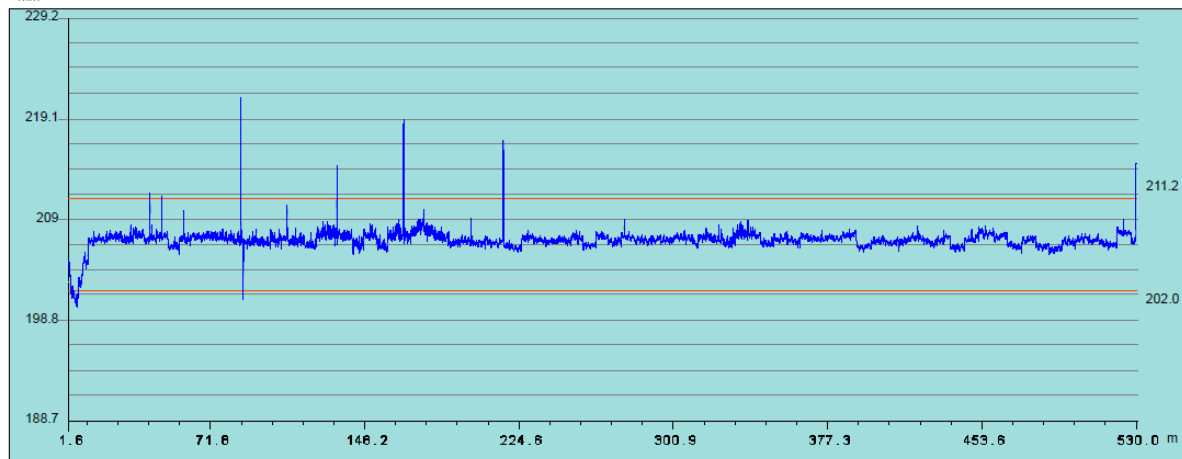
Max Diameter Summary Report

0-15 meters = Concrete remaining on pipe wall after pigging

90% - Fractile: 207.7mm, Exceeded limits: 0.8%
