Inspection Report
Bracelet Probe™ Inspection
(Customer Name)

Gallery # 1, # 2 and # 3

PICA: Bracelet Probe Final Report

| Report Date | March 21, 2024 |

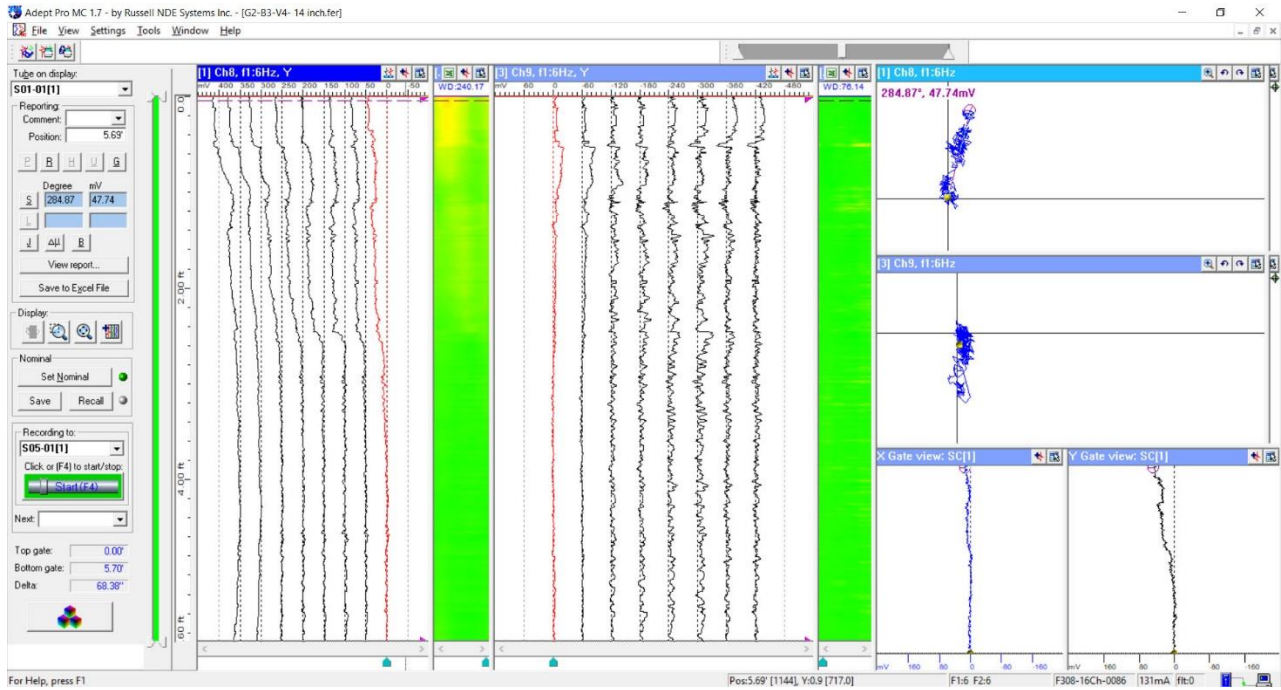
Figure 1 (Scan S01-01) BP data for a scan covering 48.0" to 0" to 4.5" circumference. (Probe centered at +0" position)

The lowest UT measurement was 0.256" at 0' 0".

The pipe at this location exhibits Moderate internal corrosion (pitting) at 39%.

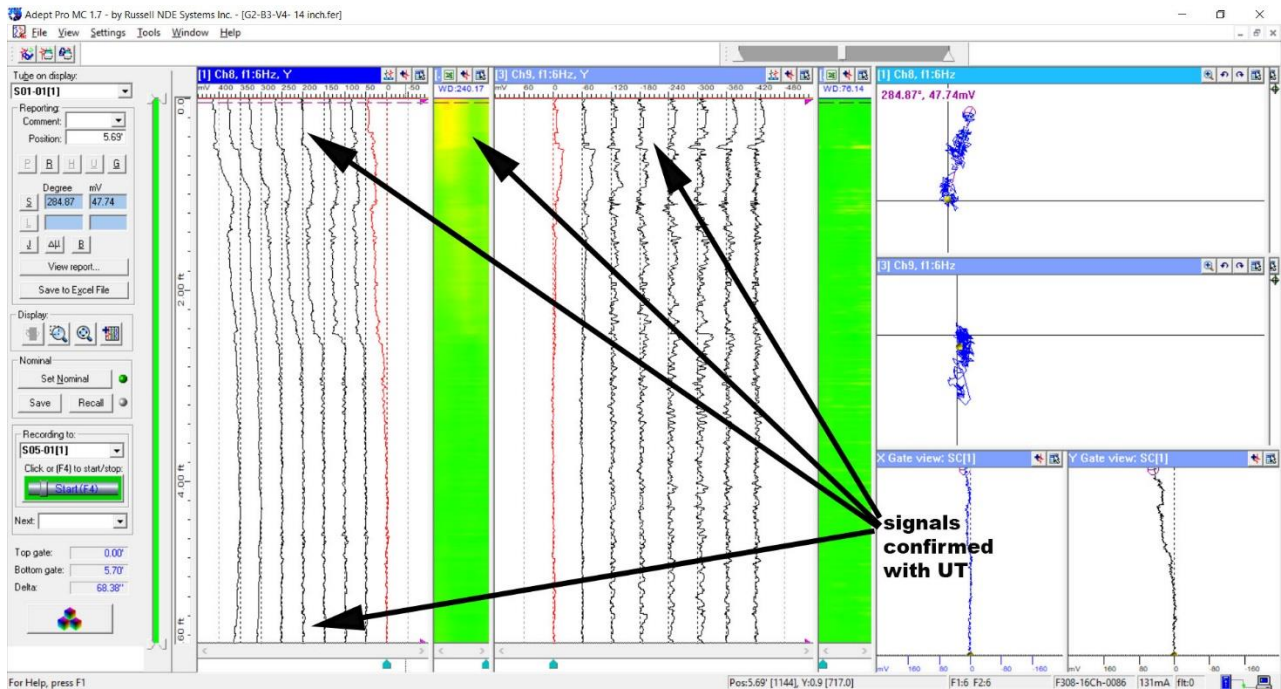
Note: The image above has been labeled showing some of the signals confirmed with UT.

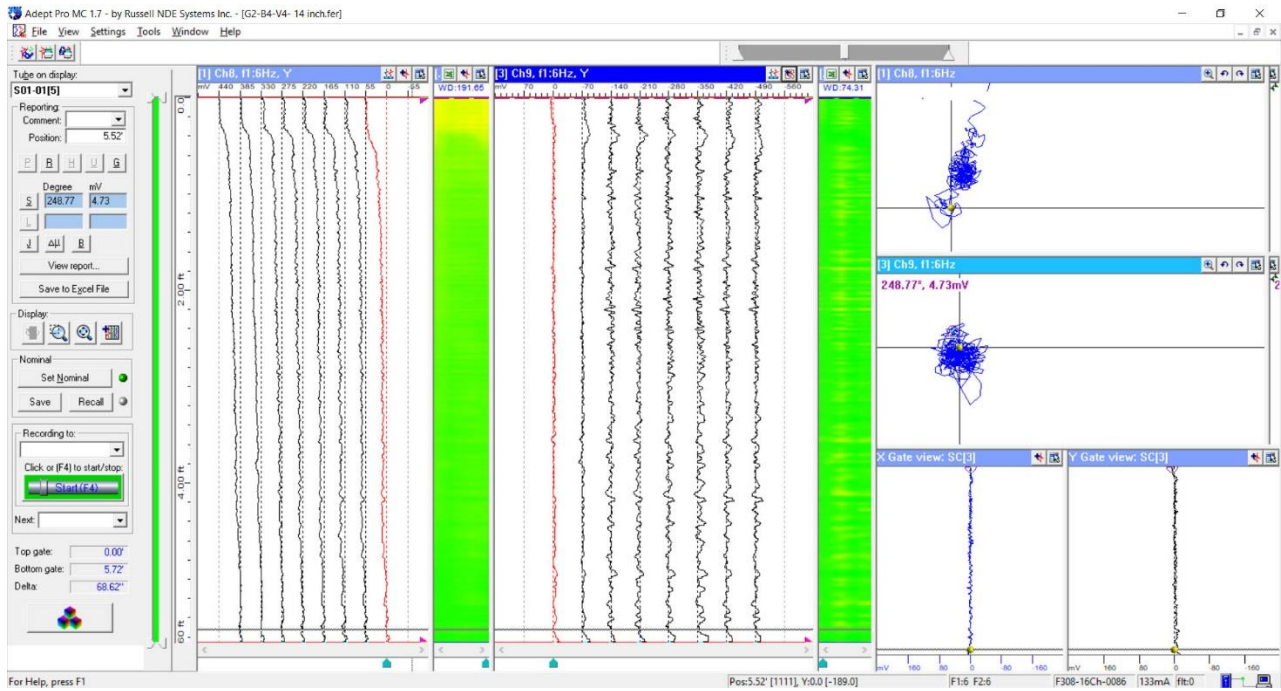
Figure 4. (Scan S01-01) BP data for a scan covering 48.0" to 0" to 4.5" circumference. (Probe centered at +0" position)

The pipe at this location exhibits Moderate internal corrosion (pitting) at 33% and 45% with the used above low UT measurements.

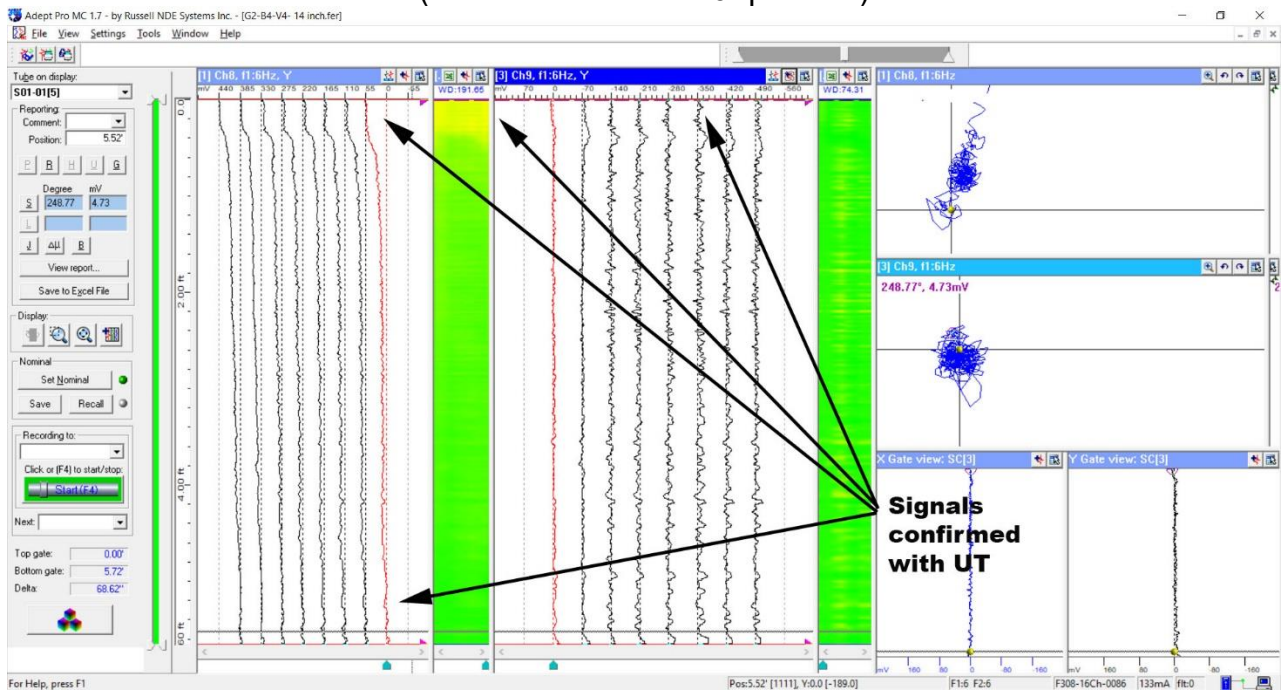
Table 2 has been added showing the results of this UT inspection. The lowest UT measurement found here was 0.232" which is a 45% wall loss.

The image above has been labeled showing some of the signals confirmed with UT. The upper yellow area on the color map shows moderate corrosion. As noted, an additional UT grid was performed in this area (Table 2 on page 23).

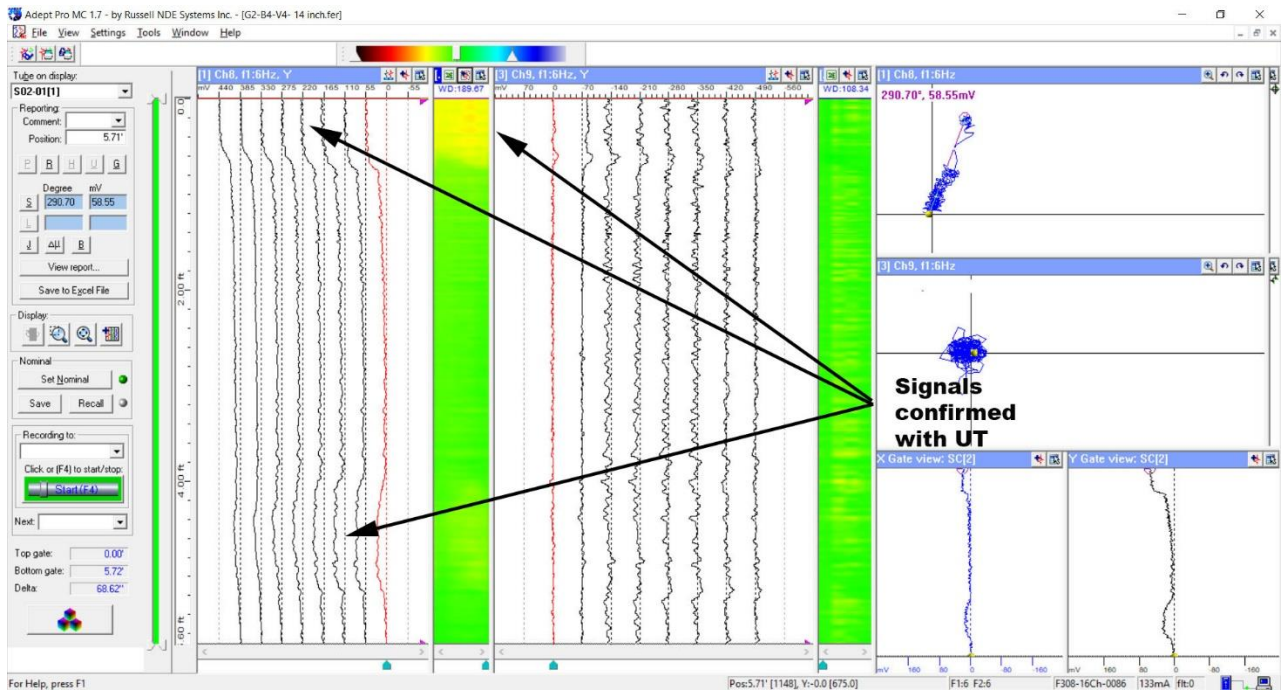
The image above has been labeled showing some of the signals confirmed with UT. The upper yellow area on the color map shows moderate corrosion.

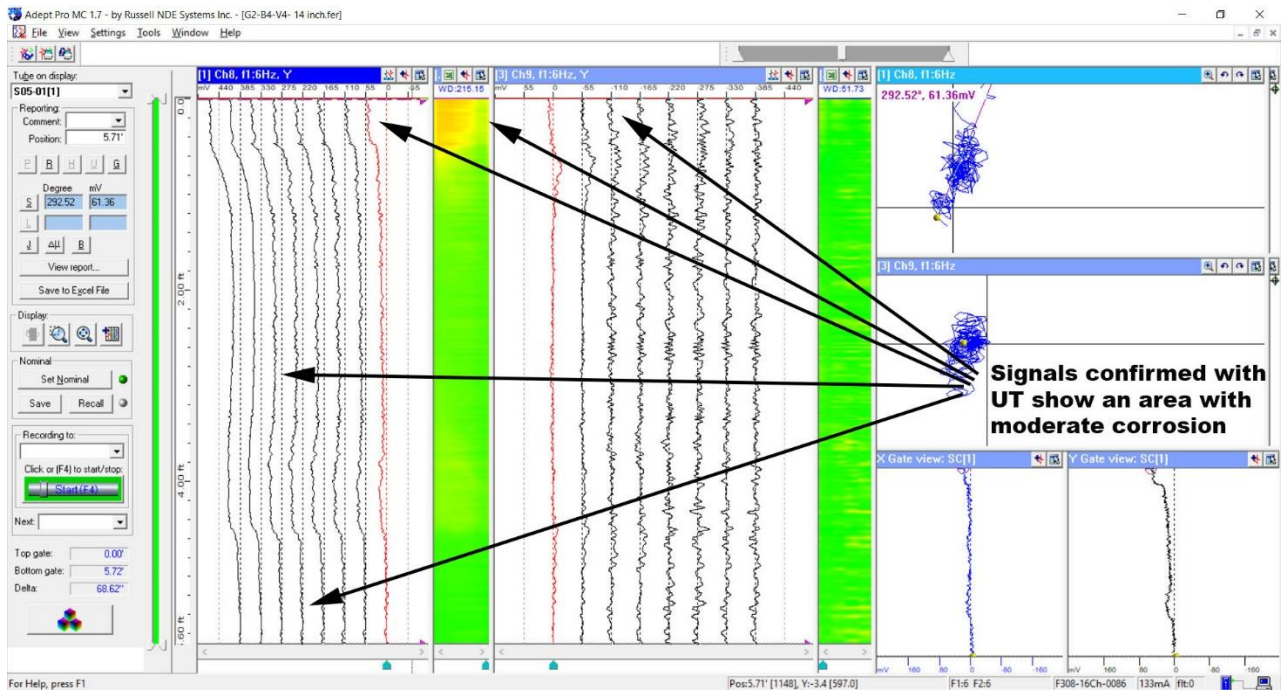
The image above has been labeled showing some of the signals confirmed with UT. The upper yellow area on the color map shows moderate corrosion.

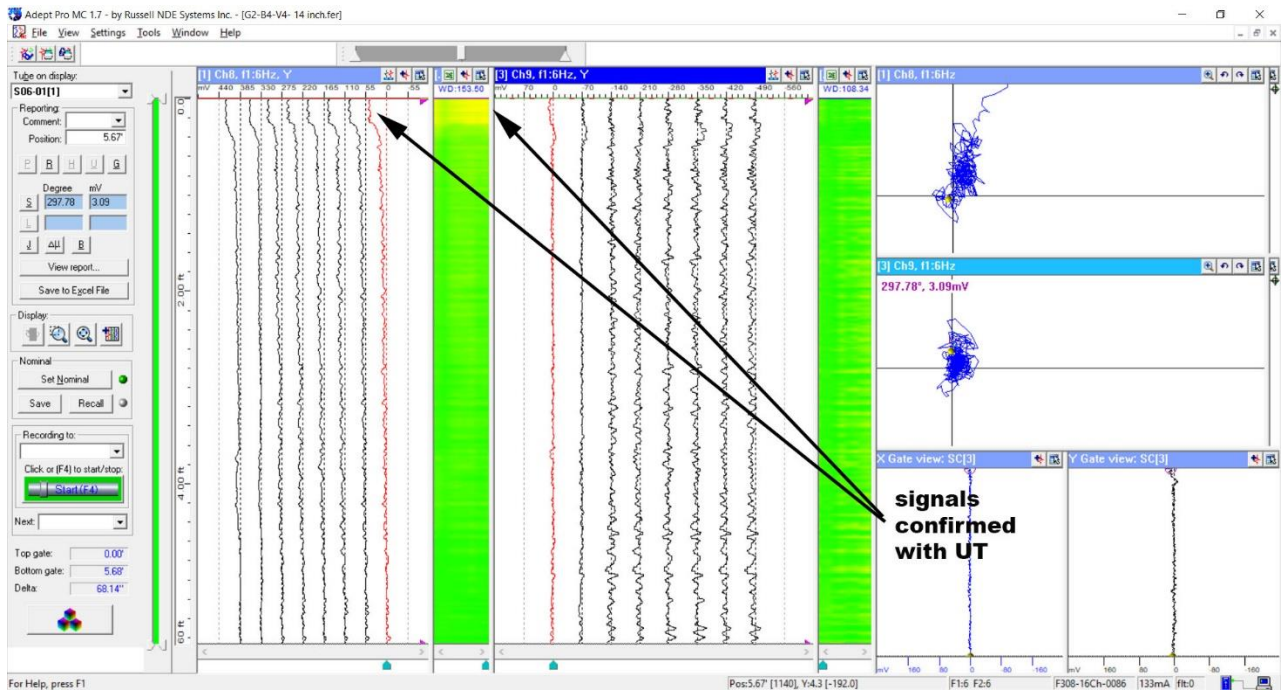
The image above has been labeled showing some of the signals confirmed with UT. The upper yellow area on the color map shows moderate corrosion.

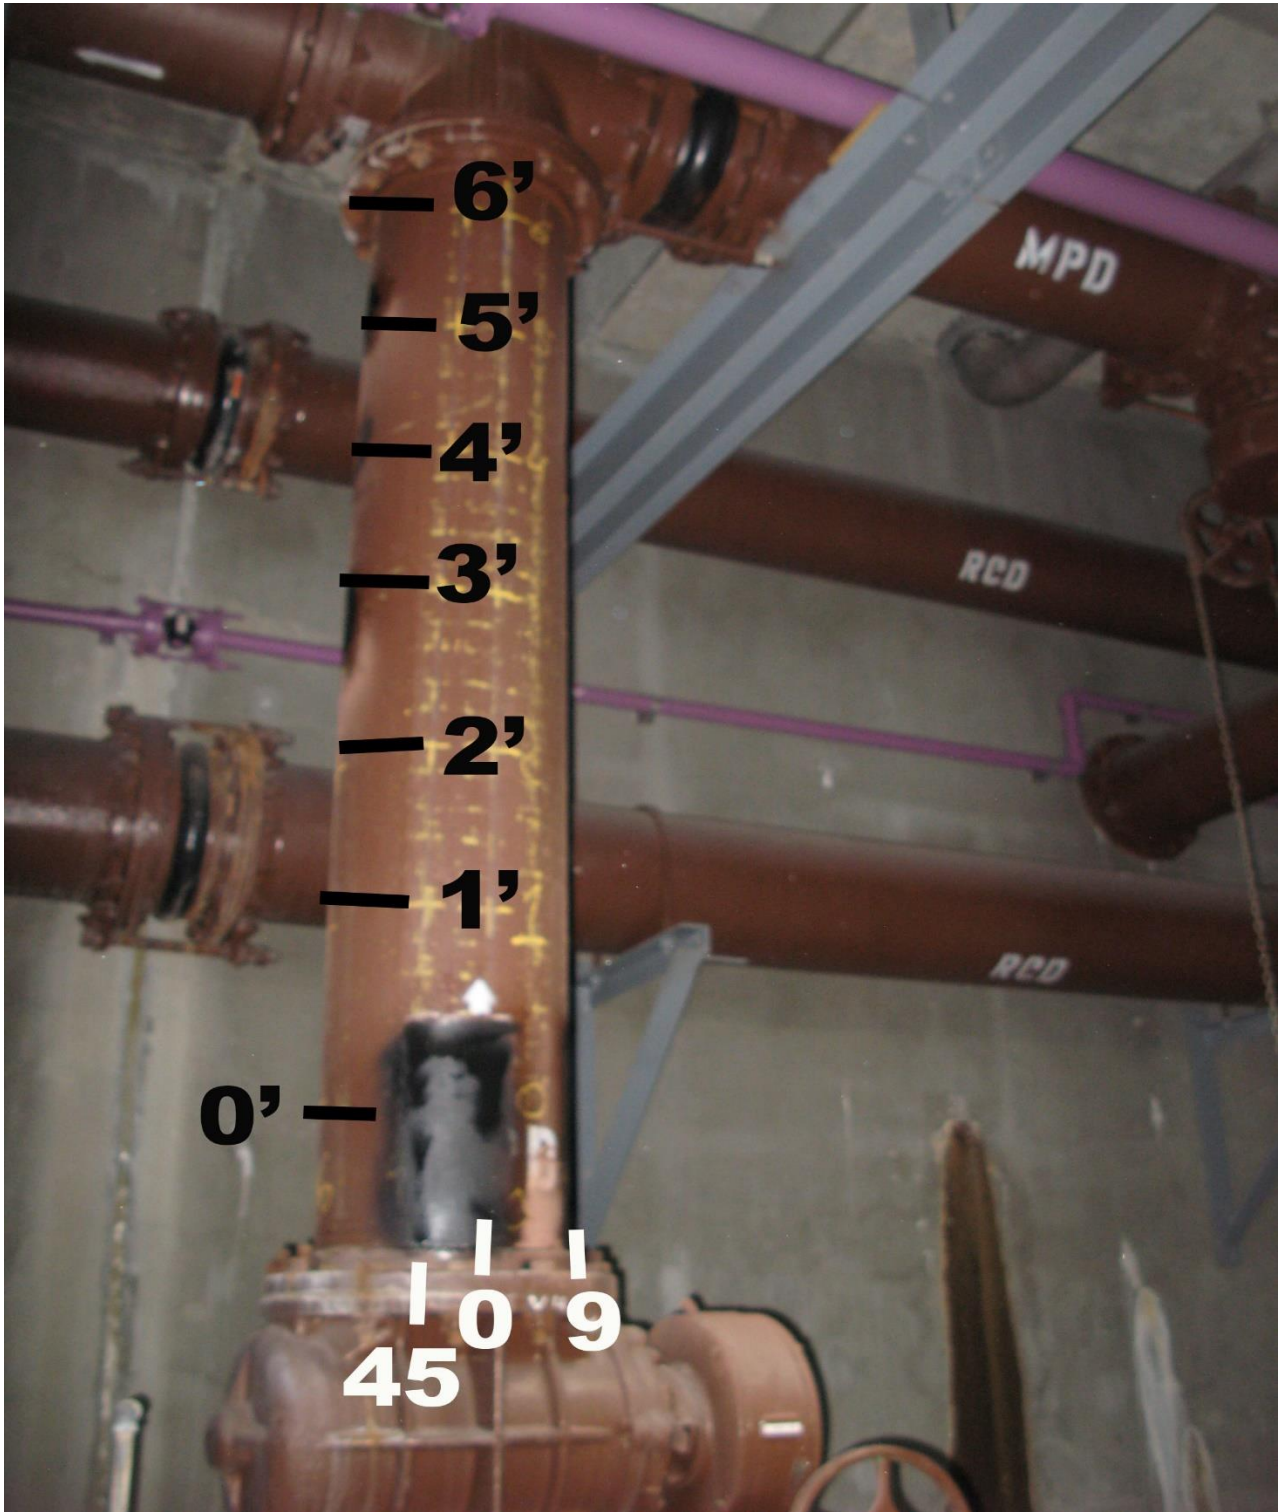
Figure A2. The picture above shows an overview of the pipe. 2 additional UT areas are shown near the bottom flange.

After finding the low of 0.279" at 0'4" in the area of moderate internal corrosion as seen in the BP data, a larger UT area was requested to be inspected in this area. The UT area was made up, using a grid pattern, from the flange, axial direction up 15 inches and covered the circumferential direction 7" at the 0" mark and 3" at the 9" mark. This is shown in the following digital pictures.

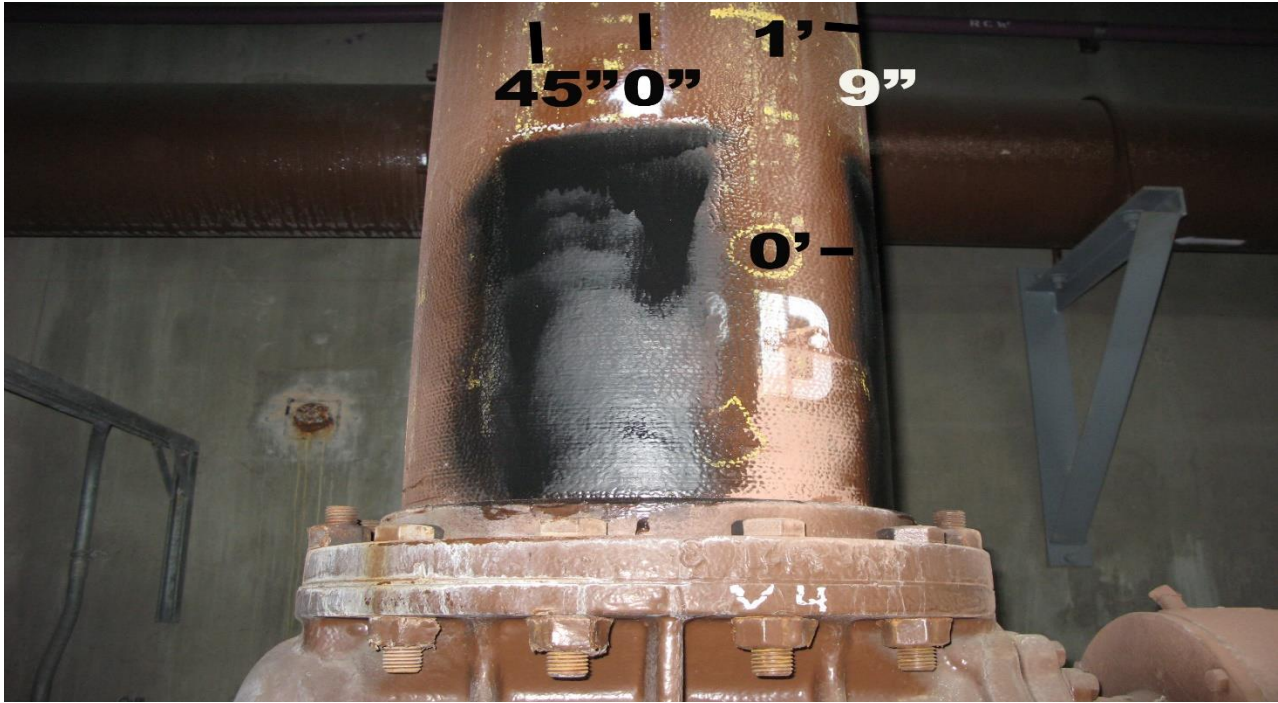
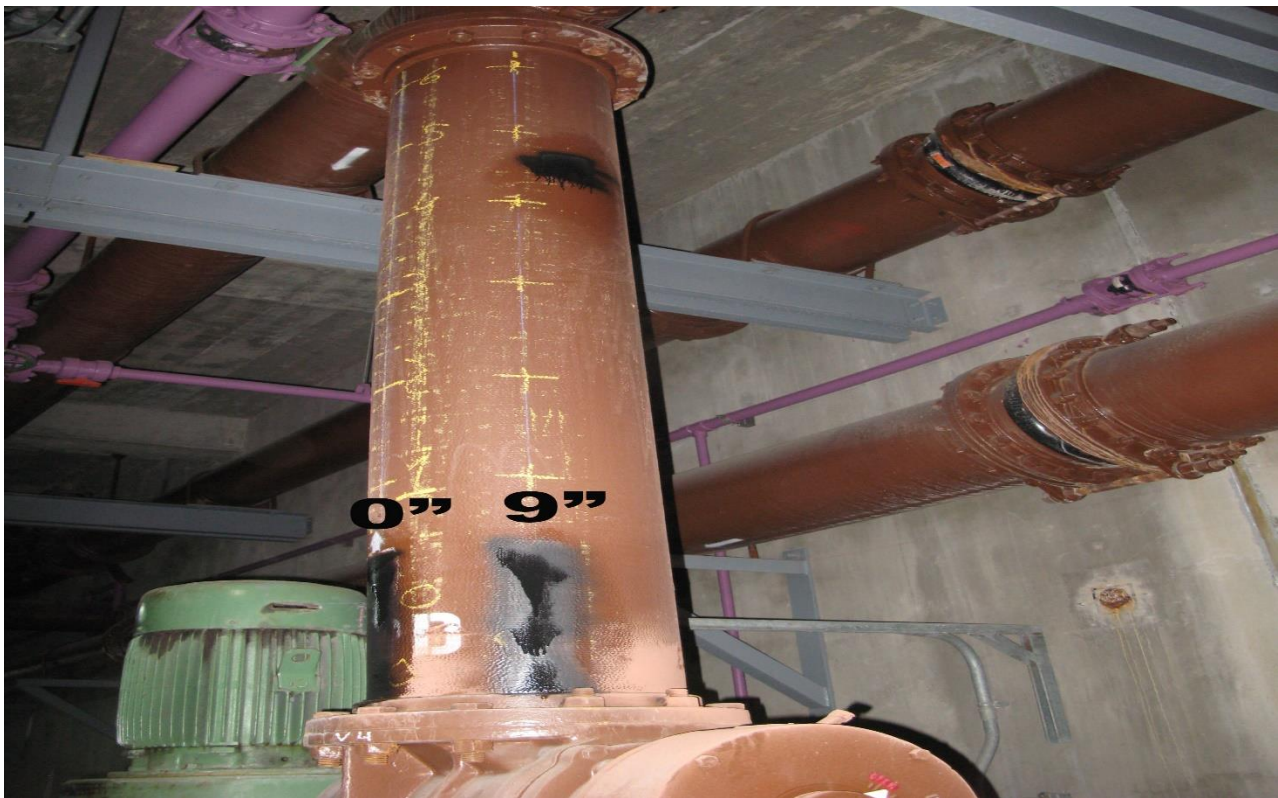
The pictures above show a closer view of the additional UT inspection areas on the pipe.

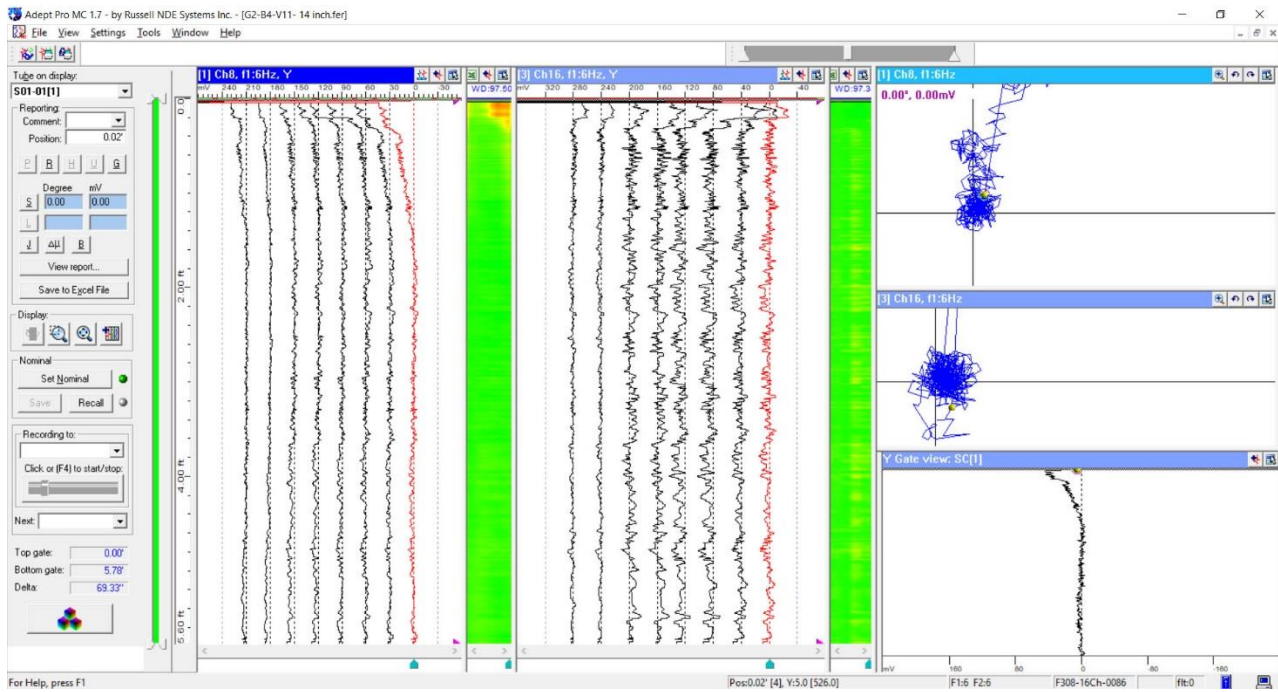
Figure 8. (Scan S01-01) BP data for a scan covering 48.0” to 0” to 4.5” circumference. (Probe centered at +0” position)

After scanning the first scan a corrosion area was found. UT inspection was performed in this area and it was determined to move on to a different pipe after confirming the corrosion area with a low UT measurement of 0.105".

The pipe at this location exhibits Severe internal corrosion (pitting) at 75%.

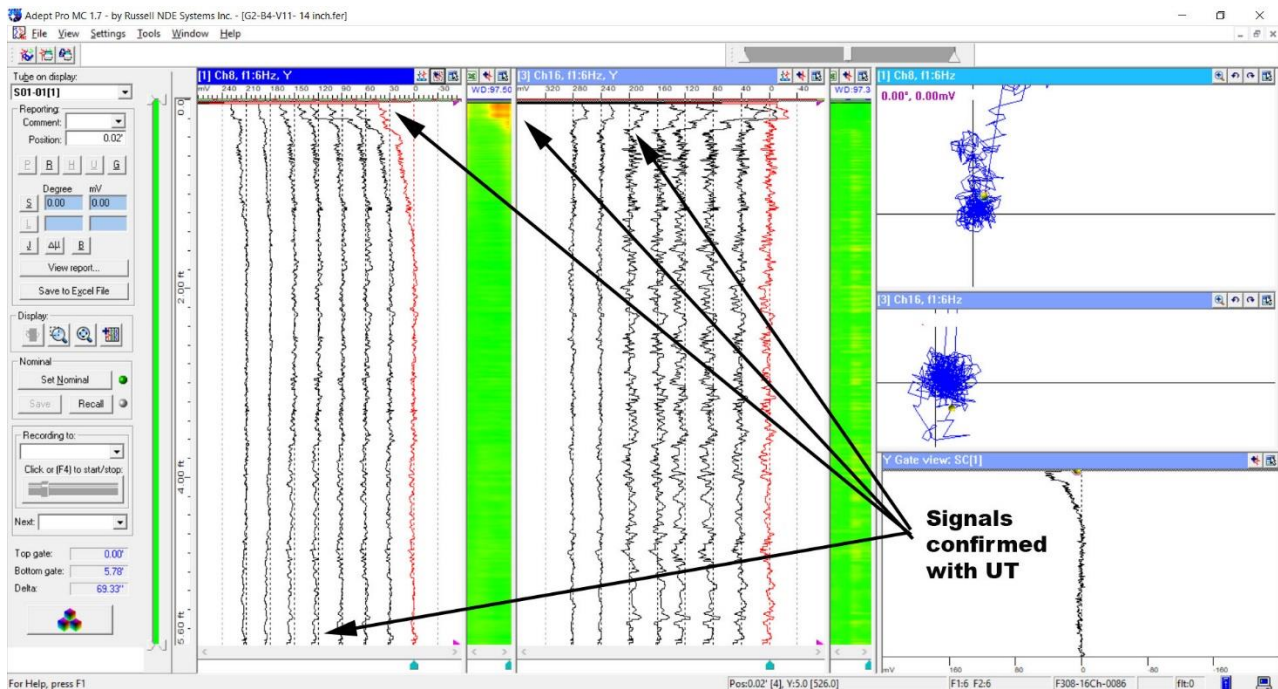
The image above has been labeled showing some of the signals confirmed with UT. The upper yellow area on the color map shows moderate corrosion

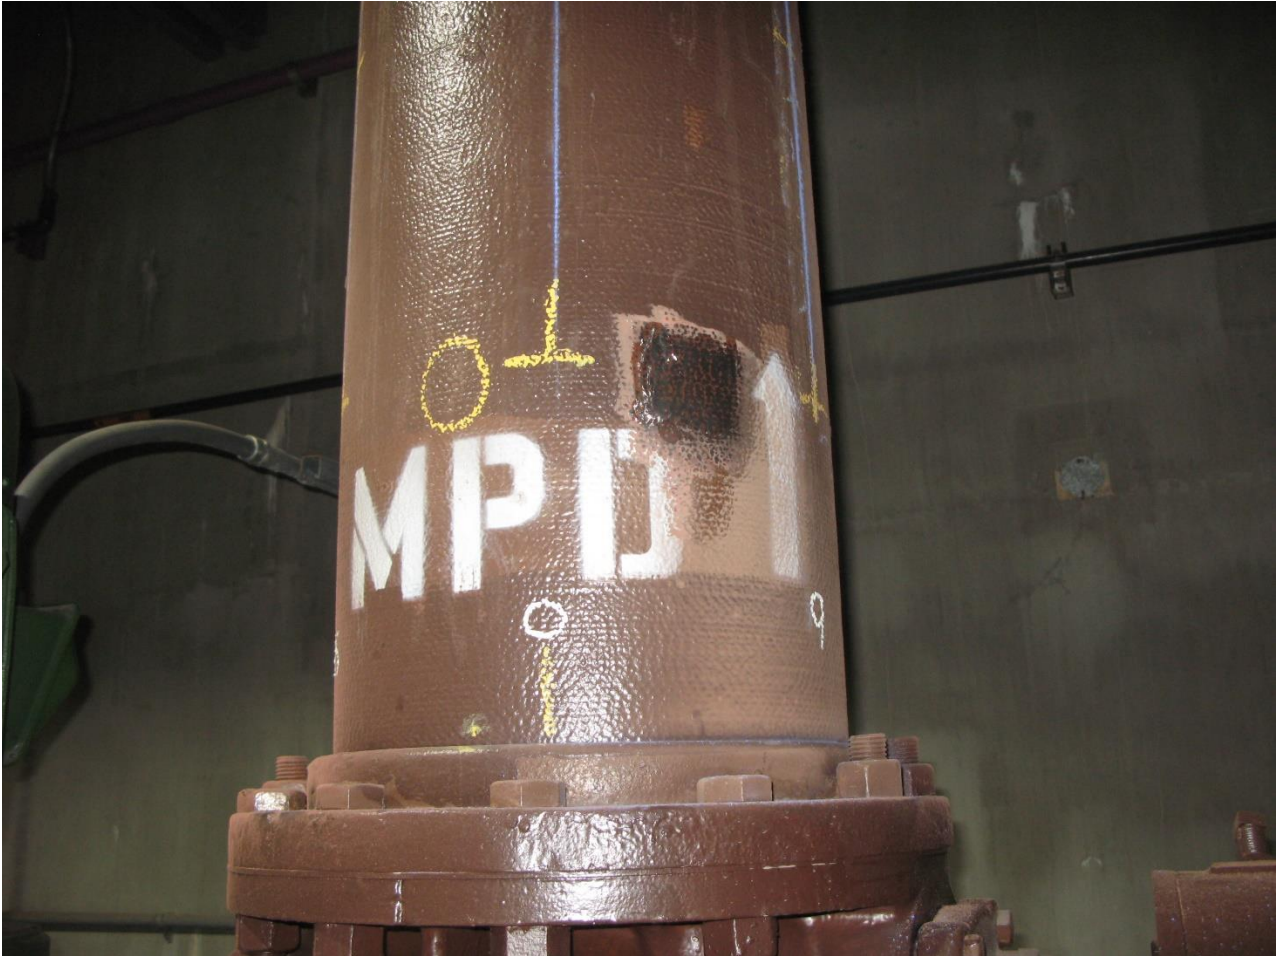
The picture above shows a closer view of the UT confirmation area before being recoated.
