PIPELINE OWNER
36” CI River Crossing Twin Force Mains
Condition Assessment Report, Standard Analysis

RFT ILI Tool
36” Cast Iron

PICA Project: 7074

Inspection Date(s): July 10 & 19, 2018 & January 8, 2019
Report Submission: June 11, 2019
Operators: B. Senka, D. Russell, A. Russell, G. Bouchard, P. Ryhanen, S. Popovic
Analyst: A. Liwoch, S. Popovic
Reviewer: J. Regala, M. Korz
Report Revision: 1.1

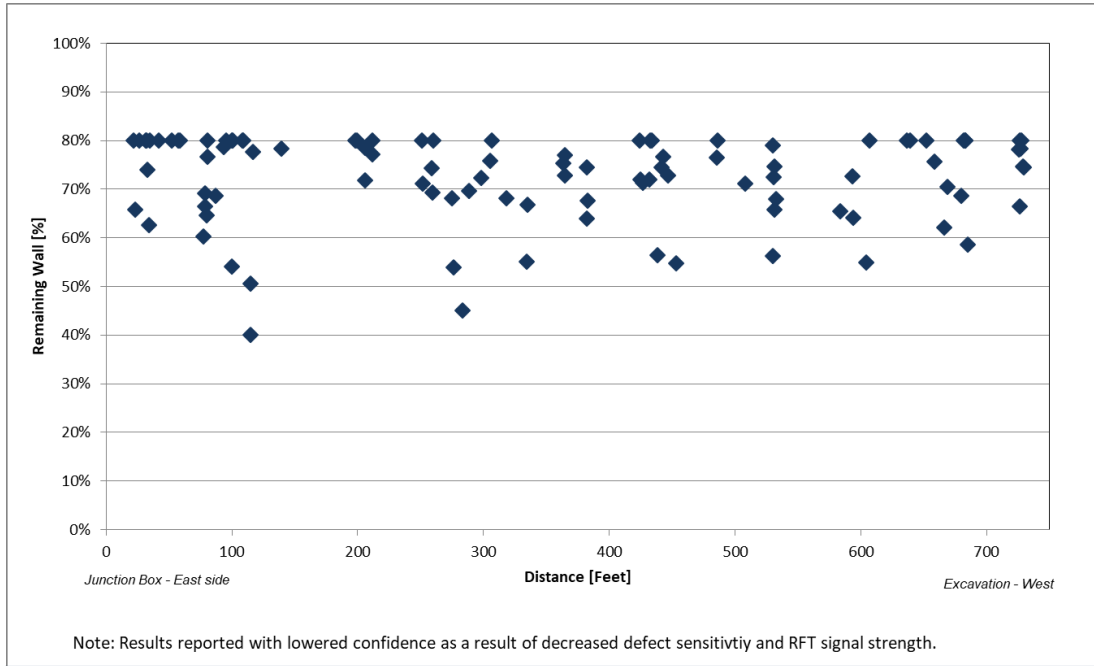
- ***South Line:*** A total of 100 pitting indications were identified across 32 pipe segments. A total of 11 indications measured between 40% and 59% Remaining Wall (RW), with the remaining 89 indications measuring 60% RW or shallower. No through-hole indications were identified.
- ***North Line:*** A total of 106 pitting indications were identified across 38 pipe segments. A total of 91 indications measured 60% RW or shallower. A total of 14 indications measured between 40% and 59% RW, and one (1) indication measured less than 40% RW. No through-hole indications were identified.

Figure 1a: Distribution of wall loss with respect to remaining wall (%NWT) in pitting regions along the inspected section of the **South Line** of the 36" CI River Crossing FM.

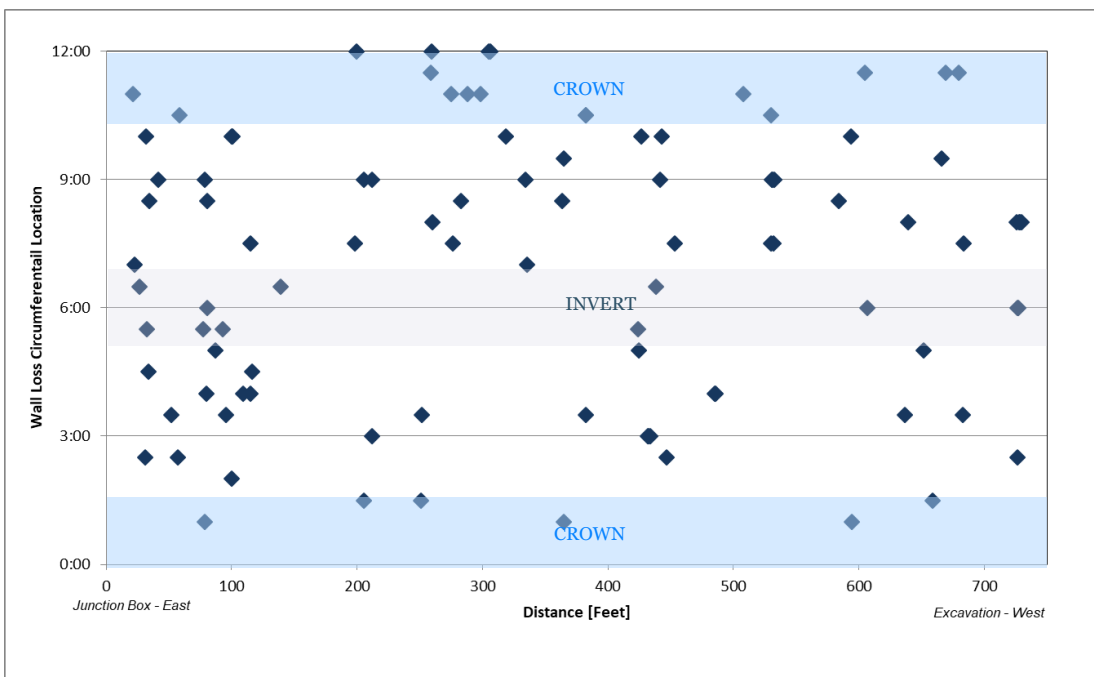
Figure 1b: Circumferential distribution of pitting regions along the inspected section of the **South Line** of the 36" CI River Crossing FM.

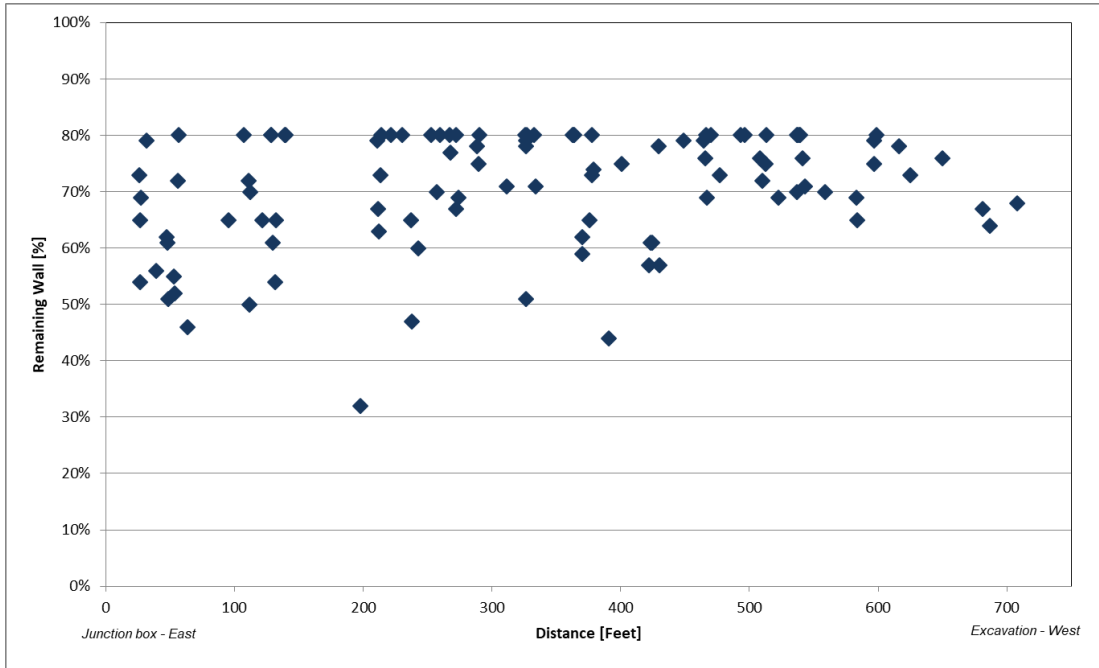
Figure 2a: Distribution of wall loss with respect to remaining wall (%NWT) in pitting regions along the inspected section of the **North Line** of the 36" CI River Crossing FM.

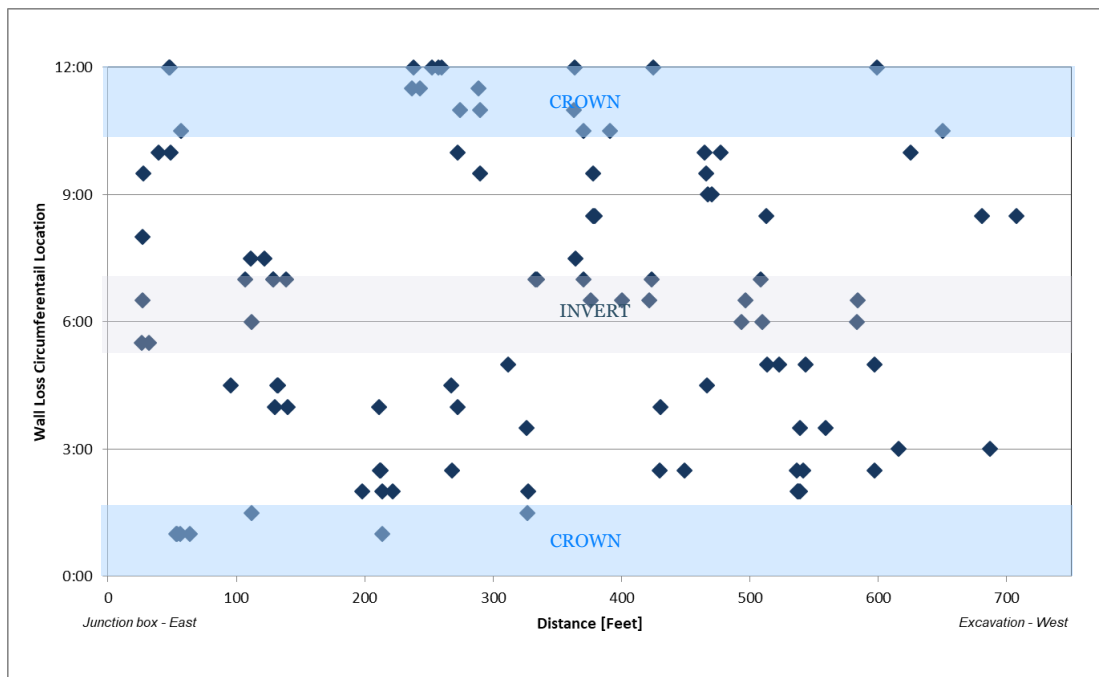
Figure 2b: Circumferential distribution of pitting regions along the inspected section of the **North Line** of the 36" CI River Crossing FM.

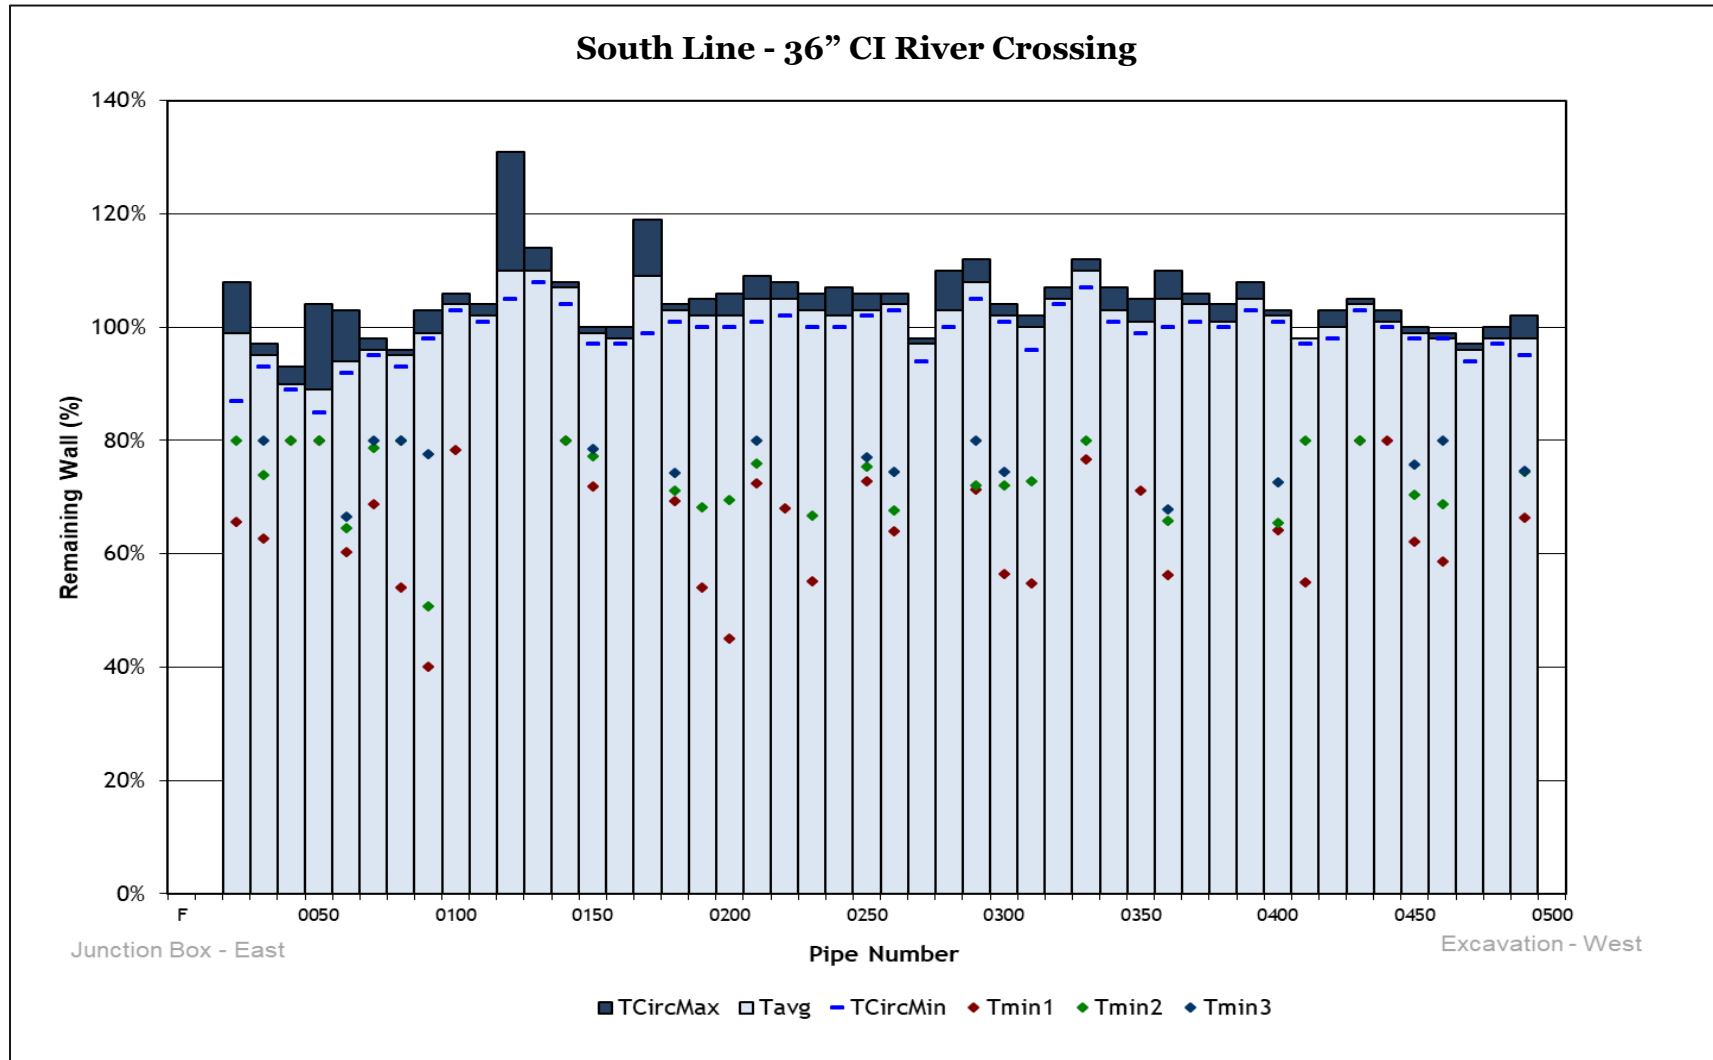
Figure 6: Structural Condition Assessment Summary – **South Line** 36" CI River Crossing

- ***South Line:*** All inspected pipes were found to be within the expected tolerances.
- ***North Line:*** Most inspected pipes were found to be within the expected tolerances. P0320 and P0350 were identified as being slightly heavier walled than expected, with PARW values of 124% and 120% respectively. Given the minimal departure from the normal $\pm 15\%$ spread, these variances are likely due to manufacturing tolerances.

Figure 6 shows an overview of the structural condition of the **South Line**. This figure plots the minimum circumferential (Tcircmin), maximum circumferential (Tcircmax) and average (Tavg) remaining wall of each segment of pipe, as well as the three deepest pitting indications within each pipe segment.

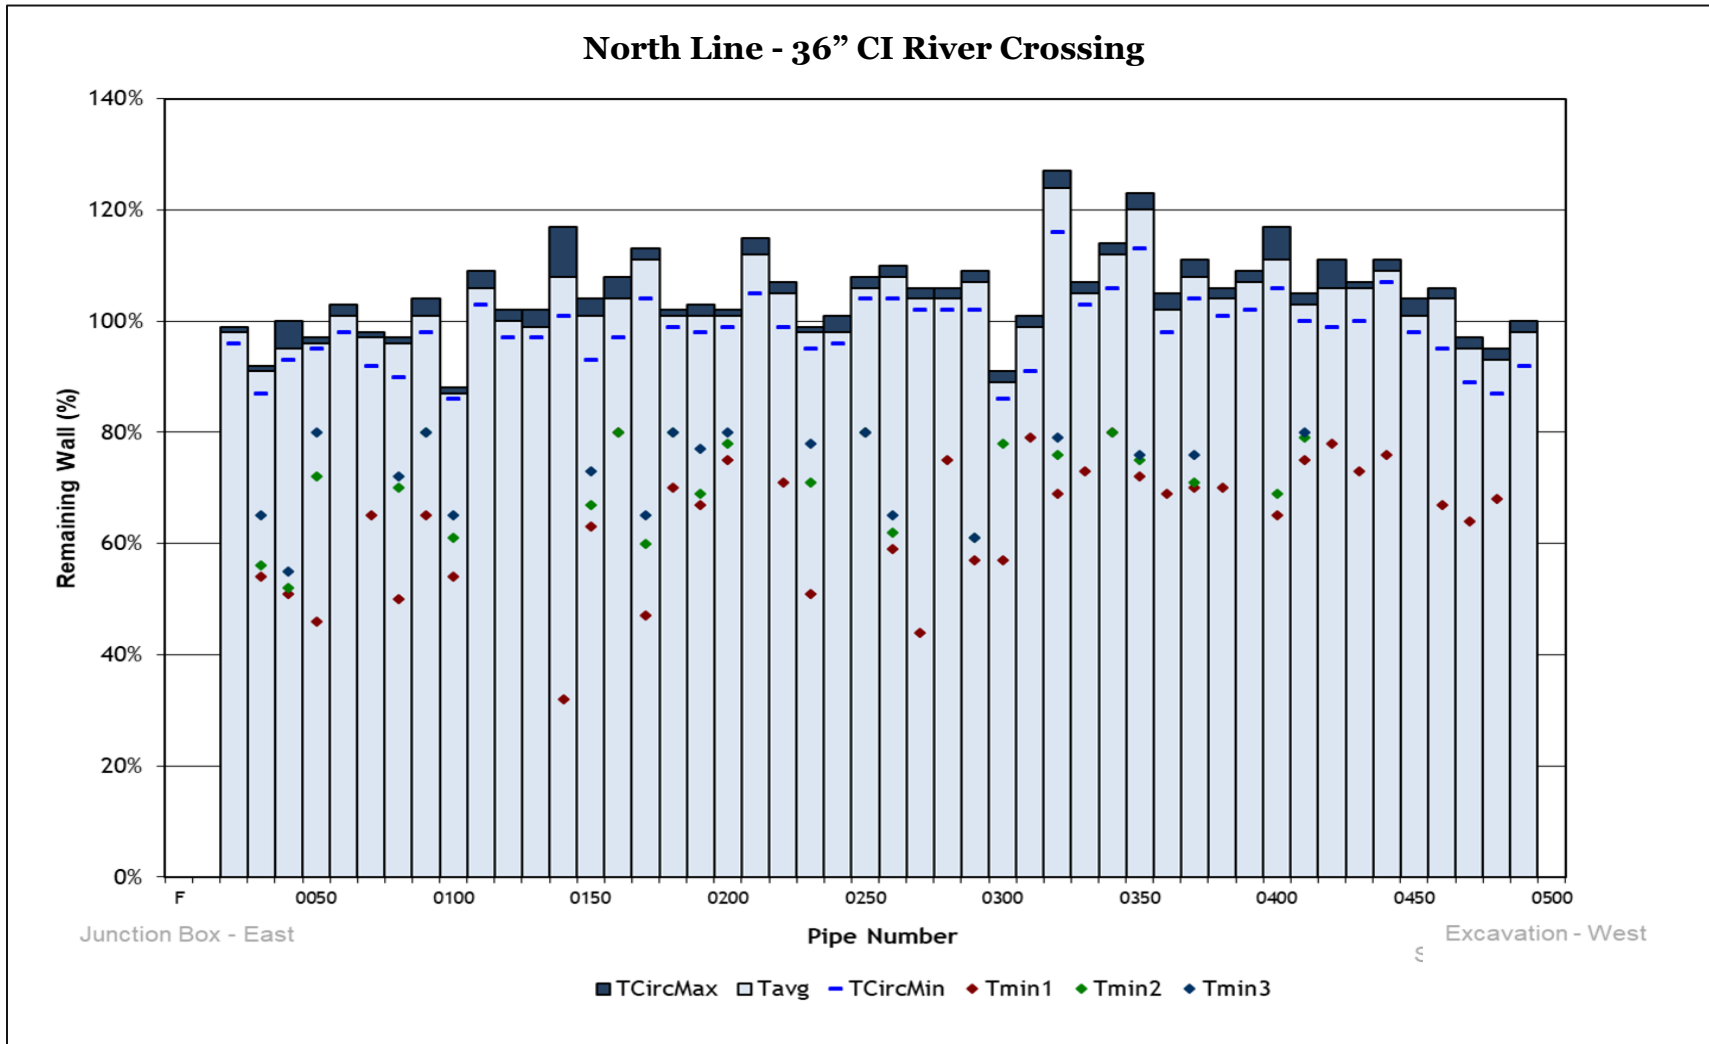
Figure 7: Structural Condition Assessment Summary – **North Line** 36" CI River Crossing

Figure 7 shows an overview of the structural condition of the **North Line**. This figure plots the minimum circumferential (Tcircmin), maximum circumferential (Tcircmax) and average (Tavg) remaining wall of each segment of pipe, as well as the three deepest pitting indications within each pipe segment.
