DRAFT REPORT

Navigator Survey

Conducted For:	ABC Consulting
Location:	Anytown, CT
Pipeline Inspected:	Subway 12" FM 3
Inspection Date:	April 10, 2024
Revision:	1.0
Submitted By:	Dmitri Shilov
Submitted on:	May 13, 2024

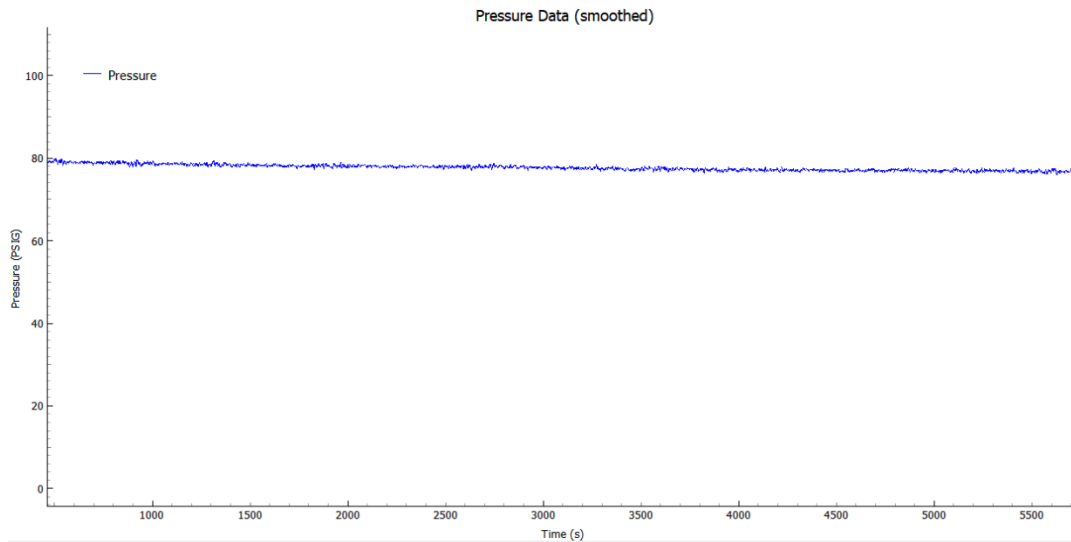
Slowly declining pressure and no flow condition is observed until 5,802 (s) **Figure 6.**

Figure 4 Slowly Declining Pressure

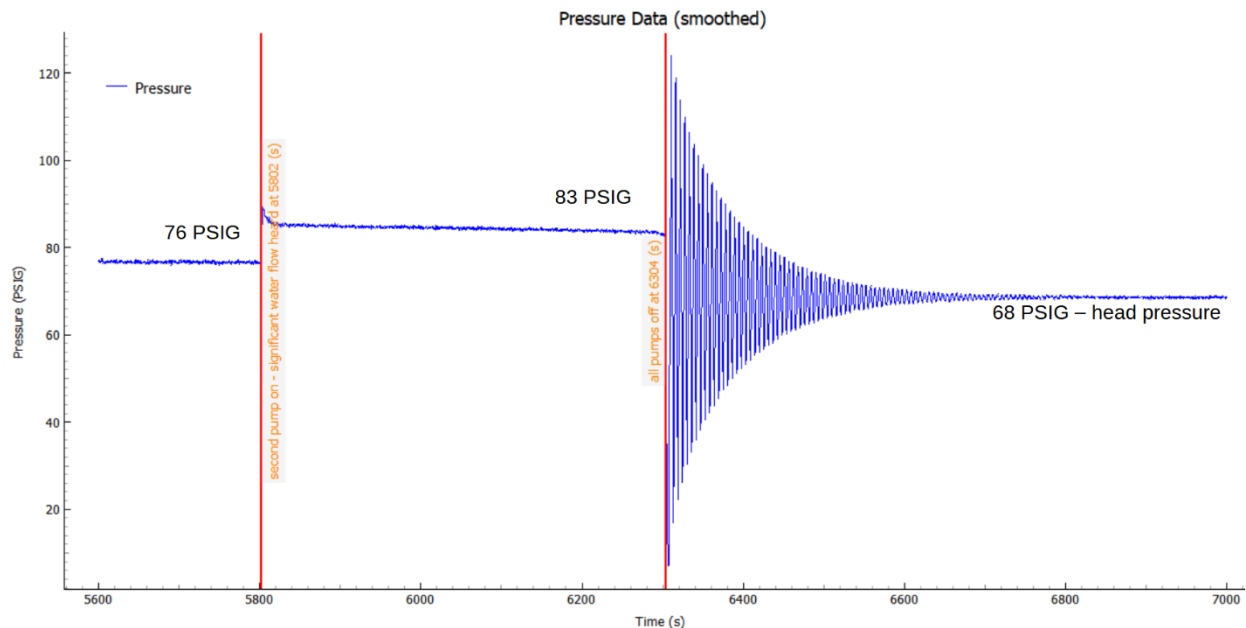
The second pump can be heard coming on and water flow is heard by the Navigator at 5,802 (s), although it remains mostly stationary with slight vibrations seen in the IMU data. All pumps stop at 6,304 (s). That is also when the most significant pressure swing down to 5 and up to 135 PSIG is observed. (**Figure 5**)

Figure 5 The second pump turns on until all pumps are shut off.

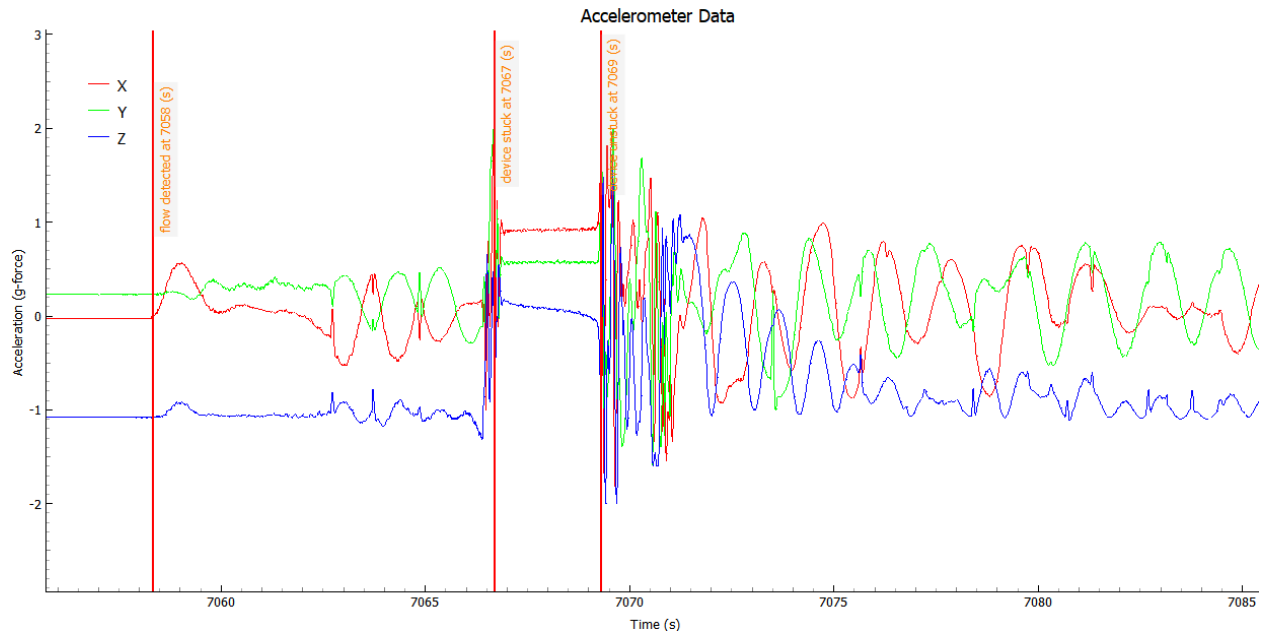
At 7,054 (s), a pump can be heard powering up, and at 7,058 (s) the pressure at the Navigator increases and the device starts moving. The device gets properly stuck for 2 seconds between 7,067 and 7,069 (Figure 6, Figure 7), likely in some features inside the pump station piping system. The device moved steadily with each pump cycle after.

Figure 6 IMU data at 7067 (s), where the device was briefly stuck.

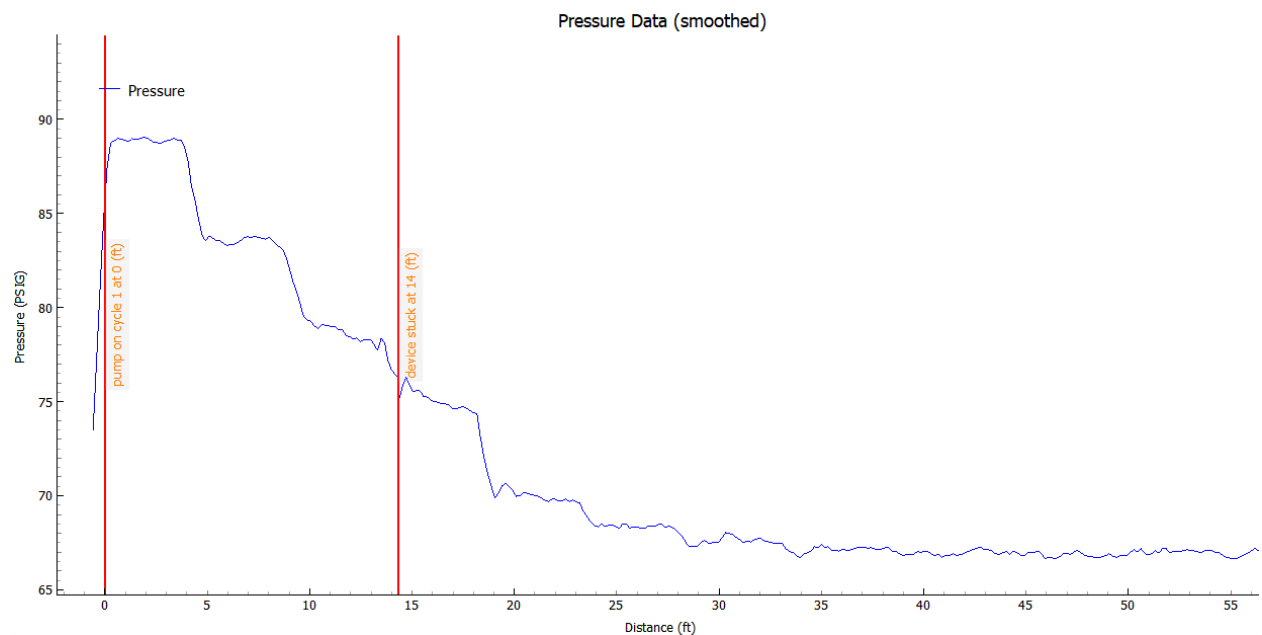
Figure 7 Pressure log at estimated distance where the device briefly stopped.

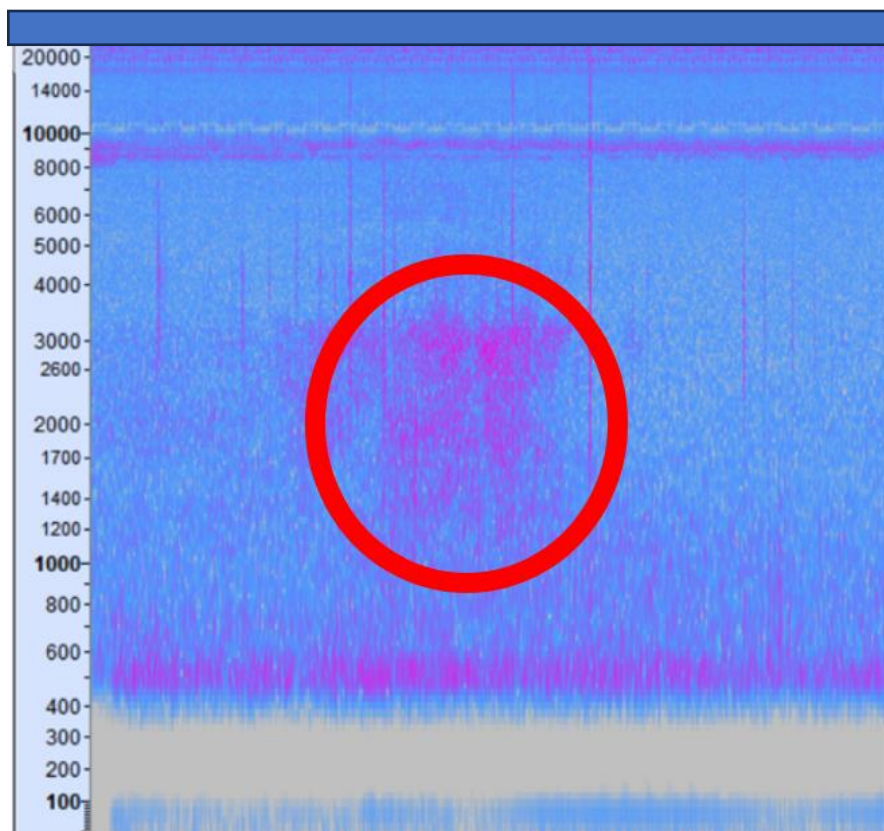
Figure 8 Leak # 1 acoustic signal as seen in spectrogram view. Color represents loudness of sound (grey to red), x-axis is time. Audio attached to report.

An acoustic indication was found at 473 ft. **Figure 10** shows the indication. The indication is believed to be a leak (Leak #1), as it has a distinct sound of a leak. It doesn't present every characteristic of a leak, such as reaching into the kHz range of frequencies, but enough characteristics (distinct peaks, rapid fall-off of signal, "hissing" characteristic) to give a likelihood of 90-100% probability.

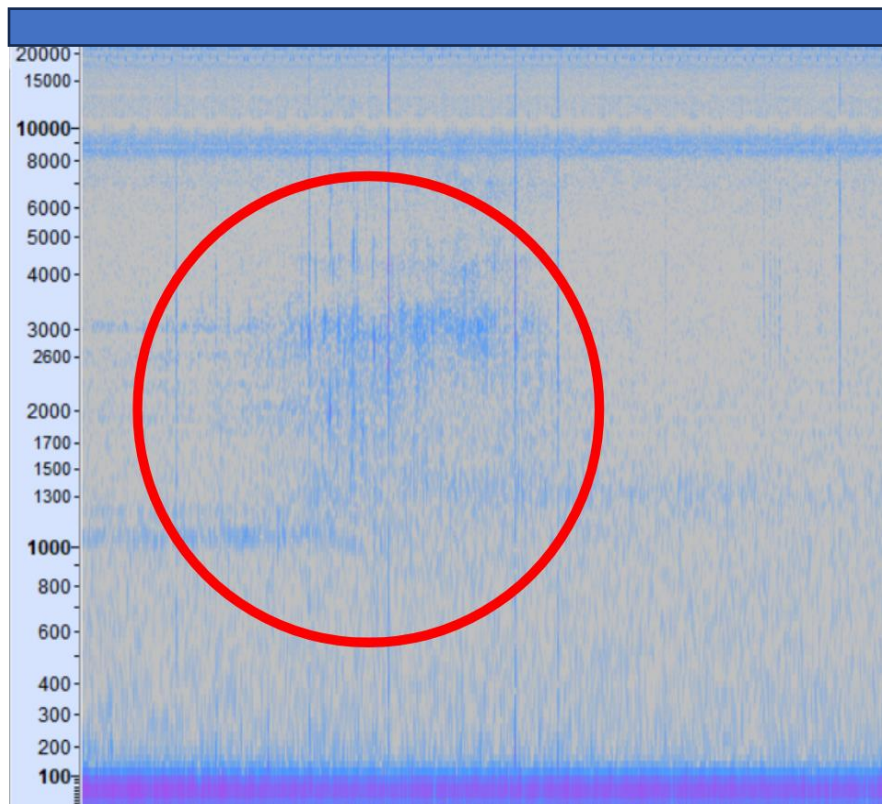
An additional acoustic indication was found at 3,183 ft (**Figure 11**). It is found within an air pocket, and it is believed to be a factor in reducing the loudness of this indication. There are enough characteristics to give a likelihood of 66-100% probability.

Figure 9 Leak # 2 acoustic signal as seen in spectrogram view. Color represents loudness of sound (grey to red), x-axis is time. Audio attached to report.

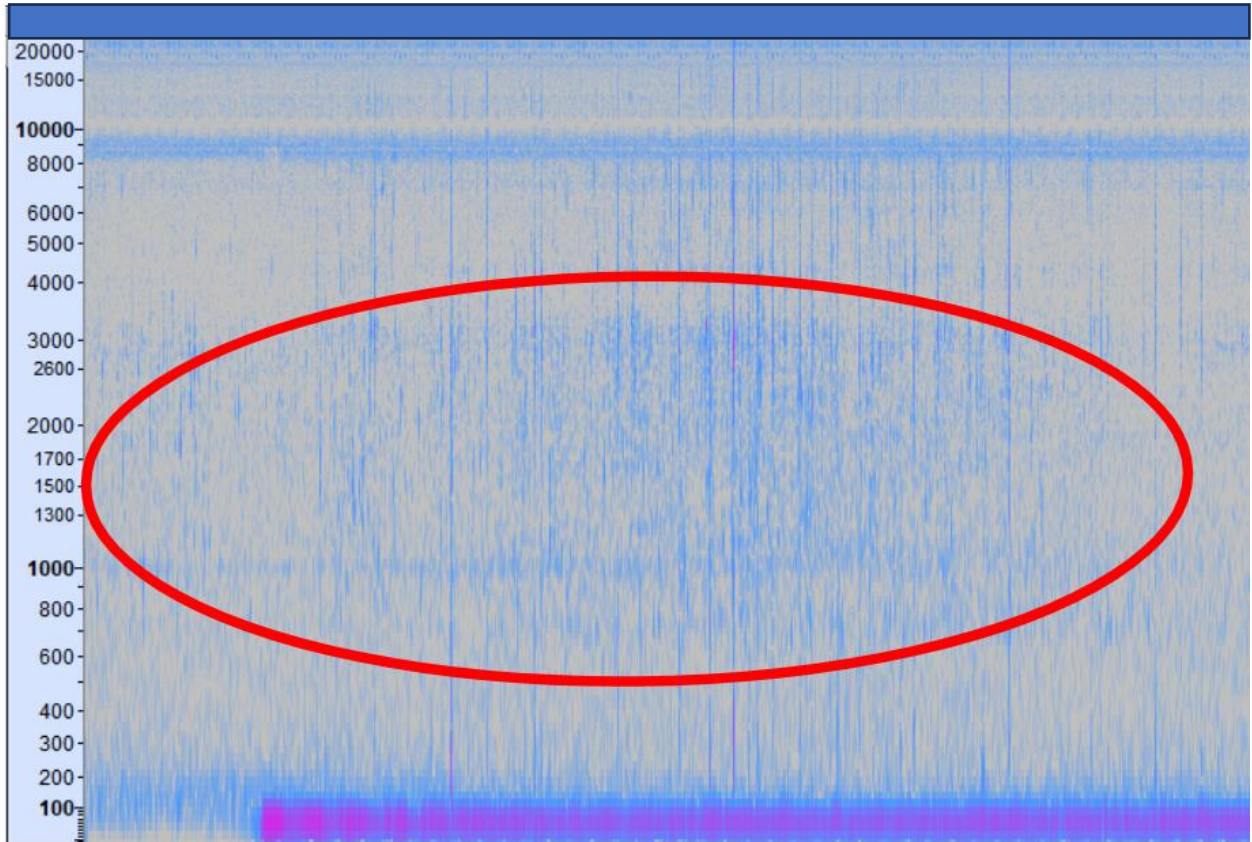
Most of the air pockets found cannot be visualized. **Figure 12** is air pocket number 4.

Figure 10 Air Pocket #4

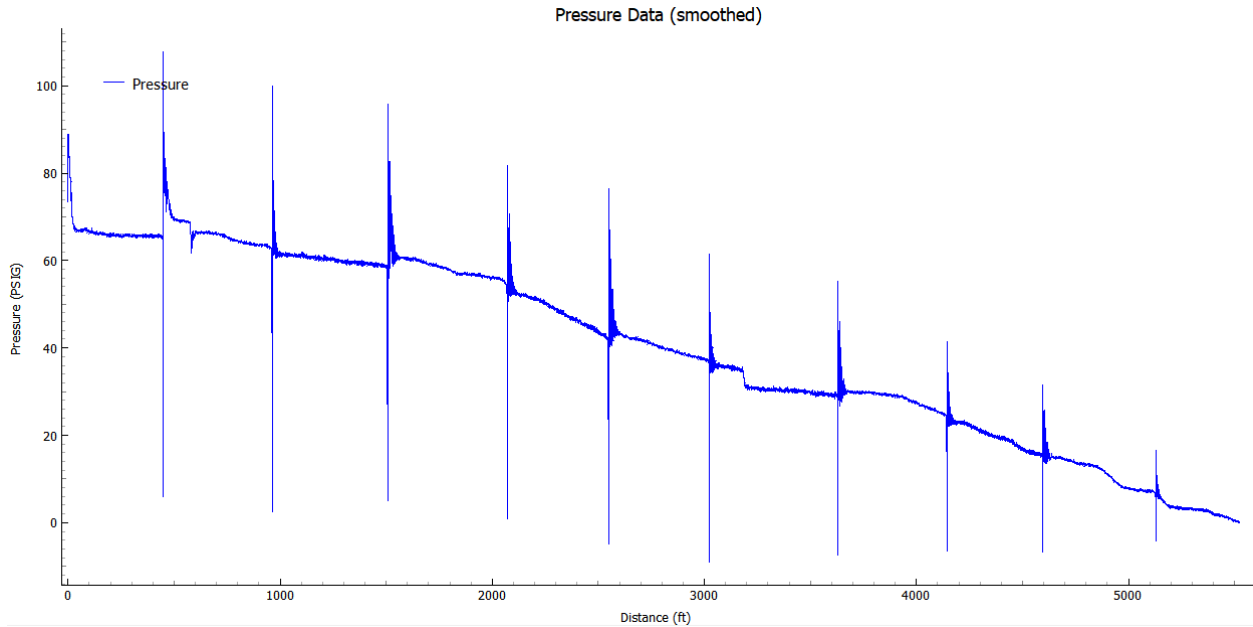
Figure 12 Complete run pressure log vs. distance. Note large swings of pressure at every pump cycle end.

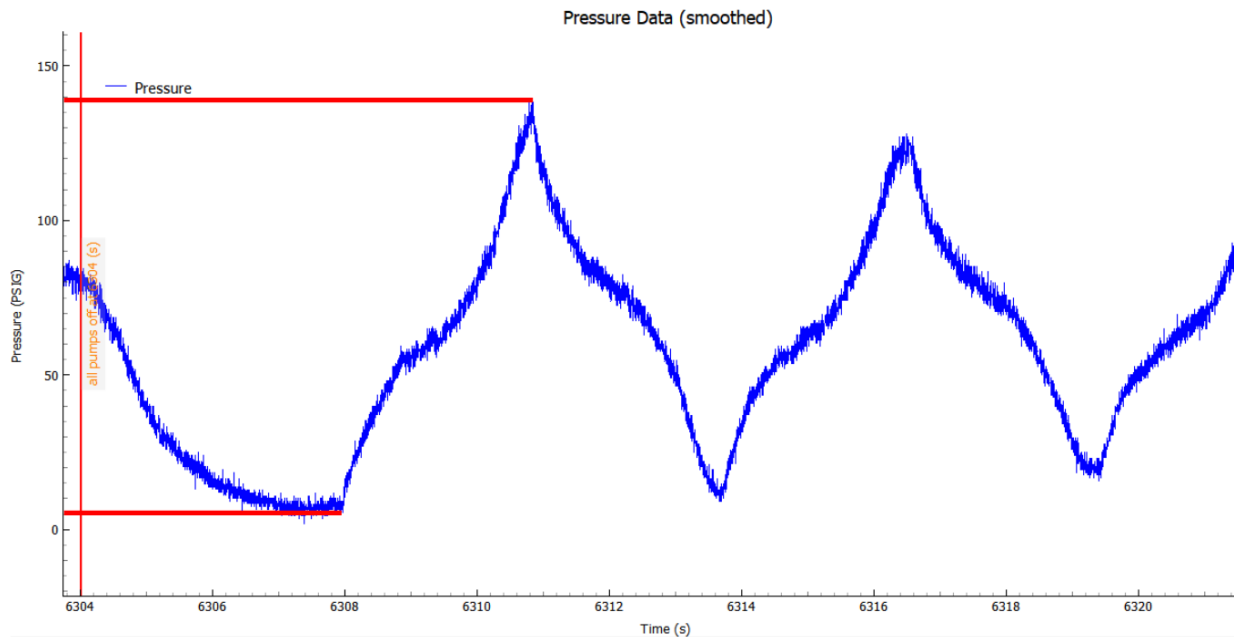
Pressure data was successfully logged (**Figure 12**). Pressure swing of 5-135 PSIG (**Figure 14**) and an obstruction (**Figure 14**) were observed.

Figure 13 Data log of pressure swing at pump shutdown.

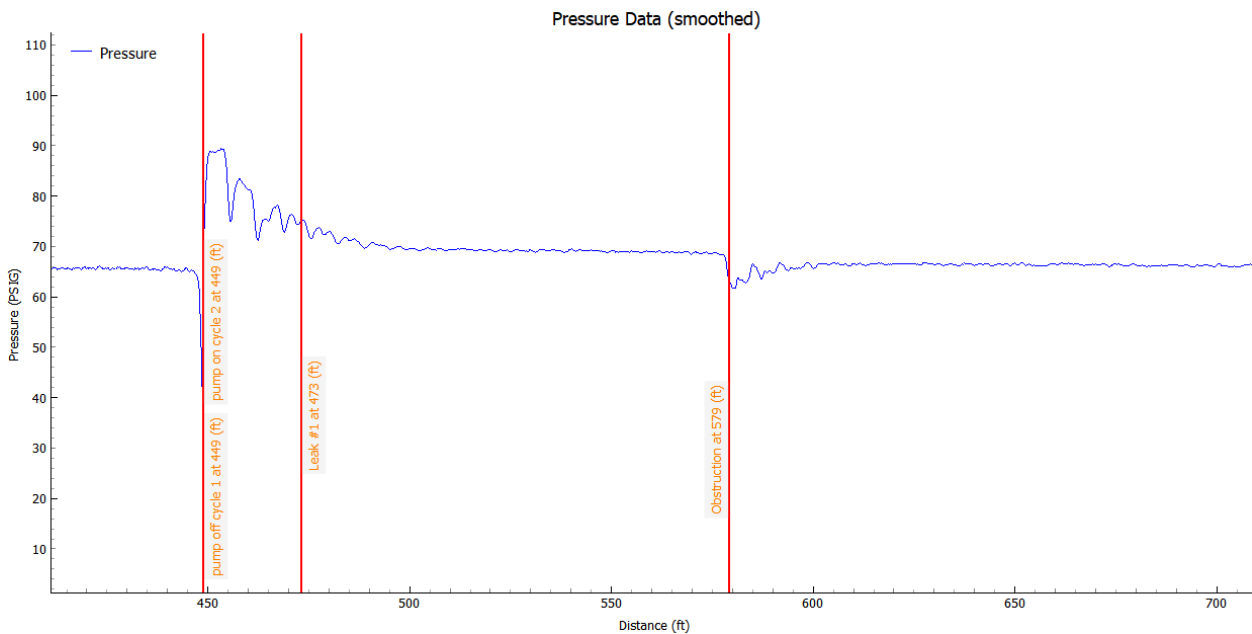
Figure 14 Pressure indication of an obstruction.
