Near Field EM Inspection

- Prestressed Concrete Cylinder Pipe
 - Potable Water
 - Raw Water
 - Industrial (including Nuclear)

Overview

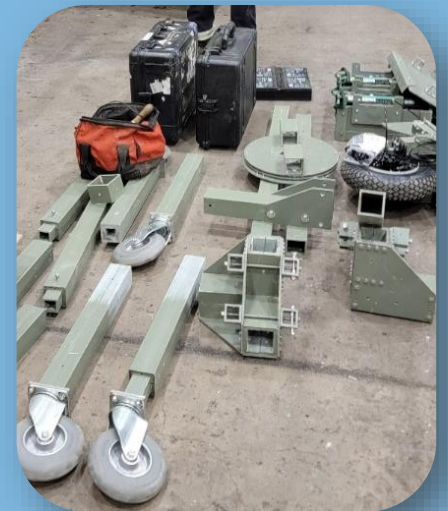
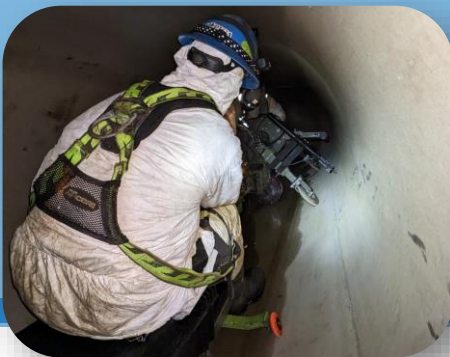
PICA's NFT tools detect 5 continuous wire breaks (or more) in pipelines from 36" to 200+" diameter in dewatered applications.

PICA's Near Field Testing (NFT) EM technology can accurately identify and quantify broken prestressing wires in PCCP. Other important benefits include: modular tool design enabling introduction through 18-inch access ports, ability to simultaneously support complimentary data sets (such as CCTV or LiDAR), and on-site 48-hour data turn around.

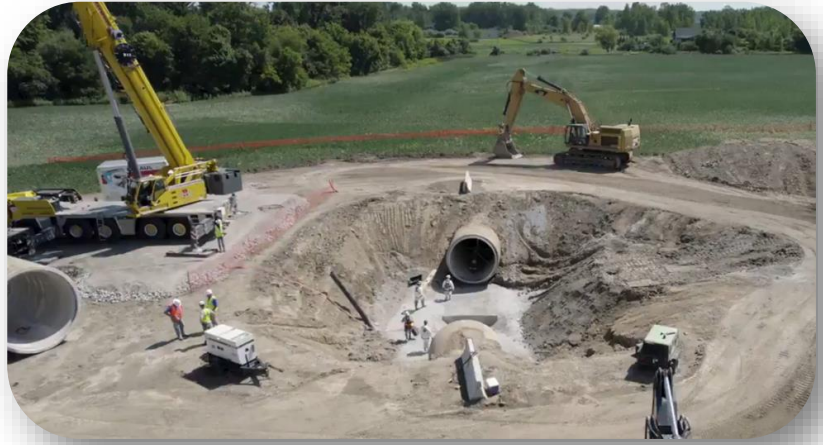
Case Study Where: Detroit, Michigan

- What: 120-inch PCCP water main.
- When: August 2022.
- How: NFT inspection using large diameter tool.
- Why: Pipeline failure.
- Distance: 1.5 miles (2.4 kms) in total.

In the summer of 2022, a 120-inch diameter critical water transmission main constructed of embedded cylinder PCCP experienced a sudden disruptive failure. With the main down for repairs, PICA was contracted to conduct an emergency inspection. PICA assembled and shipped the inspection equipment within a day after being contacted. On the first day after arrival, PICA's crew collected the inspection equipment from the warehouse, constructed the tool, and performed short calibration scans. The inspection was successfully completed the following day.

Wire break data was reviewed on-site the same evening and preliminary inspection results were submitted to the client within 48 hours. Wire breaks were accurately logged on 7 of the 525 pipes inspected.
