**Inspection Report**  
**Bracelet™ Probe Inspection**  
**ABC County Force Main Sites**

**Site # Main Street #254**

**PICA: BP Report # 36**

**(254 Main Street, Albertville, CA)**

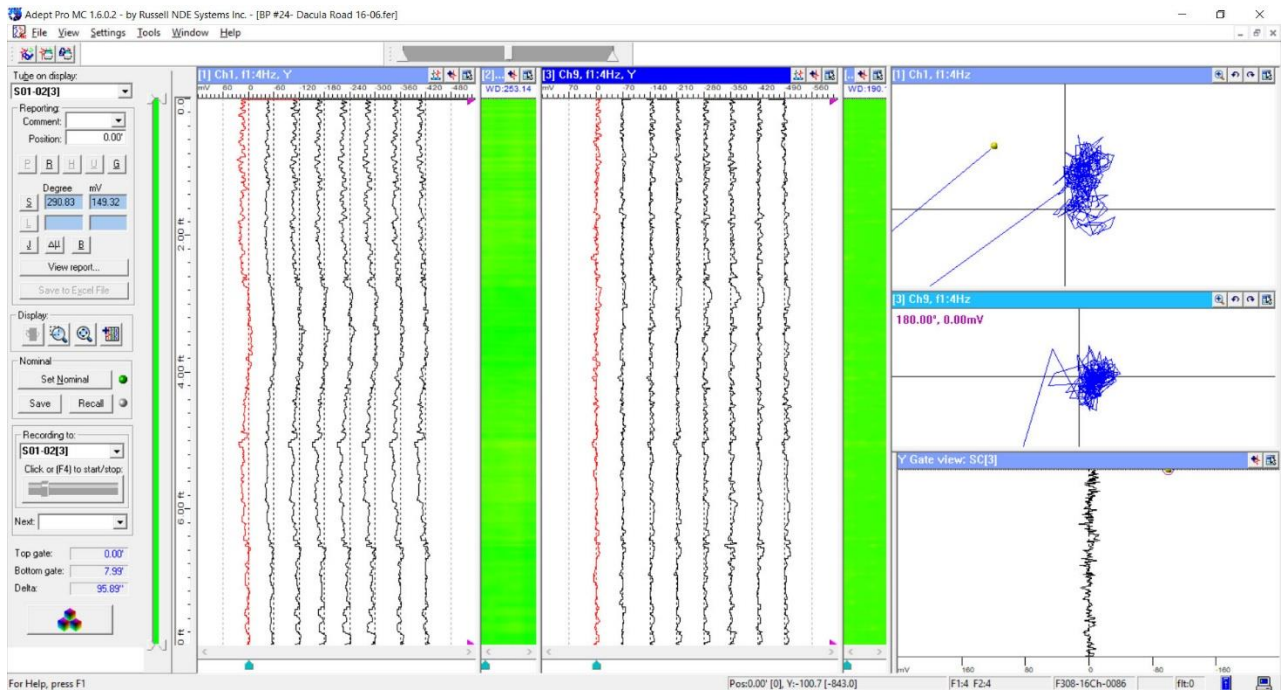
**Figure 3.** (Scan S01-02) BP data for a scan covering 0" to +9" circumference (Probe centered at +4.5" position).

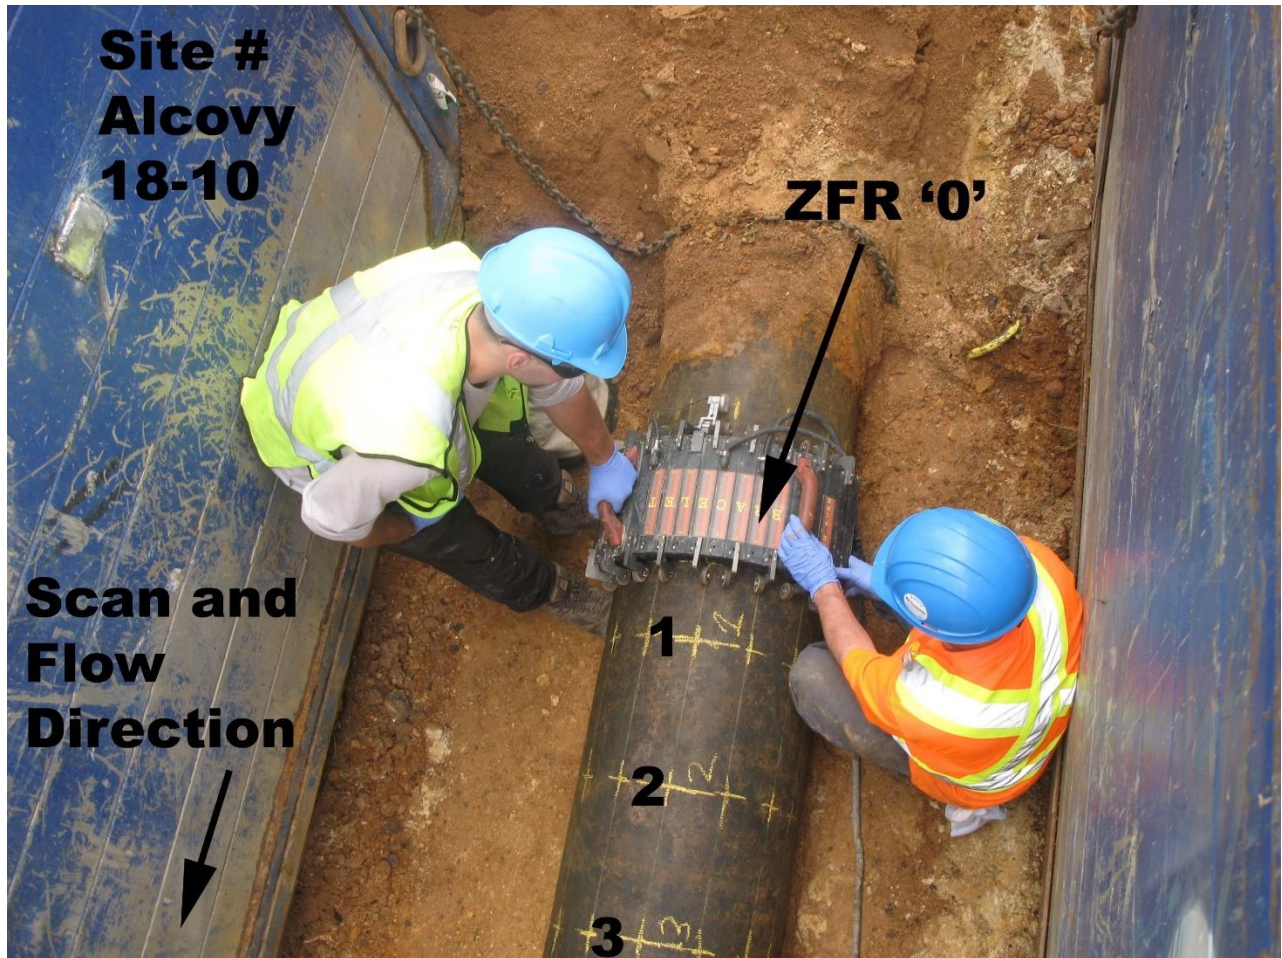
A "Zero Foot Reference" (ZFR, or Datum Line) was marked on each pipe and indicates the start of each BP scan. The scanning direction is from upstream (US) to downstream (DS), as shown in Figure A2-2. Axial distance increases downstream (DS) from the ZFR. Axial distance increases downstream (DS) from the ZFR. Note: measurements provided by the Bracelet Probe are +/- 2".

Figure A2-2. Bracelet™ Probe placed at the start location.

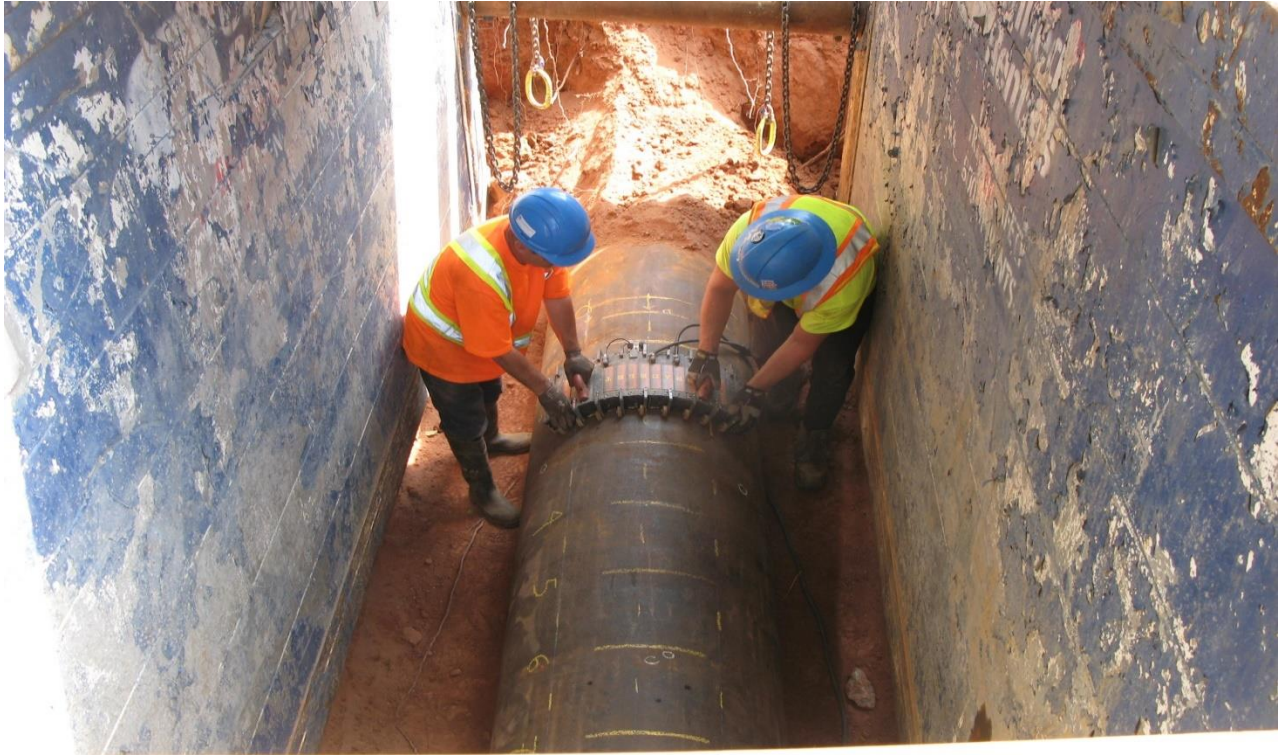
The probe was scanned at a speed of 1-2 feet per minute on the pipe, as shown in a photo in Figure A2-3. The BP data and distance information were gathered and stored in the laptop computer while the data was displayed real-time on the computer screen. The data was analyzed on site and any defects were noted and marked on the pipe with UT (Ultrasonic Testing) performed if needed for confirmation of BP results. Typical setup for Ferroscope and laptop computer is shown in Figure A2-4. The laptop was connected to the Ferroscope for data gathering and real-time data display.

**Figure A2-3.** Typical BP scanning a pipe.

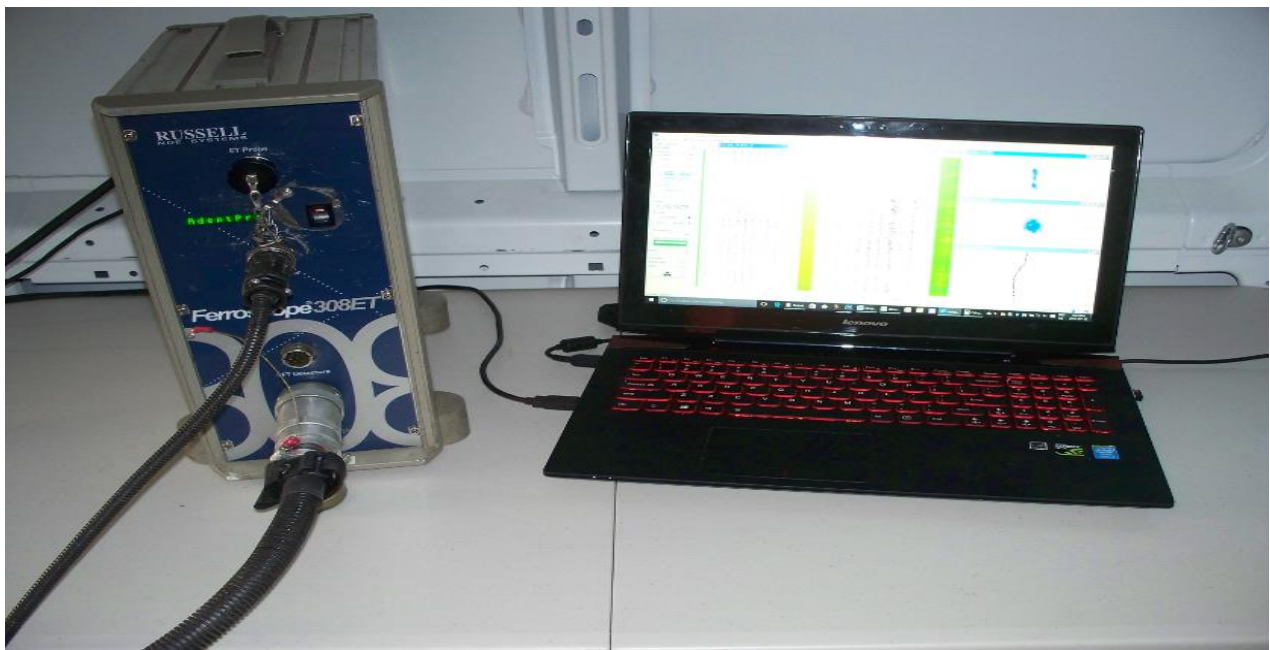
**Figure A2-4.** Typical setup for Ferroscope and Laptop computer at job site.

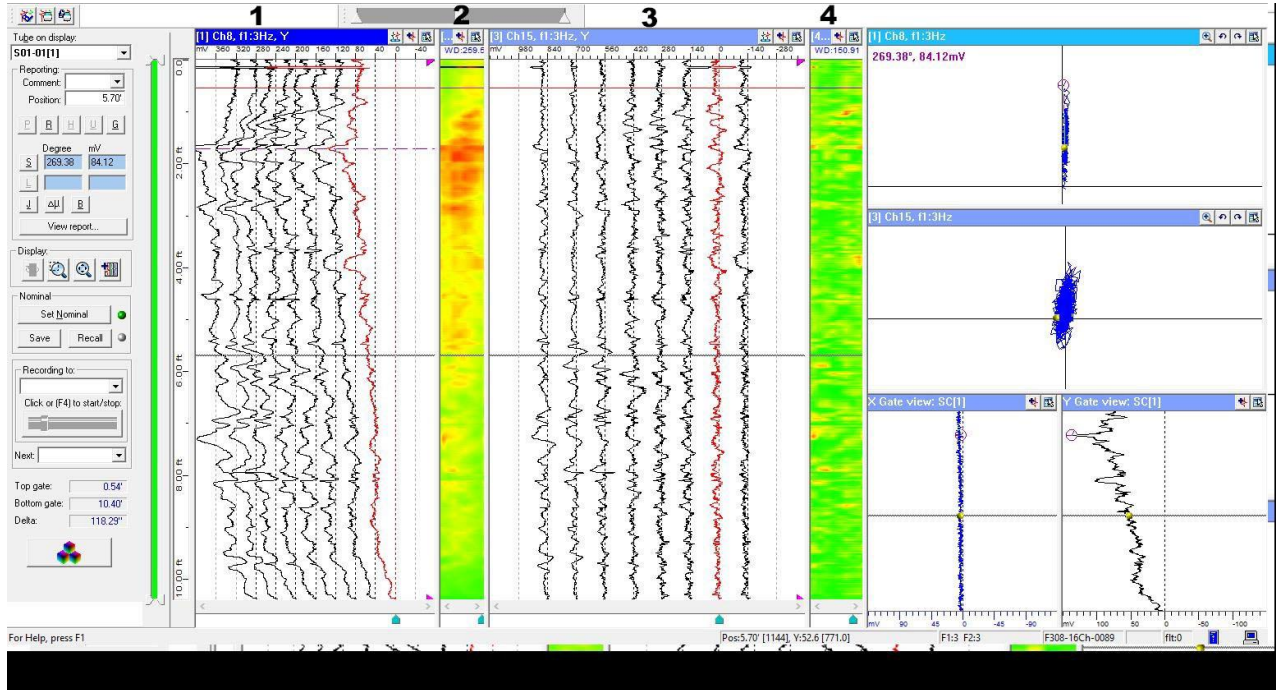
**Figure A2-5.** Example Screen Capture of Data

The example above shows a Screen Capture of a 10-foot pipe with numerous and deep pitting along the entire length. The picture has been labelled with a number above each chart column, which represents as follows:

Chart 1 and 2: Absolute coils for viewing General Wall Loss

Chart 3 and 4: Differential coils for viewing Pitting

Chart 2 and 4: Color maps for viewing the Data

For Chart 1: As a general guideline when the line trace moves to the left there is less material, as it moves to the right the wall is thicker.
