# Inspecting the un-inspectable

David Russell, Ad Shatat and Yuwu Yu, Russell NDE Systems Inc., Canada, demonstrate the benefits of using an RFT ILI tool for sour gas pipeline assessment.

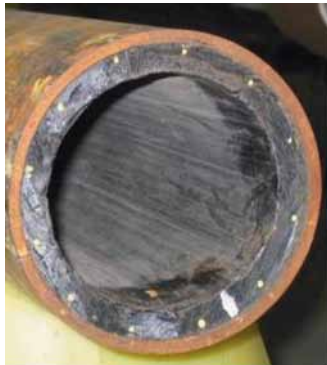
Figure 1. Cross-section of an 8 in. sour gas pipe.

Sour gas pipelines in Alberta, Canada, usually consist of carbon steel pipes with thick internal high density polyethylene (HDPE) lining. The thickness of non-structural HDPE varies and depends on several factors, including corrosiveness of the sour gas, pipe diameter and operating pressure. A cross-section of an 8 in. sour gas pipe is shown in Figure 1. The liner thickness is about ¾ in. HDPE lining is intended to prevent corrosive agents in sour gas from entering annulus between pipe internal surface and liner. However, methanol used for hydrate control and de-icing can permeate through the liner and enter the annulus. In the presence of moisture conditions,

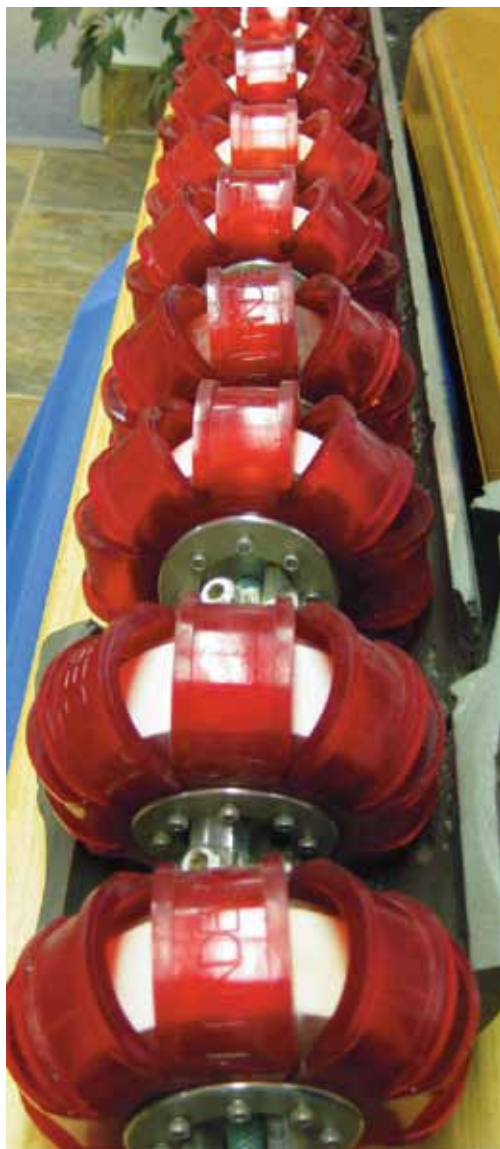
Figure 2. A typical RFT ILI tool.

A typical RFT ILI tool is shown in Figure 2. The tool is flexible and can go around bends. Centralising loops keep the ILI tool properly centred inside the lined pipe and prevent damage to the liner. Exciter coils, sensors and electronics are sealed and encased in various modules of the tool. Working on the physical principle of double through wall transmission<sup>5-6</sup>, the RFT technique is characterised by its many advantages to other NDE techniques such as: equal sensitivity to ID and OD defects; relatively insensitivity to tool wobbling; tolerance of large clearance between pipe internal surface and sensors, allowing inspection through thick liner and ability to continue taking readings at very low speed (and even when stationary).
