**ASCE Conference Proceedings Paper:
Multi-Sensor Autonomous Inspection Device for Condition Assessment**

Timothy Andrews, MBA ¹, Dmitri I. Shilov, EET ², David Burton M.Sc. P.Eng. ³

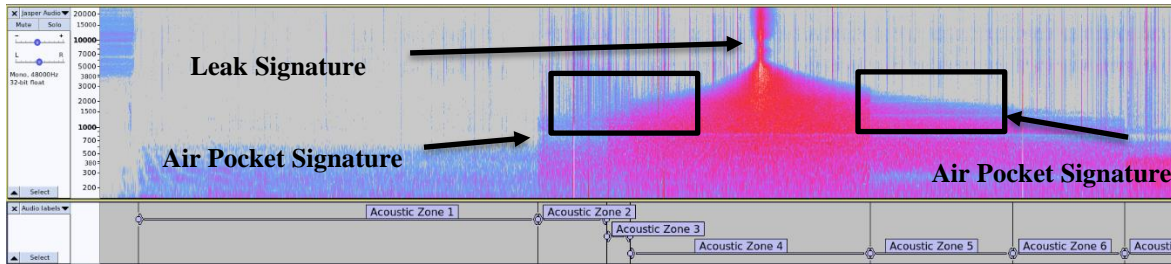
A super-sensitive ultrasonic crystal is used to detect leaks and air pockets through acoustic anomalies. The ultrasonic crystal uses piezoelectric materials to detect ultrasonic noises which are recorded by internal electronics. The piezoelectric materials can detect sound up to 30 MHz and the human ear can detect sound up to 20 kHz. (Platte 1996) Leaks produce a sound that generates a sharp acoustic change from the baseline level of the acoustic spectrum. Air pockets produce an acoustic change that can be described as between the two extremes of baseline acoustic change. Figure 1 below shows the data from a leak and corresponding air pockets leading to the location of the leak.

Figure 1. Acoustic Leak Data

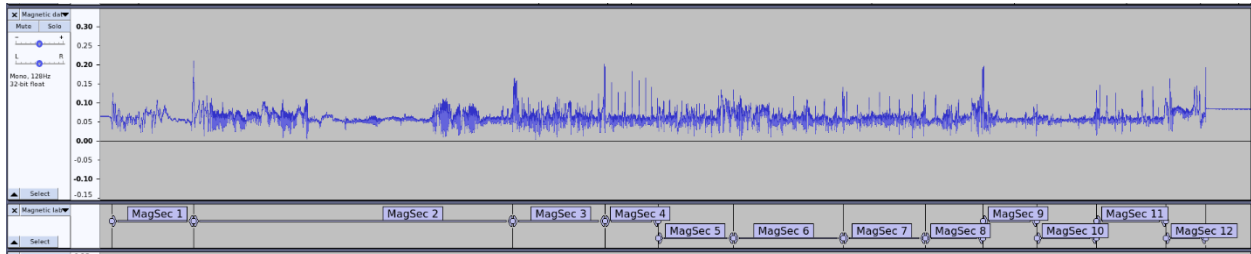
Using a magnetometer to collect data in a pipeline underflow while contained in a sphere can provide a baseline of pipe magnetic data. In a nonmetallic pipeline, the magnetometer can detect metallic features along the pipeline path. In a metallic pipeline, a baseline measurement of magnetic flux resident in the pipe wall can provide a basis for comparison to future runs where the loss of wall through corrosion may have changed the magnetic properties of the pipe. For the application of MSAID and the challenges in the water and wastewater industry, the data collected by the magnetometer on an initial data collection inspection indicate that the results of magnetometer data should only be used in correlation with other data analysis methods. The limitations of historical qualitative data analysis, controlling the speed of the device, pipe wall magnetic saturation, etc. affect the accuracy of magnetometer data. (Shi, et al. 2015) The data gathered is useful in providing the data analyst with a more comprehensive picture of the condition assessment of the pipeline in question. Figure 2 reflects the magnetometer data collected around the leak detected for the Jasper, AB pipeline.

Figure 2. Magnetic Features

The image above provides a visual representation of magnetometer data from an initial data collection run of the pipeline. Patterns can be recognized, and varying levels of magnetic flux can be seen. Without knowledge of what the baseline conditions were when the pipeline was installed the data gathered should only be used to correlate the data collected by the other sensors. In the future, the desire is to measure the data collected over periods to assist in providing an analysis of changes in magnetic flux.

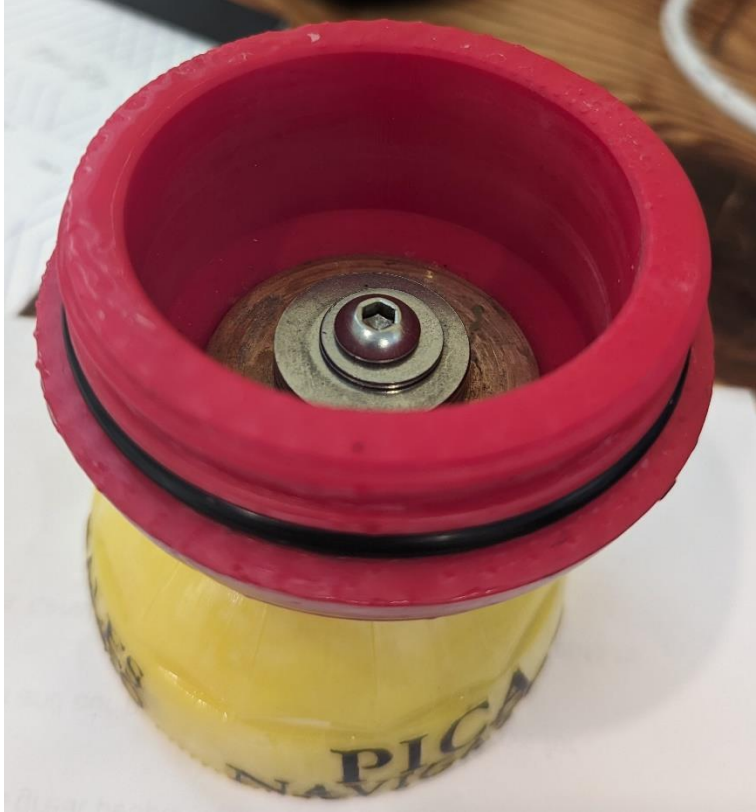
A significant challenge in ensuring that the device makes it through the entire pipeline path is the buoyancy of the device in the pipeline fluid. If the device is too buoyant then it could become obstructed by air release valves or other unknown blockages in the crown of the pipeline. If the device is not buoyant enough, then it can get lodged in deposits or other unknown blockages along the bottom of the pipeline. The device we created can have the weight altered on-site thus affecting the buoyancy of the device to ensure a successful completion of the proposed pipeline path. The post and weights can be visualized in Figure 4 below.

Figure 4. Buoyancy Weight Alteration Post

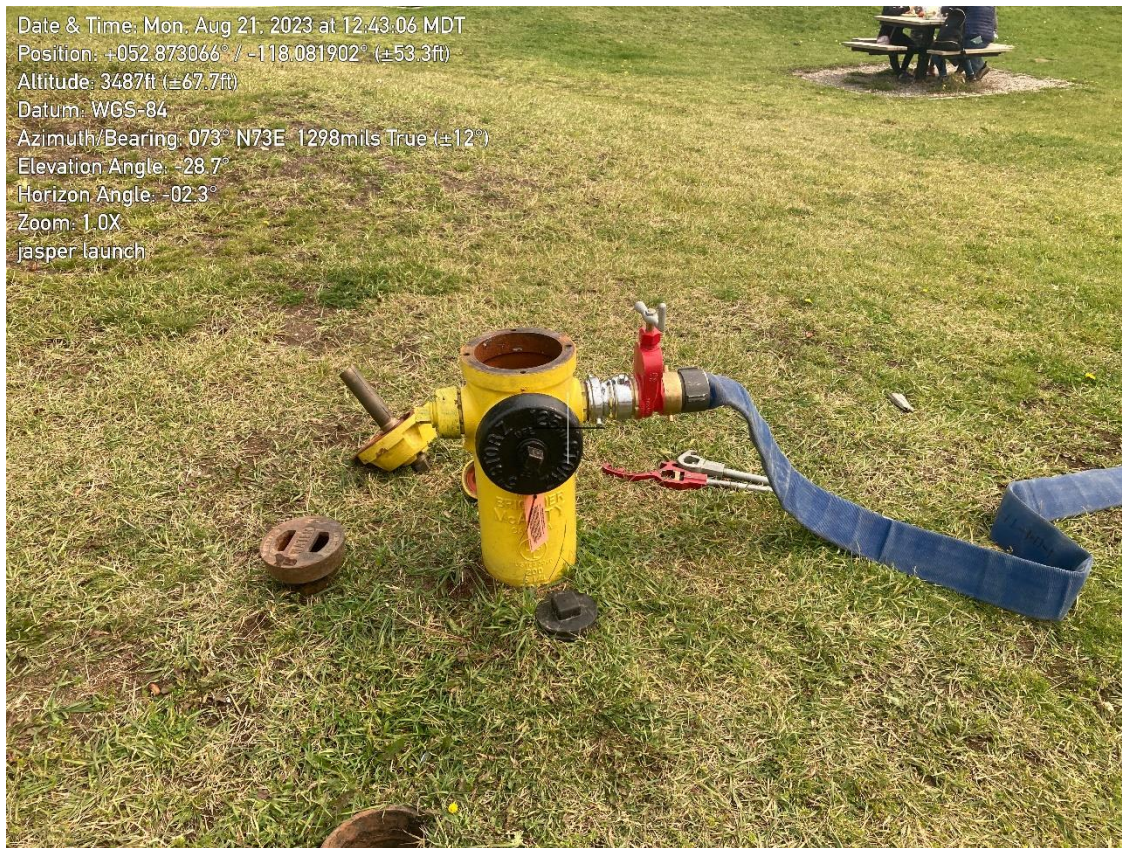
The municipality of Jasper, AB, Canada, faced a suspected water line leak, prompting a swift response from PICA. From the initial contact to the completion of fieldwork, launched and retrieved from modified hydrants seen in Figure 5 and Figure 6 below, our dedicated team ensured a seamless process, deploying a field technician equipped with our advanced inspection device in under 45 days.

Figure 5. Jasper Insertion Hydrant

PICA leveraged its extensive high-resolution inspection experience to develop a novel deployment method for inspecting pipelines. A field technician utilized a modified fire hydrant to introduce the inspection device into the pipeline. A specially designed catch device was used to seamlessly retrieve the device from another designated exit hydrant. This streamlined approach enabled swift and efficient inspection of the water line. One of the key innovations is the ability to use readily available fire hydrants, eliminating the need for creating complex insertion and retrieval points. The dedicated catch device ensures smooth retrieval, minimizing disruption and potential damage to the asset. This method streamlines the inspection process, saving time and resources.

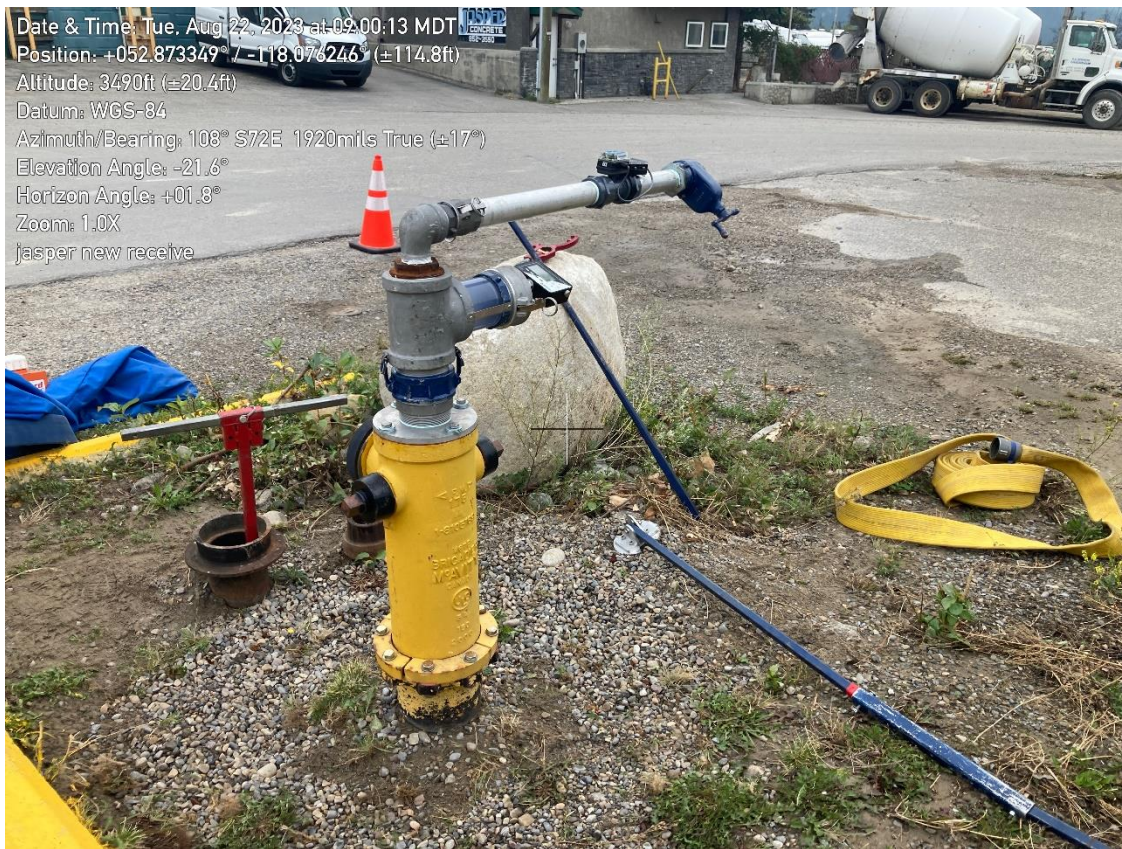
Figure 6. Jasper Retrieve Hydrant

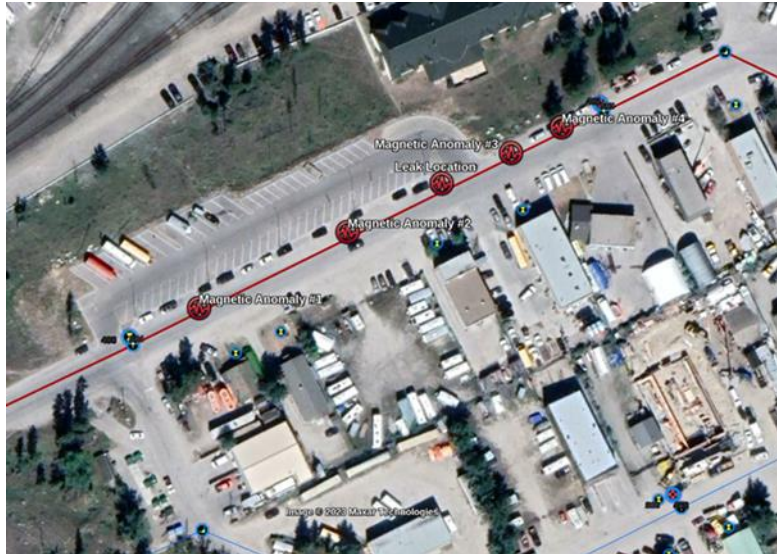
Upon completing the fieldwork, the collected data was swiftly uploaded, and our expert data analyst, utilizing the device's sensors and map files, determined on the same day that a leak had been detected. Leveraging the information gathered, PICA's analysis team provided an approximate location of the leak within a remarkable range of 10 meters. Figure 7 below shows the location of magnetic anomalies and the leak location that was detected by MSAID and our data analysis team.

Figure 7. Map Overview of Jasper Anomalies

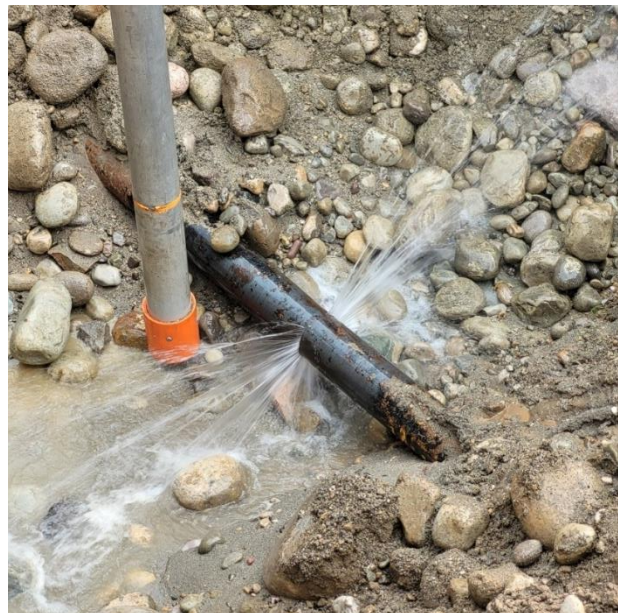
Following the precise leak location identified during fieldwork, the operations team quickly mobilized. The leak identified was a lateral split on the underside of the pipe that encompassed almost 50 percent of the circumference. They were able to locate and repair the leak within days, demonstrating effective collaboration between PICA's data analysis, operations team, and the Municipality of Jasper. This prompt action minimized disruption to the community's water supply. An image of the leak is shown in Figure 8 below.

Figure 8. Jasper Leak
