**ASCE Conference Proceedings Paper:
Pro-Active Knowledge Based PCCP Asset Management Program**

Jake Regala;¹ Kevin Weeks;²

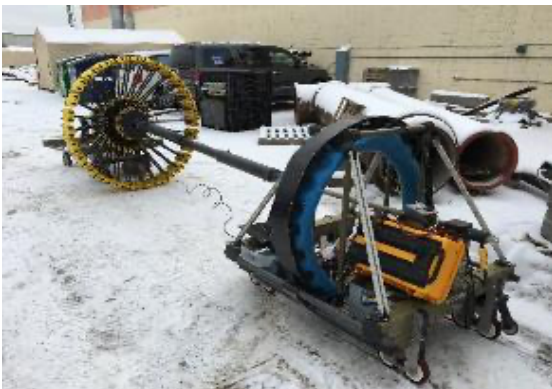
Figure 1. 54-inch EMIT fully assembled in PICA’s yard for calibration testing.

The loss of preload study was performed using PICA’s Electromagnetic Inspection Tool (EMIT) shown in Figure 1 below. With the EMIT tool shown in Figure 1, there is one exciter coil and one detector coil where both coils are wound co-axially to the examined pipe and are separated by a distance greater than two times the pipe diameter. The actual separation depends on the application but will always be a minimum of two pipe diameters. The EMIT tool works by measuring the “time of flight” (phase shift) and the signal strength (amplitude) of a signal emitted by an exciter coil and detected by an array of receivers. The receivers are positioned circumferentially so that each one is sensitive to one of the many clock locations of the pipe circumference.

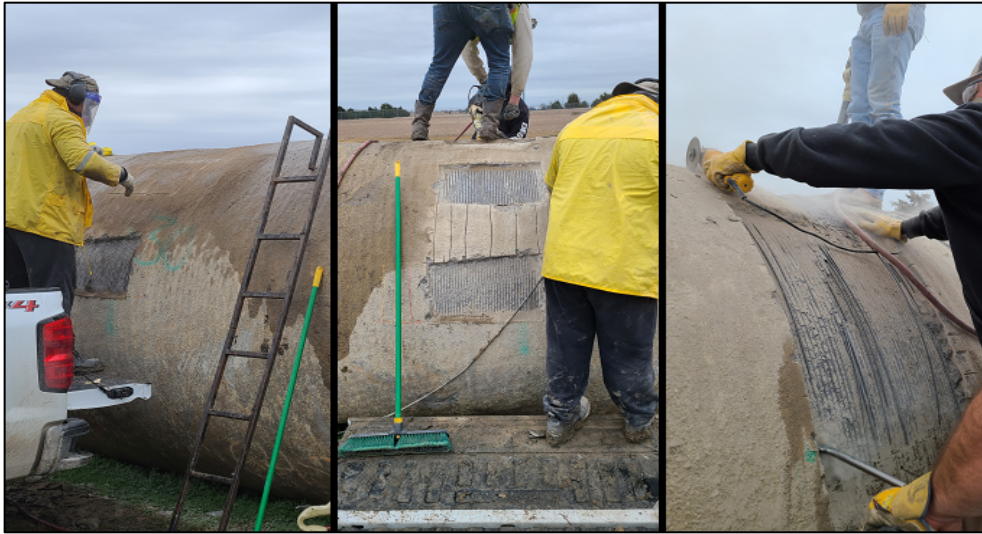
Figure 3. PICA technicians removing an outer concrete window

In the testbed environment, a series of deliberate modifications were made to simulate different failure mechanisms. Concrete mortar was removed incrementally to expose prestressing wires, which were then selectively cut to represent localized and distributed breaks. These controlled interventions allowed researchers to observe the impact of specific damage types on preload loss and electromagnetic signals. The testbed experiments also included attempts to restore preload using hydraulic tensioning straps. By applying controlled forces to the exposed steel

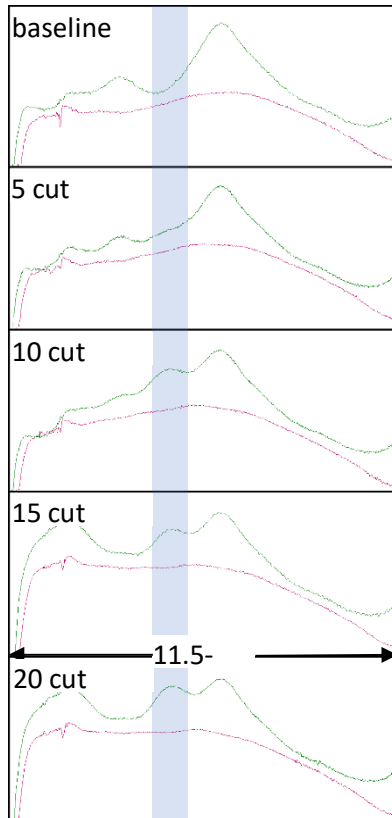
Figure 4 depicts RFT data from the region where different distributions of wires were cut. The blue shaded region highlights the signal response as the wire cut quantity and cut density increases. Even as few as five cut wires, where each cut wire is separated by three intact wires, is detectable when compared against baseline. After cutting ten wires and leaving one intact wire between the cuts, the signal perturbation is prominent and distinguishable even in the absence of baseline data. The perturbation grows at fifteen cut wires and is larger again at twenty sequential

cut wires. The growing perturbation on the left-hand-side of panes four and five is the result of pipe modifications unrelated to this experiment.

Figure 4. RFT data progression of cut wires (blue highlighted signal)

1. The outer concrete was removed, and the region was scanned to establish a baseline that included the slight loss of preload from missing concrete.
2. Five wires were cut, distributed in such a fashion as to maintain three intact wires between the cut ones. The affected region was re-scanned.
3. Next ten wires were cut, distributed such that a sequence of one cut then one intact wire was formed. The affected region was re-scanned.
4. Next fifteen wires were cut, distributed such that a sequence of three cut then one intact wire was formed. The affected region was re-scanned.
5. Finally, twenty sequential wires were cut, and the affected region was re-scanned.

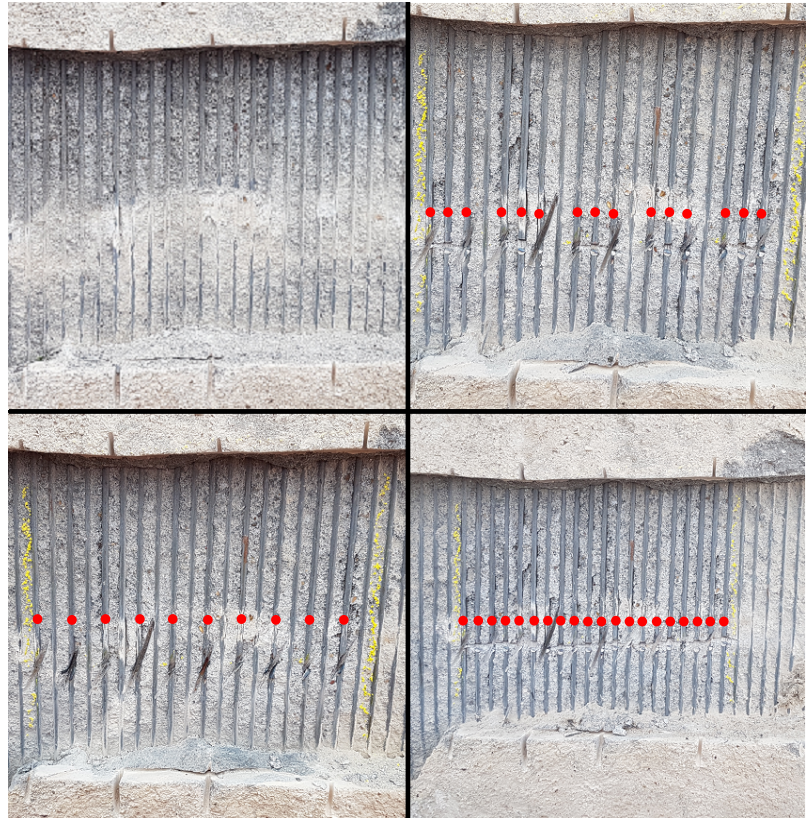
Figure 5 depicts the progression of wire cuts where each red dot signifies a wire modification.

Figure 5. Exposed pre-tensioning wires
