PIPELINES 2025 CONFERENCE

Pro-Active Knowledge-Based PCCP Pipe Asset Management Program

Speaker [Scott Popovic, Solutions Engineer, PICA Corp.](#)

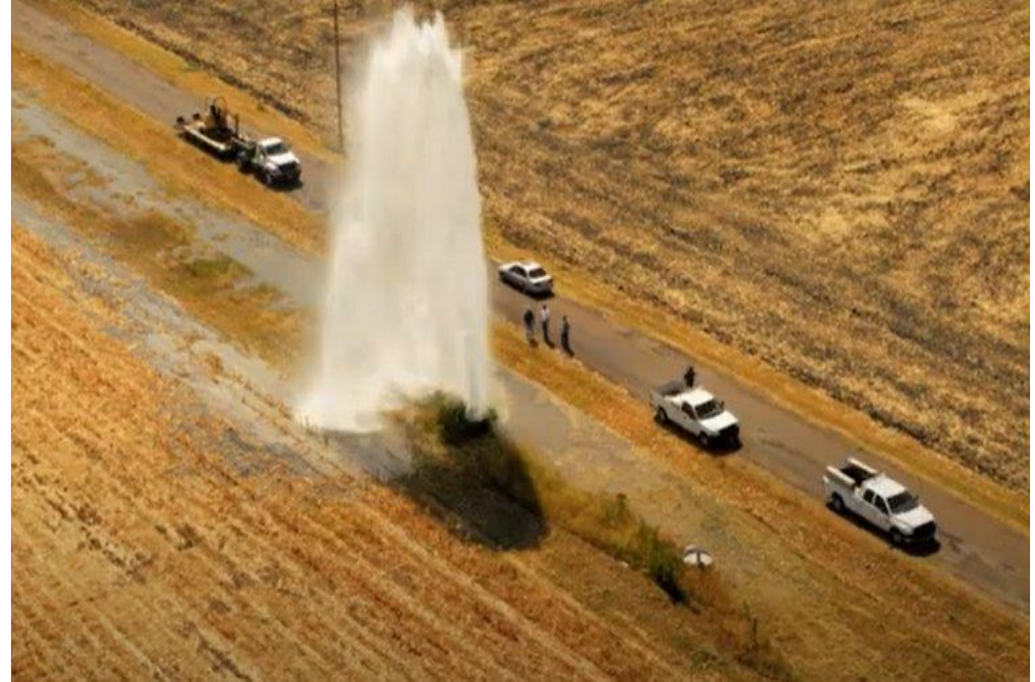
PCCP Failures

PCCP failures can be catastrophic and lead to:

- Extended service interruptions
- Sink holes
- Property damage
- Local flooding

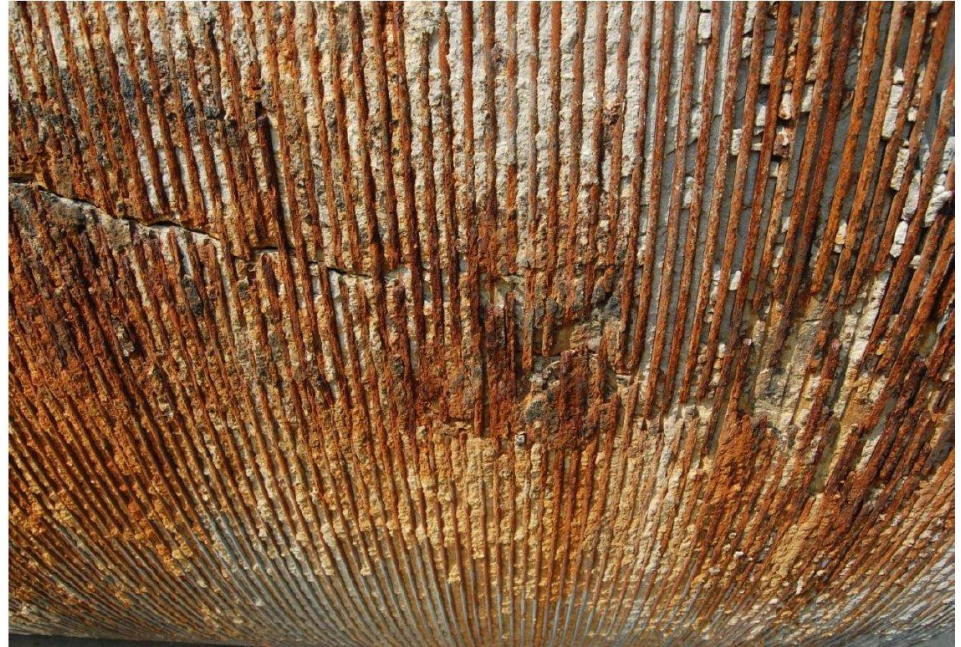
Mechanism of Failure

- Cracks in mortar allow water to corrode the pre-stressing wires
- Corrosion continues beyond the wires to the steel cylinder, allowing more water and oxygen to accelerate the process
- When enough adjacent wires break, the cylinder fails

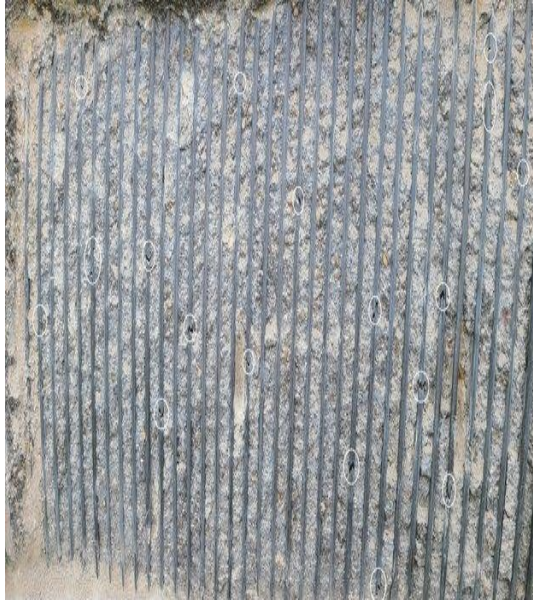
HE wires show only small separation

- Some pre-stressing wires may experience Hydrogen Embrittlement (HE) and not corrosion
- Hydrogen Embrittled wires:
 - Can occur at any clock position, and on non-adjacent wires
 - May not result in any significant separation of the wires
 - Wires can retain some or all pre-load on the cylinder
 - May not pose imminent integrity threats to the pipe

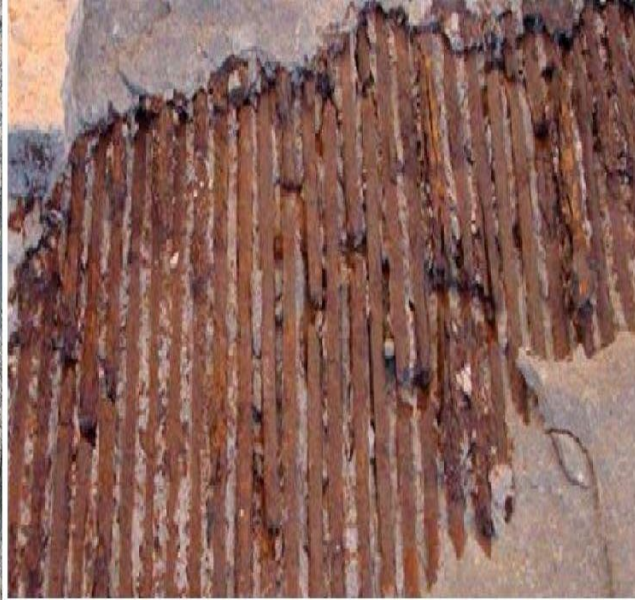
Corroded wires lose bond and recoil

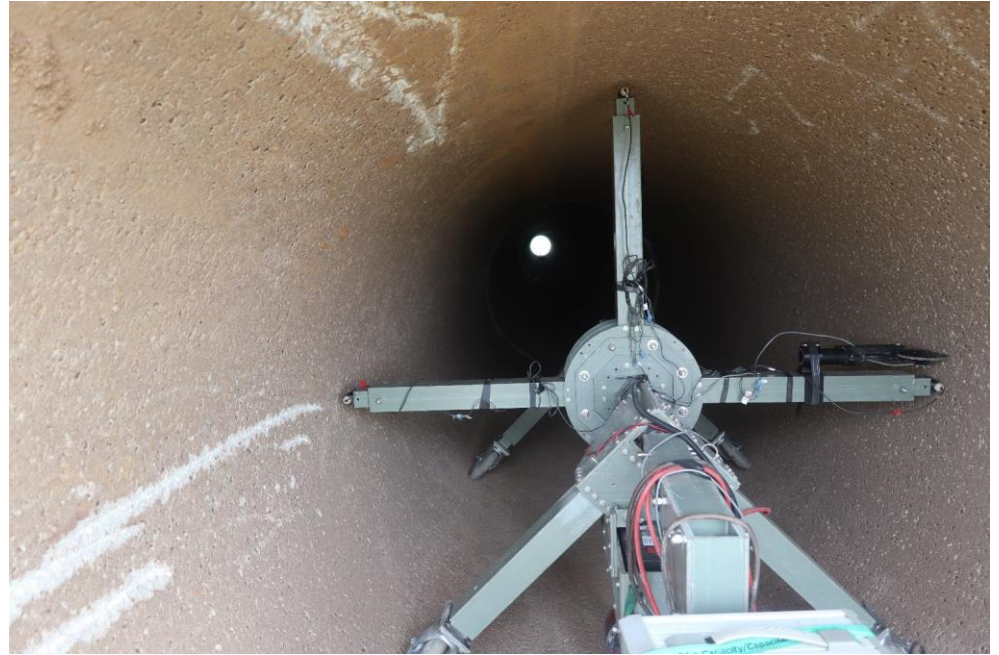
Historical PCCP Asset Management

- PCCP assets have typically been inspected using [Near Field Testing \(NFT\) technology](#)
- NFT uses a weak electromagnetic (EM) field to identify broken wires in PCCP
- Replacing all pipe segments with broken wires is not always feasible

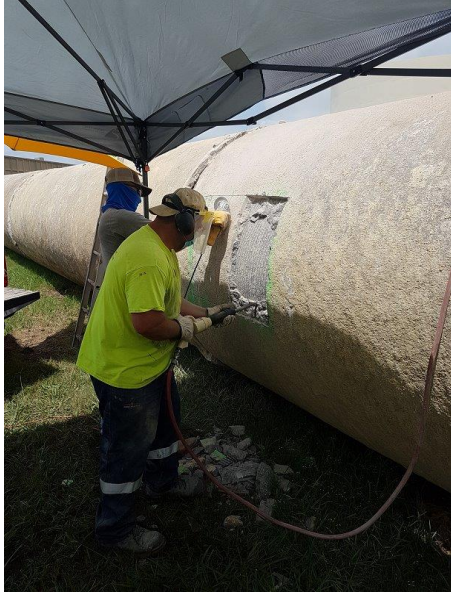
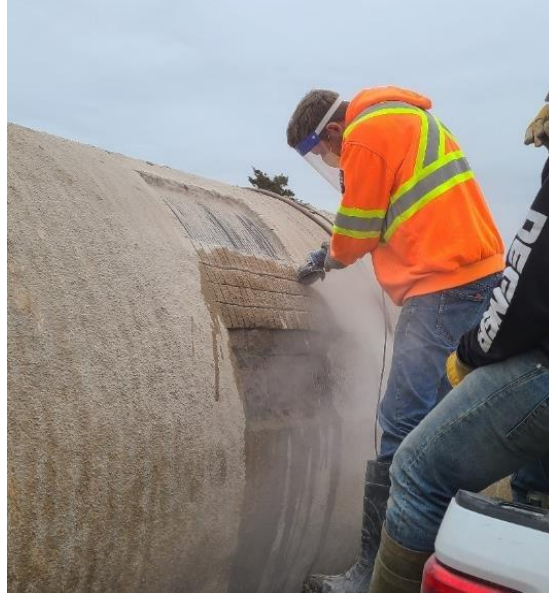
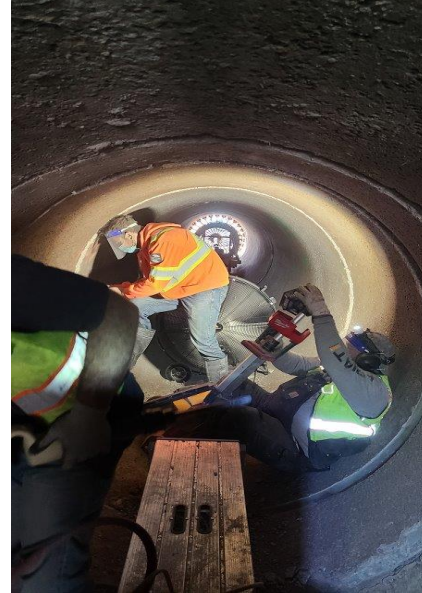
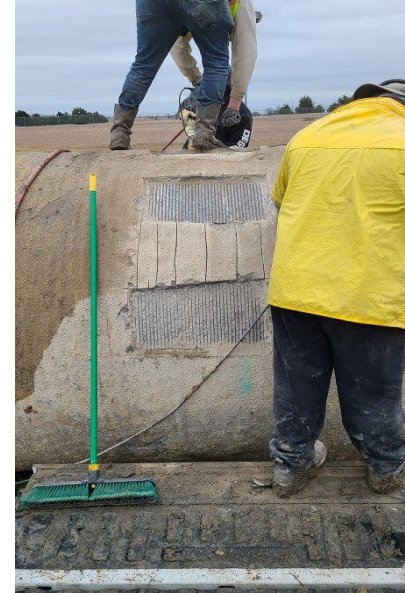
PICA/TRWD Pilot Study Photos

- A series of Advanced NDT scans were completed on excavated segments of PCCP, as well as a 5,000' buried section of pipeline
- Following the completion of baseline testbed scans, [PICA](#) technicians modified the pipe segments by removing mortar, and incrementally altering and cutting pre-stressing wires
- Strain gauges and hydraulically tensioned straps were used to monitor and artificially reintroduce pre-load on the cylinder before and after wires had been cut

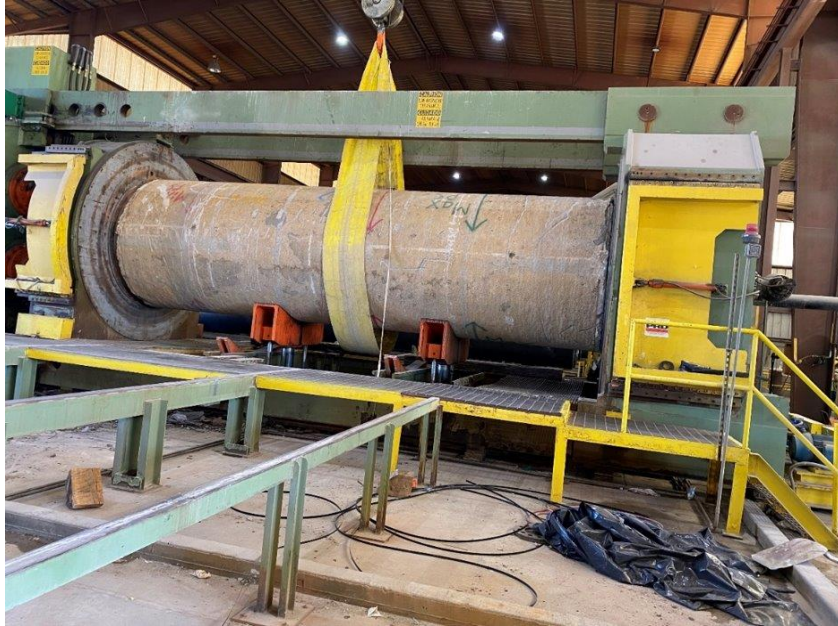
Results of Destructive Testing

- [Advanced NDT](#) results showed scattered broken wires and no loss of pre-load, suspected to be HE
- Destructive testing indicted a less than 10% loss of new strength, suggesting pipe was at minimal risk of failure while buried
