**North American Society for Trenchless Technology (NASTT)  
NASTT's 2014 No-Dig Show**

**TM1-T1-01**

**Discovering Actual Wall-Thickness in a 12-inch Steel Pipe in British  
Columbia, a 22-hour Journey**

William Jappy, PICA Corporation  
Martin, Korz, PICA Corporation  
John Kohut, BC Hydro

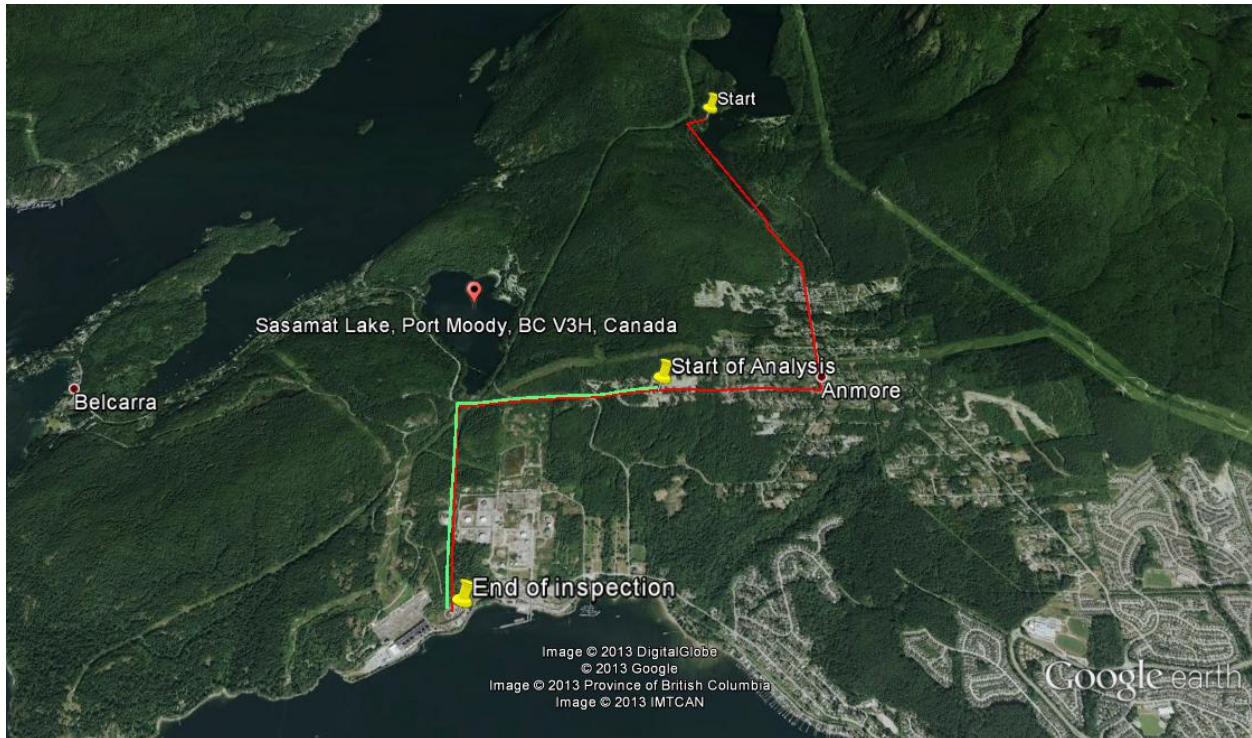
Figure 1: Inspection overview for project

The inspection was performed over three days: a gauge run was completed on April 16, and a Remote-Field-Testing (RFT) inspection was completed on April 17 and 18, 2013. This paper documents PICA's RFT condition assessment results for a subset of the inspected pipeline.
