**North American Society for Trenchless Technology (NASTT)  
NASTT's 2015 No-Dig Show**

**MM-T1-04**

**A Tale of Two Inspections: Using Condition Assessment to Manage  
Force Main Assets**

Chris Garrett, PICA Corp., Miami, FL  
Dennis Dineer, Donohue & Associates, Milwaukee, WI

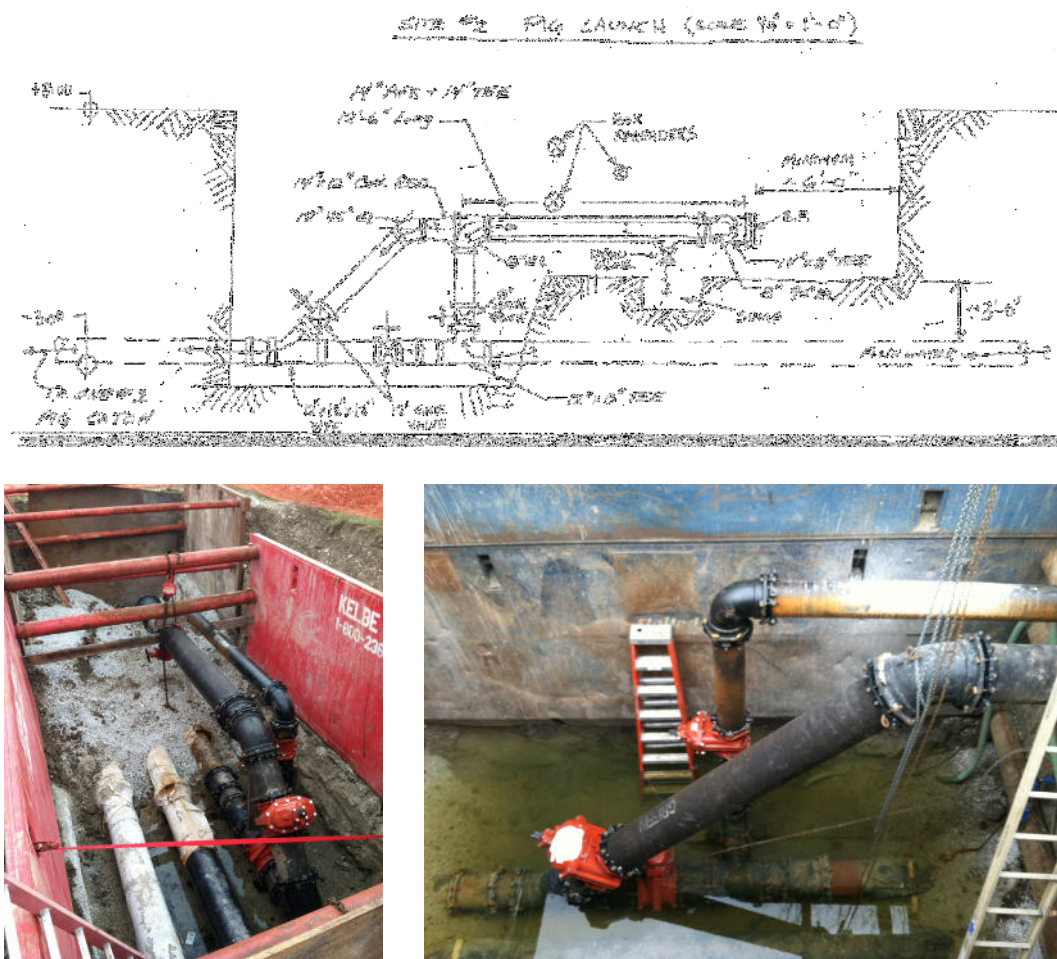
Grunau Company excavated and located the existing pipeline and installed temporary launch and receive stations (Figure 3). They also provided general field support including heavy lift capability and valve operation.

Figure 3. Sketch of launch modifications (top); Launch facility (bottom-left); Receive facility (bottom-right)

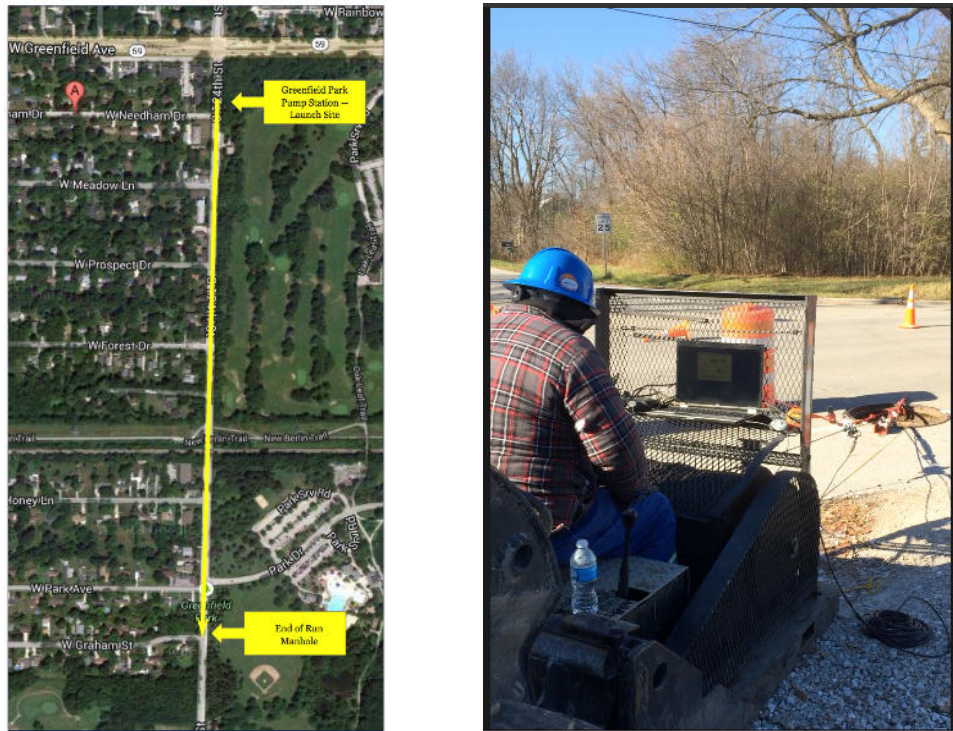
Figure 6. Aerial of Project Two (left); Receive manhole with winch and operator (right)

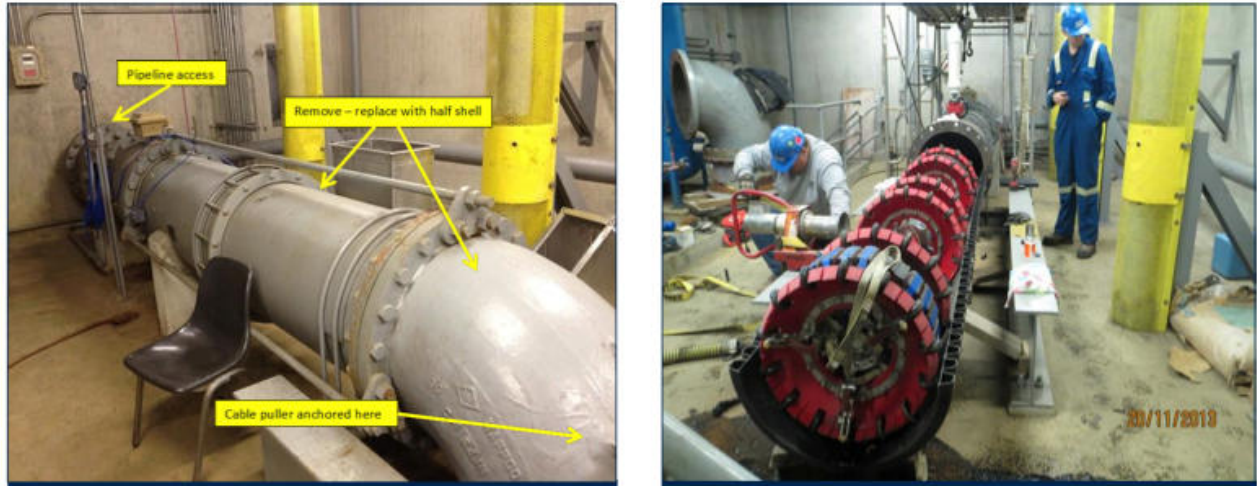
PICA mobilized to Milwaukee in November 2013. Once the pump station was locked out, MidCity began disassembling pipe within the pump station. National Power Rodding’s tagline was still safely secured in place and PICA was able to attached their SeeSnake tool and being inspection (Figure 7).

Figure 7. Pump station piping under normal operations (left); Station modifications and SeeSnake during inspection interval
