**North American Society for Trenchless Technology (NASTT)
NASTT's 2014 No-Dig Show**

**Leveraging Condition Assessment to Improve your Asset
Management Plan**

Chris Garrett, PICA USA, Miami, FL
Kelly Derr, Brown & Caldwell, Raleigh, NC
David Niese, Mount Pleasant Waterworks, Mount Pleasant, SC

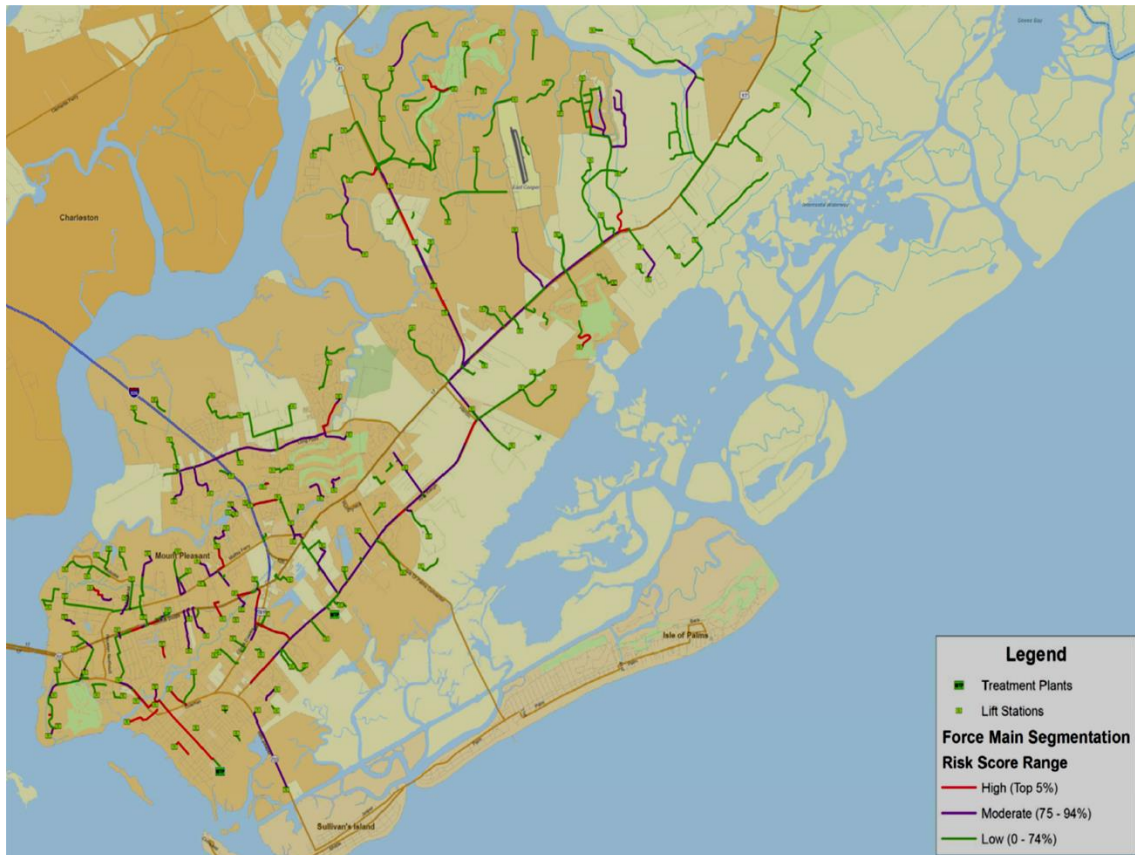
Figure 1: An overview of the MPW force main system, scored for Risk Ranking Prioritization

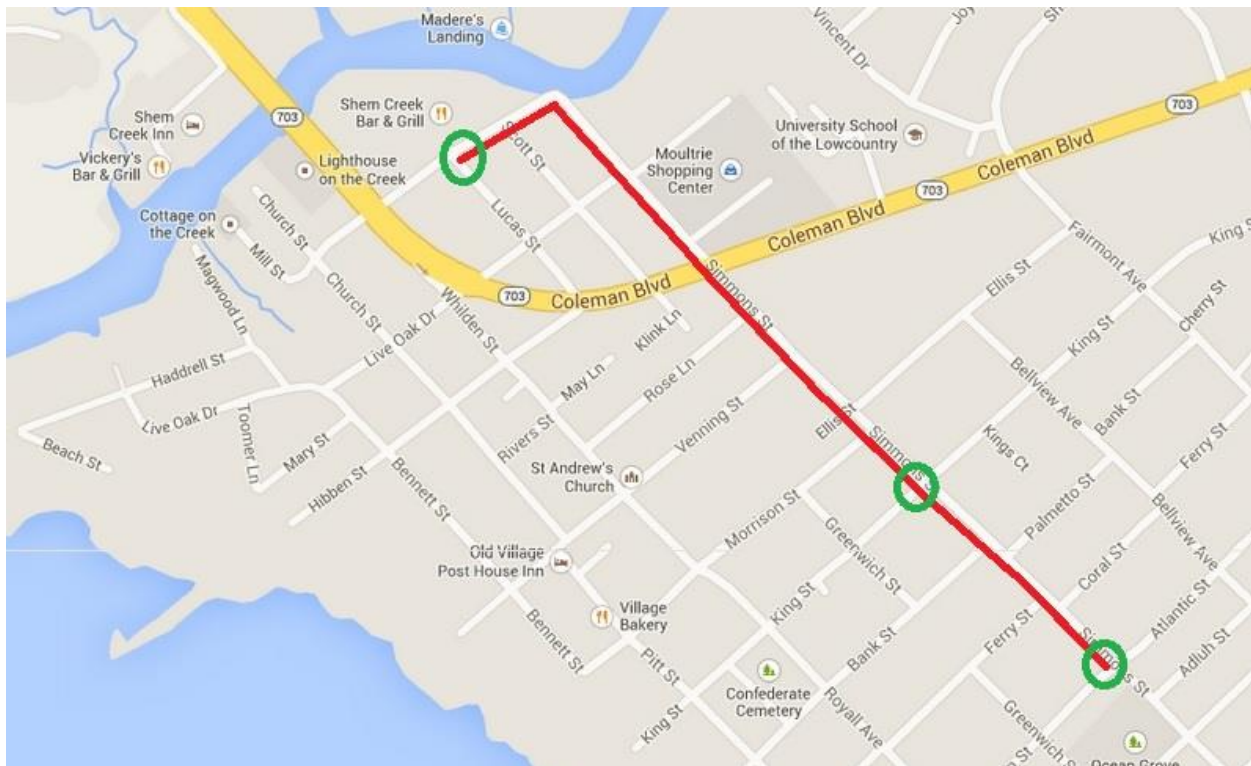
Figure 3: Overview of the pipeline that was inspected using PICA’s SeeSnake tool. The Green Circles signify the excavation locations that were used for access to the pipeline. Section 1 is ~2,940 feet and Section 2 is ~1,355 feet.
