In-line Inspection Experience with Lined Upstream Pipelines

ABSTRACT

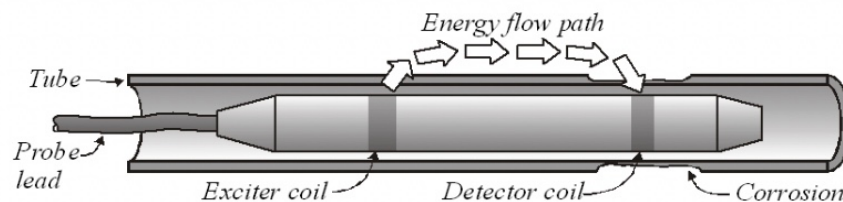
Figure 1: Basic RFT ILI Tool Configuration

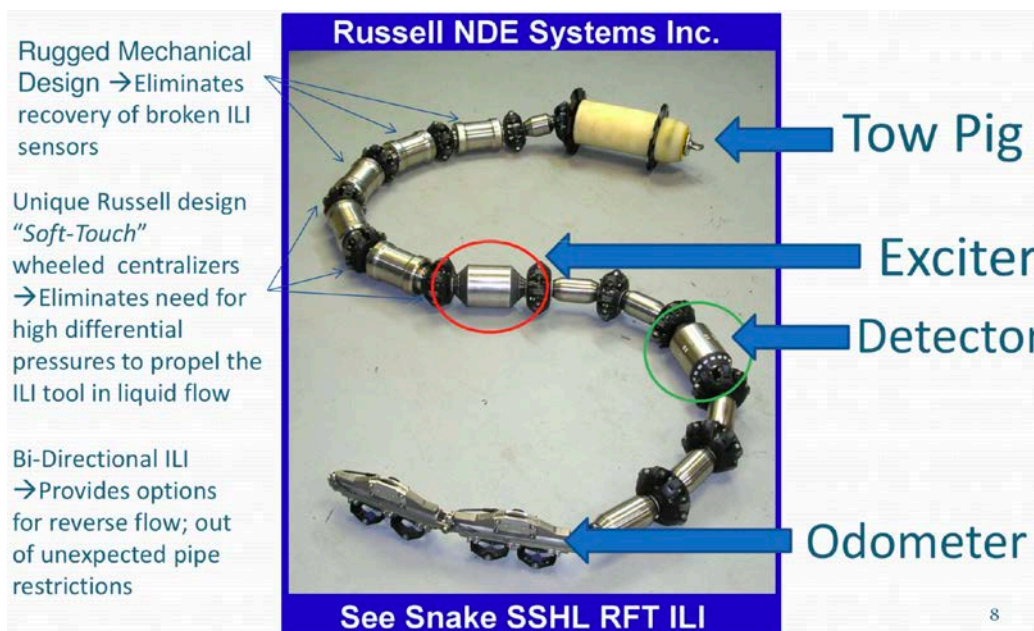
Figure 2: RFT ILI Tool and Components

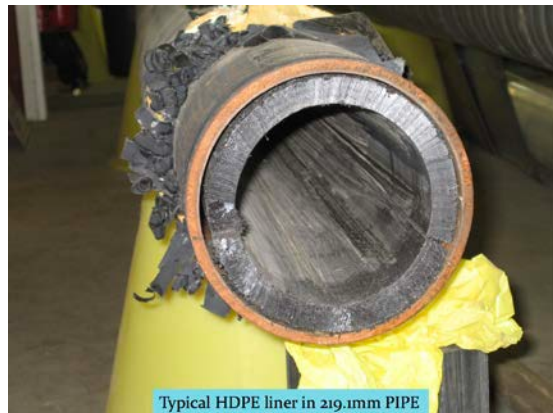
Shell partnered with Russell NDE Systems Inc. (Russell) to develop an RFT ILI tool for Shell's custom pipeline internal diameters of its lined NPS6 and NPS8 pipelines (Ref. 3). The thick HDPE liner precluded the use of other ILI techniques (Figure 3). MFL requires intimate contact of the sensors with the pipe wall and ultrasonic testing (UT) cannot measure through the liner. Removal of liners to allow MFL or UT inspection was not practical.

Figure 3: Lined Sour Gas Pipelines - ILI Technology Challenge

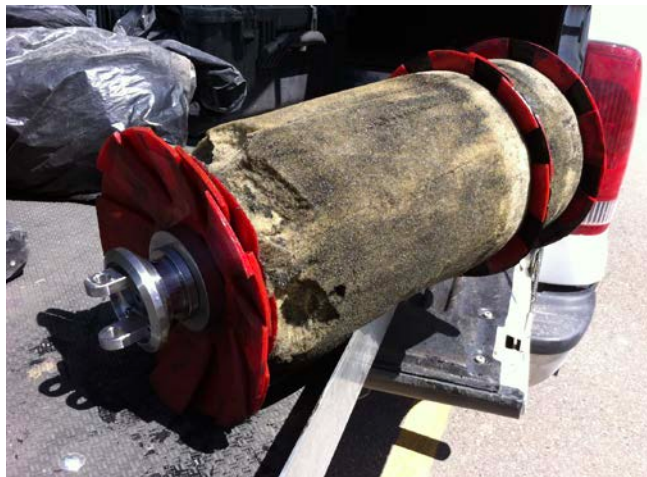
Conventional multi-diameter style pigs are not well suited for internally lined pipelines, but Russell's dual density foam pigs have been used successfully to clean and dewater without damaging the HDPE liner (Figure 7).

Figure 7: Dual Density Foam Tow Pig

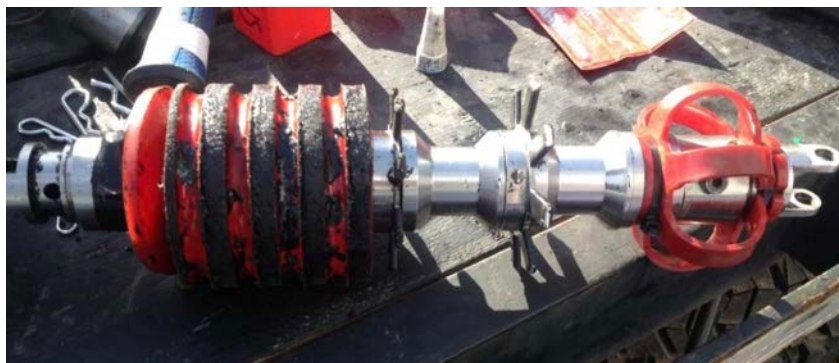
It's important to include a gauge/IMU pig run prior to each RFT ILI tool run. The gauge/IMU pig (Figure 8) is run prior to the RFT ILI tool to ensure there are no excessive liner restrictions that would prevent safe ILI tool passage. The Gauge/IMU tool provides a record of the location and severity of any pipeline restrictions caused by partial liner collapse and/or swaging at the flanged liner stubs. It also records the locations of all major construction features including pipeline bends which helps in accurate positional location and interpretation of results.

Figure 8: Gauge/IMU Pig
