Sample CCTV & Laser Report

Laser Profilometry Assessment

Project: XXXXX

Project Summary

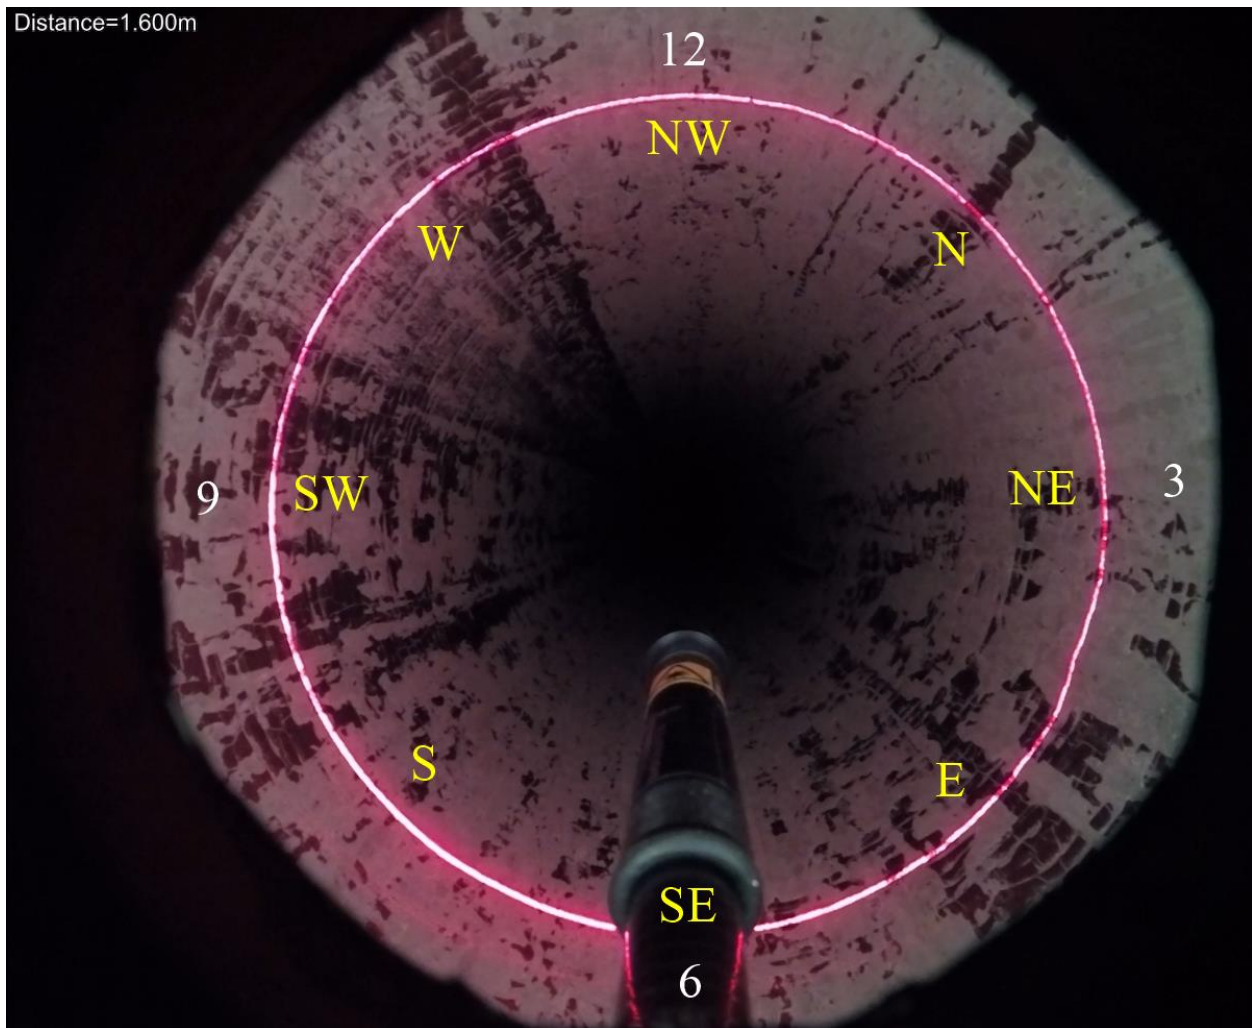
Figure 8. The deployment of the inspection tool going down into Slick Lines #1 & #2 were orientated where the tip of laser tip was facing the SE side wall of the pipe. The inspection length coverage showed no evidence of rotation of the tool during the video review.

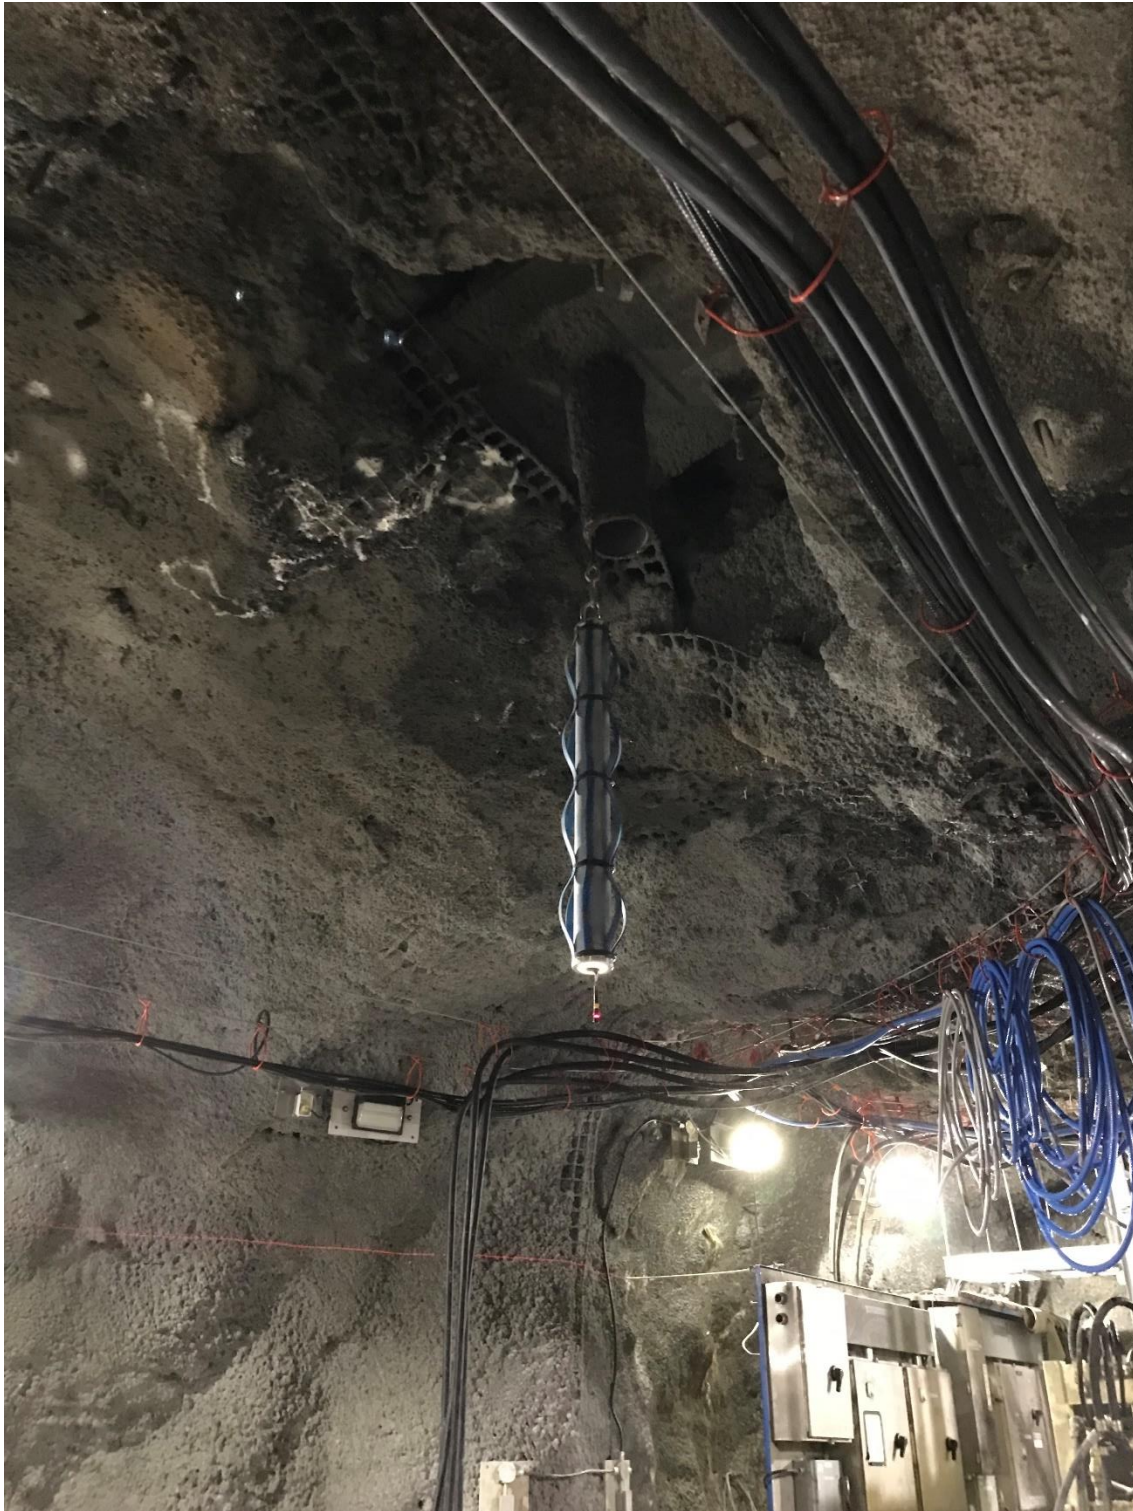
Figure 10. Laser tool exiting at 530 meters below inside mine corridor

NOTE: The hard-facing carbide liner on Slick Line #1 is noticeably thinning based on the CCTV footage from 450 meters to the bottom extent of the pipe that exits into the mine at 530 meters.

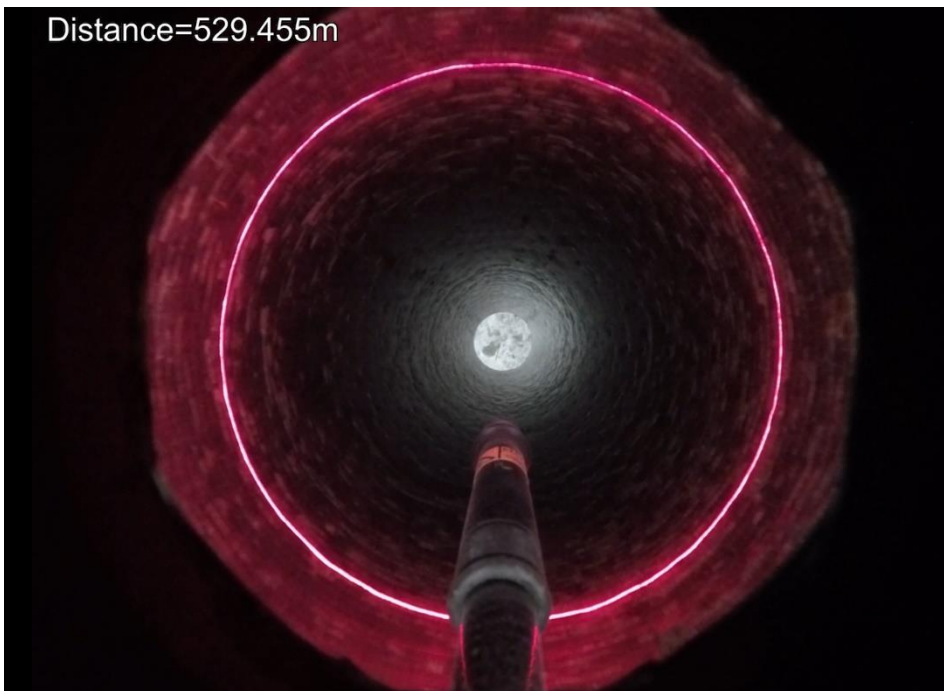
Top Image: The inspection start location at 1.6 meters shows light concrete film over the hard-facing liner on Slick Line #2

Bottom Image: The hard-facing liner is easily seen before exiting at the bottom at the mine

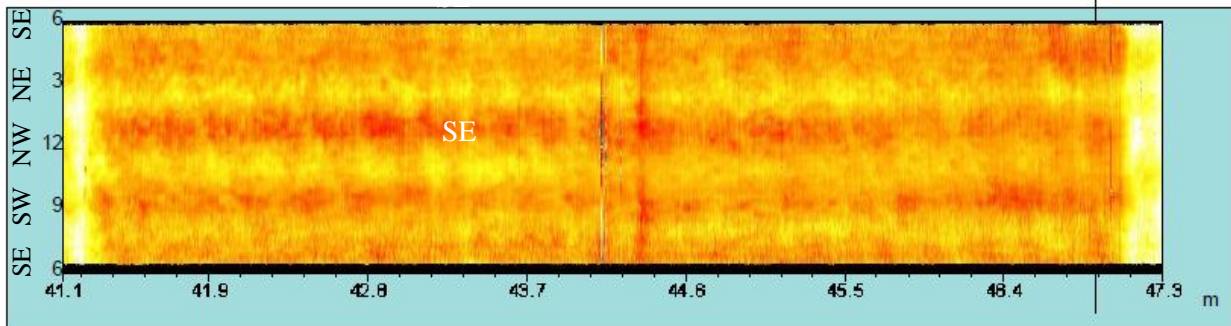
47.0m

Horizontal	206.7mm 1.9%	True	206.7mm
Vertical	206.7mm 1.9%	Ovality	0.3%
Capacity	12.04cm ² 3.7%		
Max	207.2mm 2.1%		
Min	206.1mm 1.6%
