DRAFT REPORT

Navigator Survey

Conducted For:	ABC Consulting
Location:	Anytown, CT
Pipeline Inspected:	Subway 12" FM 3
Inspection Date:	April 10, 2024
Revision:	1.0
Submitted By:	Dmitri Shilov
Submitted on:	May 13, 2024

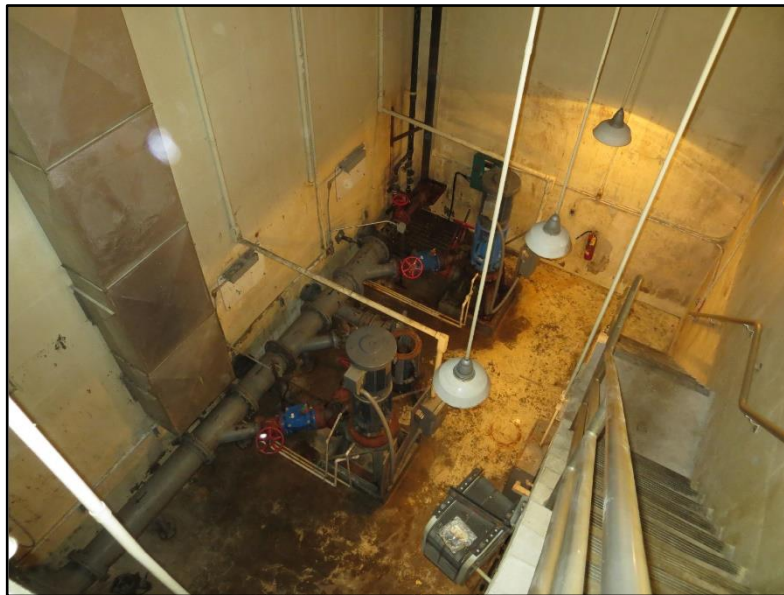
Figure 2 Launch Location at Subway Pump Station

The fieldwork was performed by ABC Consulting. **Figure 2** shows the launch location at the Subway Pump Station and **Figure 3** shows the retrieve location (MH. SR-31 Sta. 21+60). The flow speed was calculated using the pressure and elevation profiles, combined with visible pipe joints.

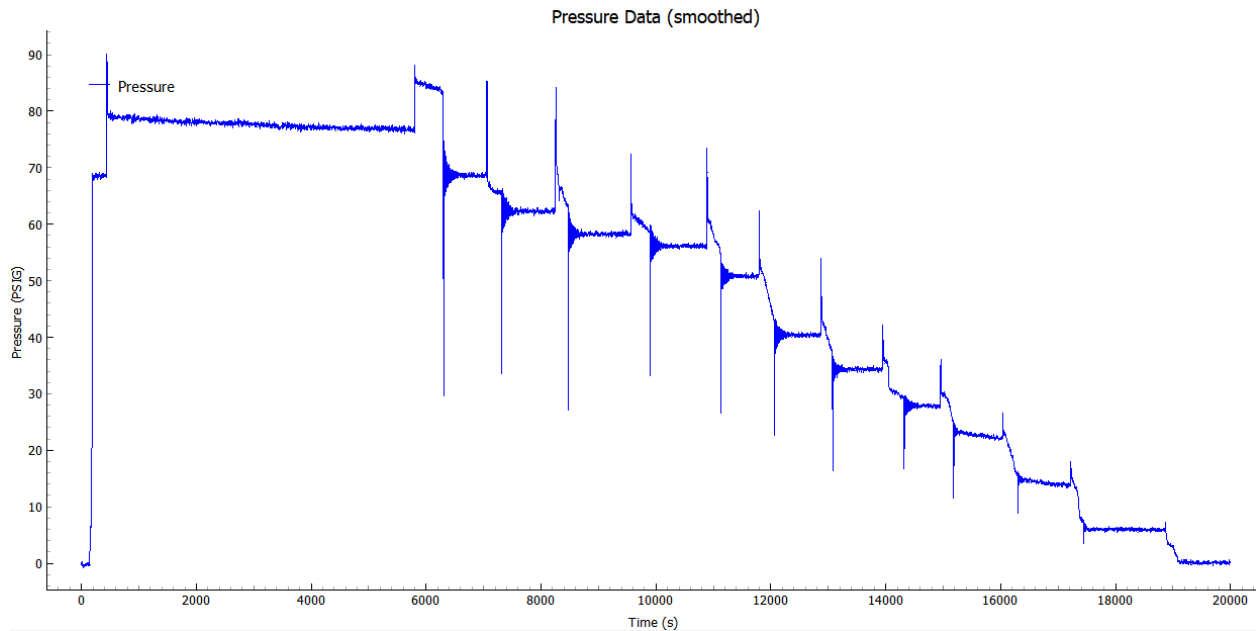
Figure 4 Pressure log of the full run.

Figure 4 shows the pressure log of the full run. The following **Figure 5** shows the pressure chart from the start of the device up to 600 seconds (s), plotted against time. Markings are added to indicate the device placed in water, first valve opened, second valve opened to head pressure, and first pump turning on. After device was placed in water, no significant movement was observed during this time.

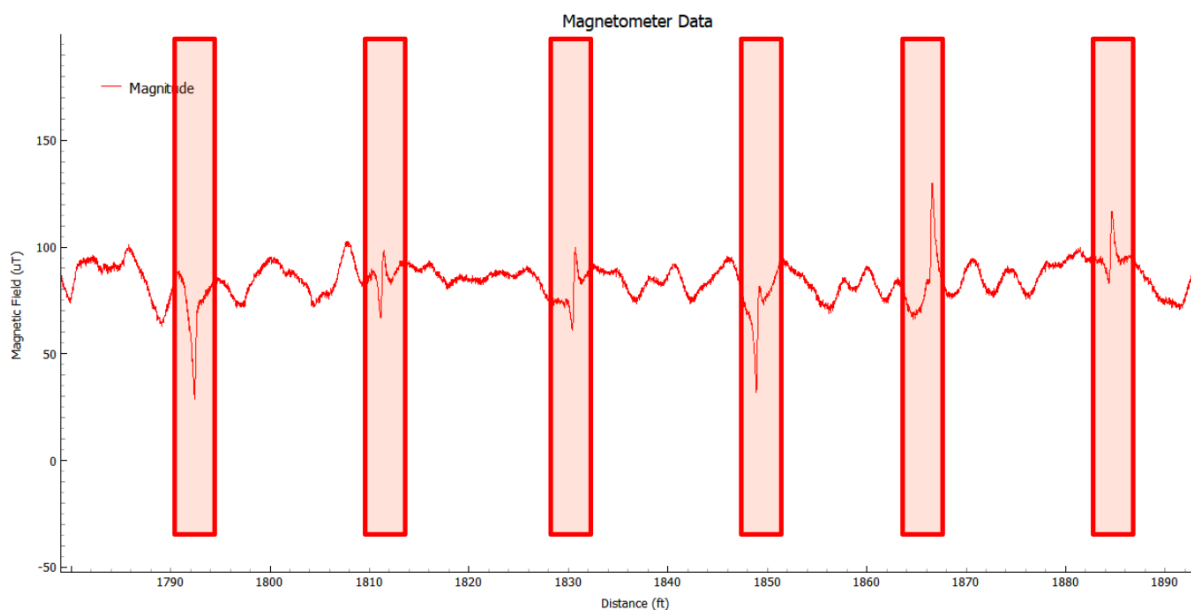
Figure 11 Excerpt of magnetometer data, highlighting the joints.

During this inspection, observed joints were used to refine the speed estimate for the Navigator device.
