## 16" SeeSnake Inspection Tool

## Project Snapshot

- Where: South Carolina
- What: Wastewater Force Main Inspection
- When: Spring 2012
- How: Tethered
- Why: Understand a previous failure and plan for an anticipated increase in capacity
- Distance: 4,300 feet inspected (3,000' section and 1,300' section)

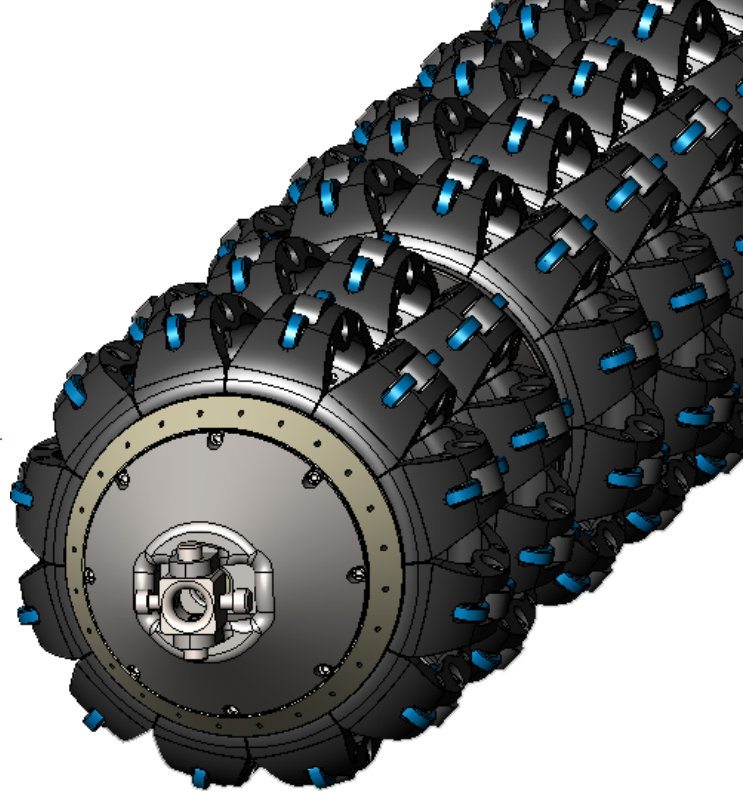
Unsurpassed in sensitivity, cornering ability and range, the new 16-inch See Snake represents the state-of-the-art in Remote Field Technology (RFT) inspection of metallic pipes. By combining some of the latest improvements in RFT technology with traditional pipeline pig designs, the 16-inch See Snake tool provides to municipal engineers the same type of information historically only available to oil and gas pipeline operators; with one major difference: “The See Snake tool determines the remaining wall of the pipe through internal scale and deposits.”

The 16-inch See Snake tool has been specifically designed to inspect the wall thickness of the pipe at variable lift-offs to accommodate wall thickness variations, pipe ovality, liners and internal scale. The ultimate goal of the tool is to provide accurate condition assessment information that will allow reliable planning for critical mains. Using the See Snake’s results operators will be able to determine the weak links in the line and address potential failures before they happen as a result of an external trigger.

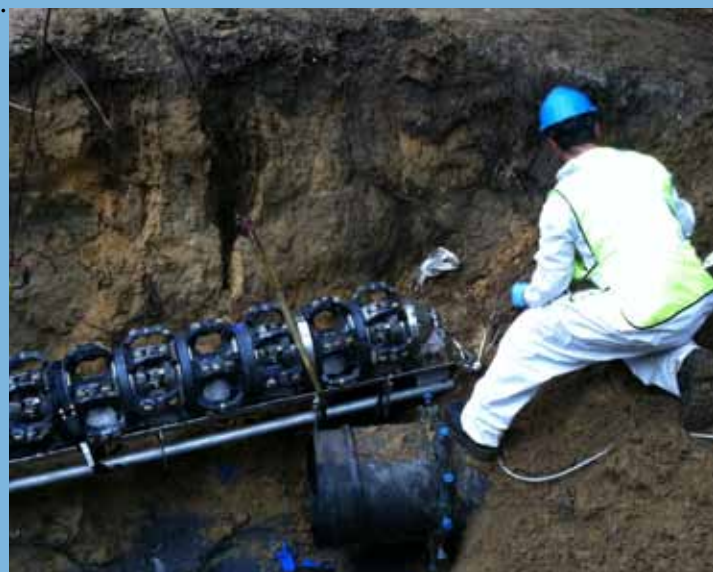
The Final Report contained the following information:

- PICA analyzed 211 pipe joints
- We located and sized the three worst defects in each pipe joint
- Possible through-holes were seen in 8 different joints
- Average Wall Thickness was 95.5% (relative to its installation)
- All of the Advanced corrosion was located within a 10% section of the pipe
